EXISTING CONDITIONS ASSESSMENT

BELMONT, MA CIVIC COMPLEX

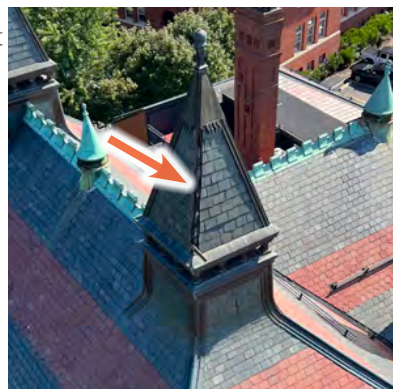
**Image A-04:** Missing hip cap at southern ventilation cupola. roof sheathing is exposed.

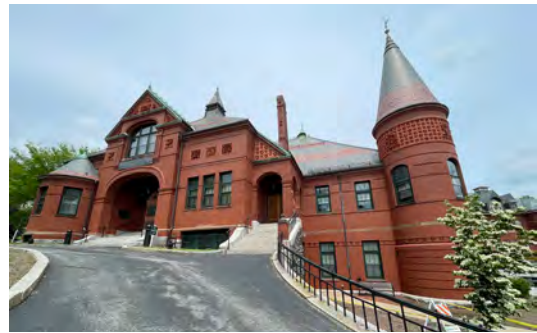
**Image A-01:** View of the south elevation of the Belmont Town Hall, constructed in 1881.

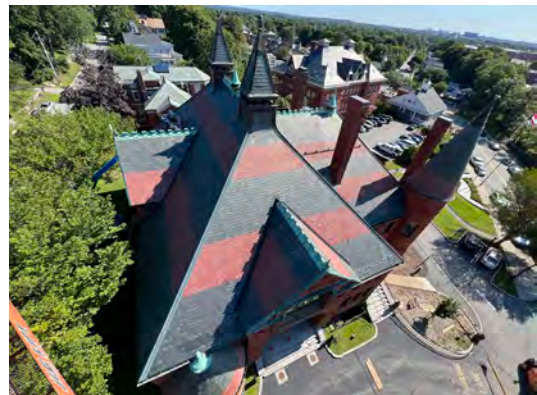
**Image A-03:** Aerial view of the roof showing recently replaced hip caps and valley flashing.

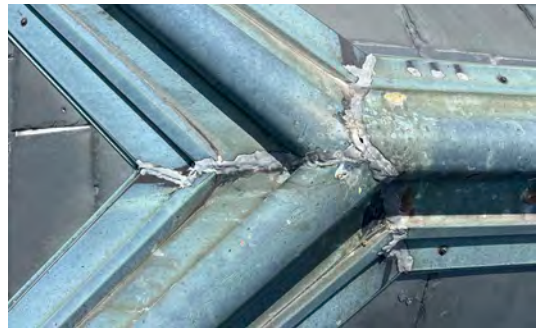
**Image A-05:** Broken solder seam at ridge cap over the northeast addition of the Town Hall.

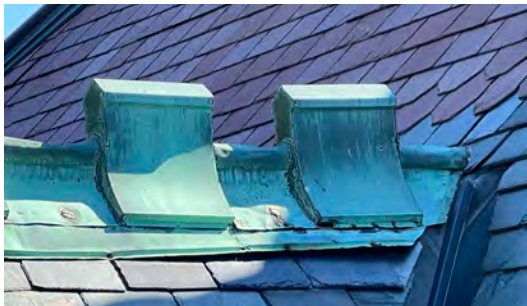
**Image A-06:** Original crenelated copper crestring is in poor condition due to age and weathering.

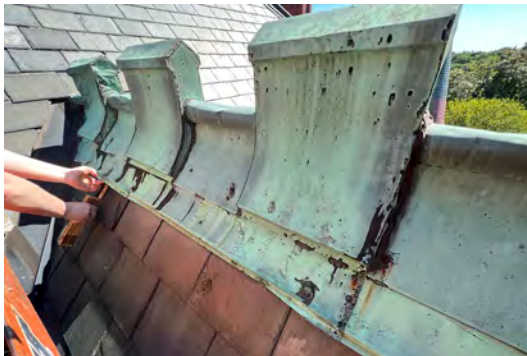
**Image A-07:** Ferrous nails were driven through the crestring to attach it to the roof. Mastic used to seal broken seams.

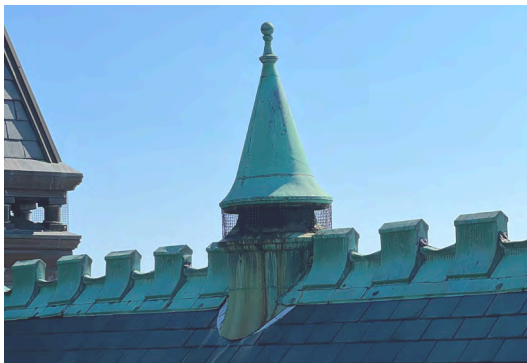
**Image A-08:** View of copper ventilation cupola intergrated with the crenelated crestring at the north-south ridge.

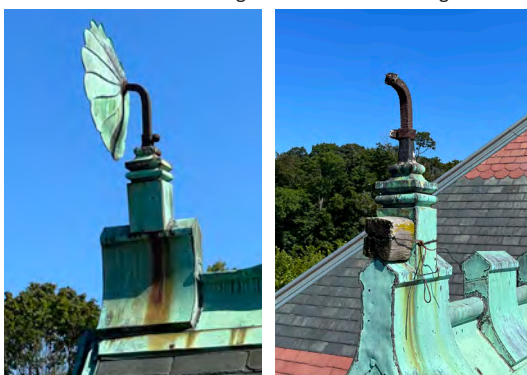
**Image A-09:** View of the original copper floral finial at the west gable end (Left) and the missing finial (Right)

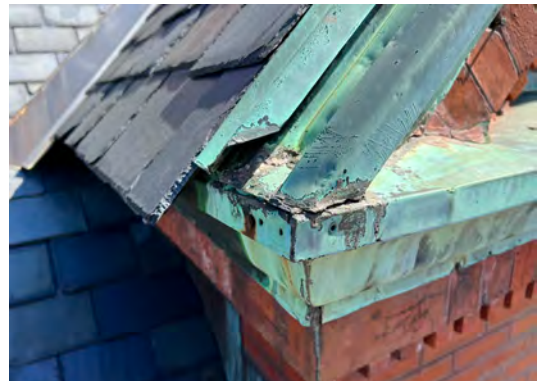
**Image A-10:** View of deteriorated decorative copper moldings at the south gable end. Condition is typical across

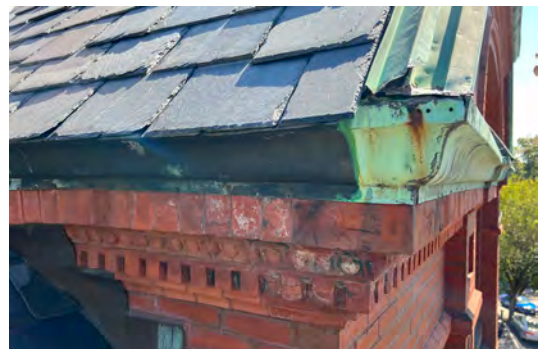
**Image A-11:** Damaged decorative brick cornice as a result of deteriorating copper and face nailing.

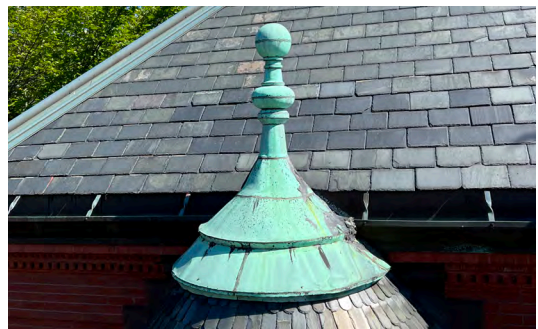
**Image A-12:** View of severely deteriorated original copper finial at south projecting bay window.

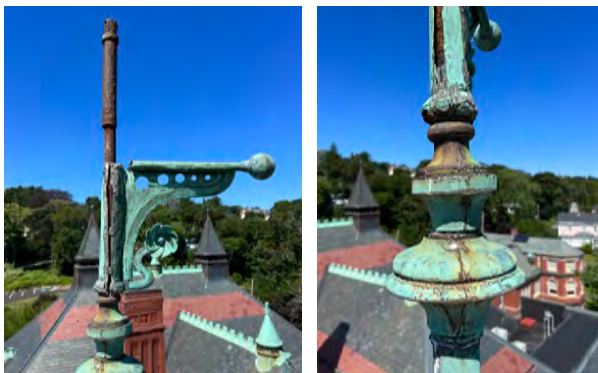
**Image A-14:** Significantly deteriorated original copper weathervane at the top of the turret. Much of the weathervane is missing.

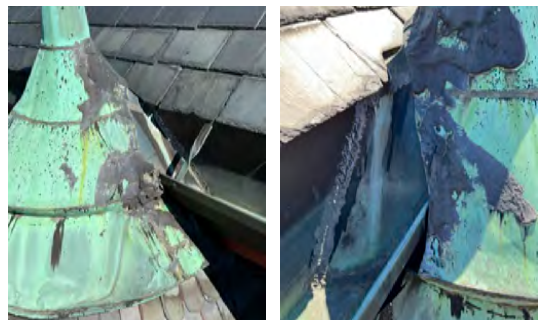
**Image A-13:** Heavy mastic and other patching to prevent water infiltration at questionable gutter intersection.

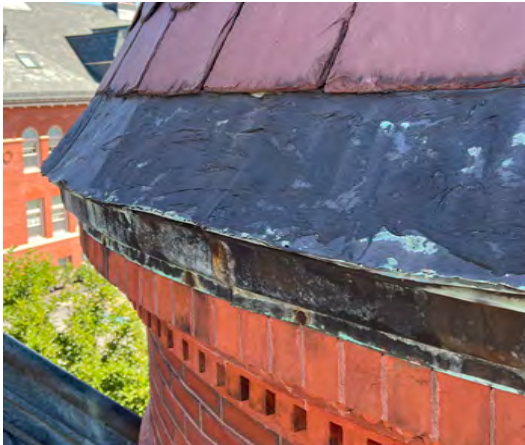
**Image A-15:** Heavy mastic wash over deteriorated copper skirt at the base of the turret roof.

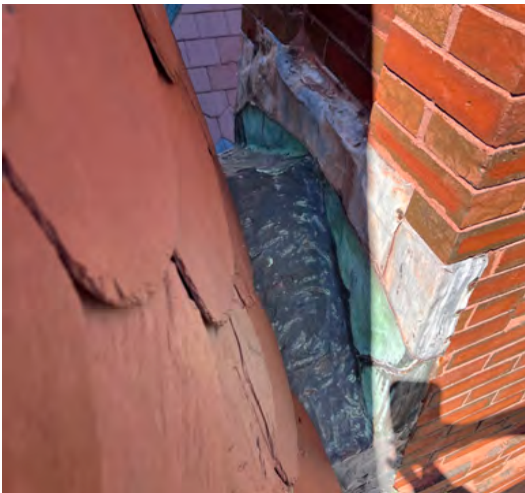
**Image A-16:** Deteriorated copper cricket and flashing between the turret and chimney. Heavily coated with mastic.

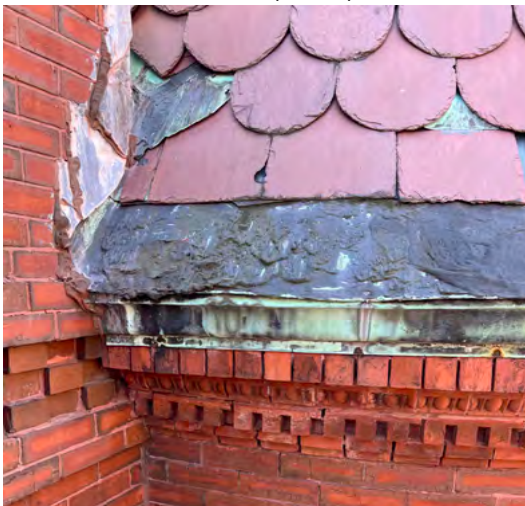
**Image A-17:** Severely deteriorated copper skirt, cornice, and flashing turret roof and chimney.

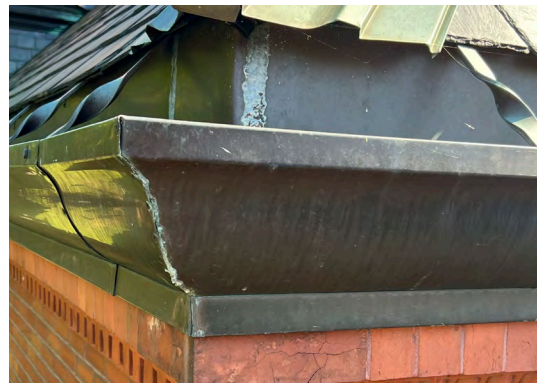
**Image A-18:** Typical k-style copper gutter at south west corner of the Town Hall. Note the open miter joint.

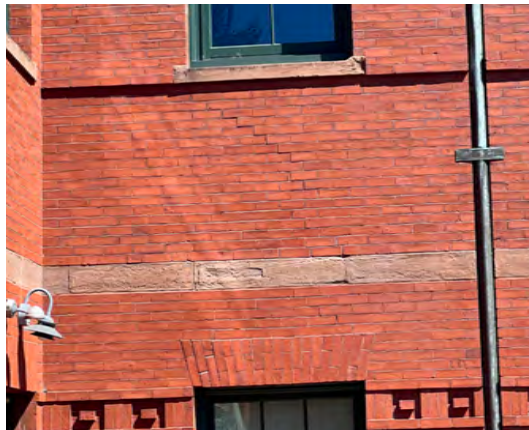
**Image A-21:** Slipping jack arch and step cracking at ground floor windows at south elevation

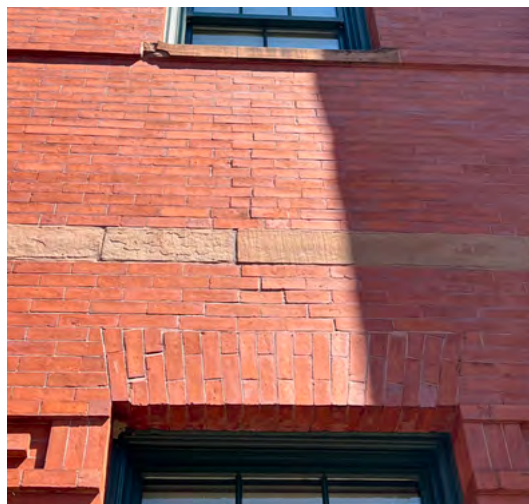
**Image A-22:** Slipping jack arch and step cracking at ground floor windows at south elevation. Note widened joint at arch.

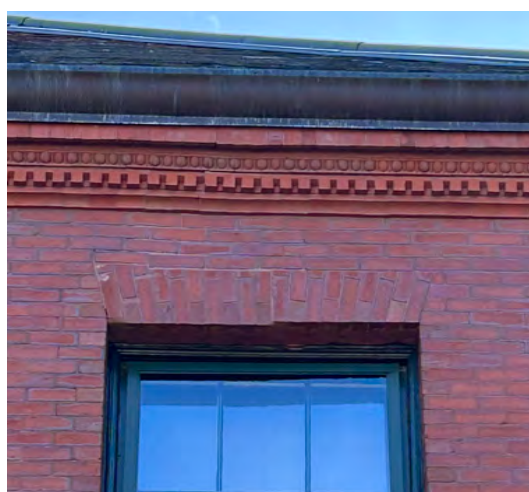
**Image A-23:** Slipping jack arch and step cracking at the second floor window at north elevation .

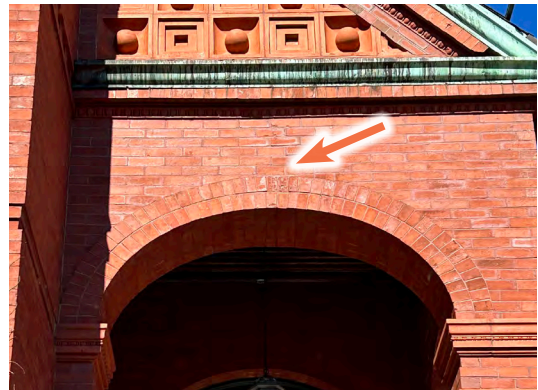
**Image A-24:** Slipping round arch and step cracking at the south portico. Note the broken keystone at the center of the

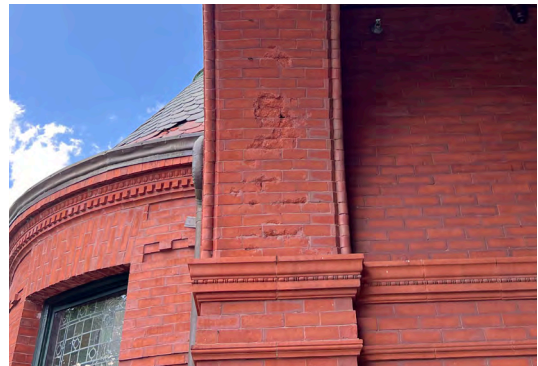
**Image A-25:** Isolated spalling at the west side of the intrados of the main entry arch.

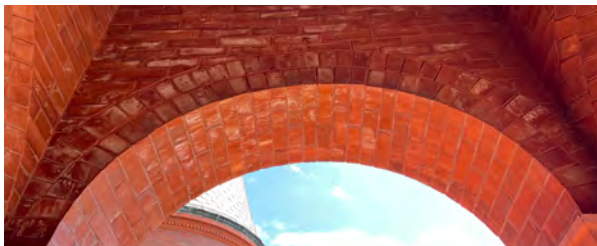
**Image A-27:** Area of efflorescence at interior brick masonry above east facing arch of south portico.

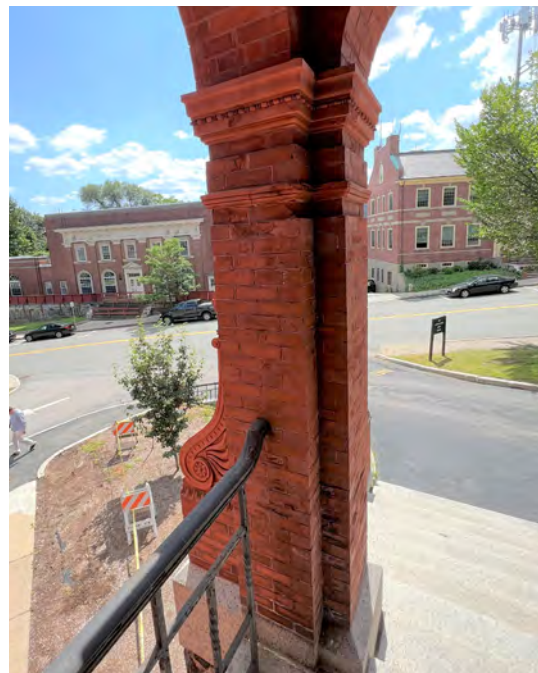
**Image A-26:** Deteriorated and spalling brick masonry at the interior of support column at south portico.

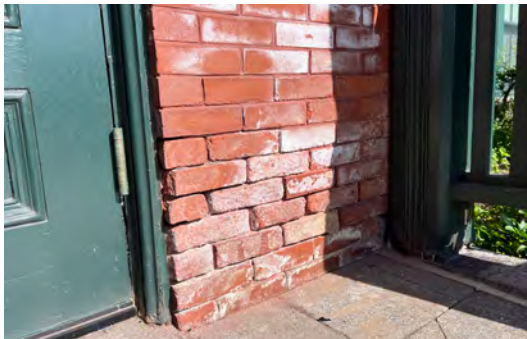
**Image A-28:** Deterioration and efflorescence at base of east entry vestibule caused by rising damp and de-icing salts.

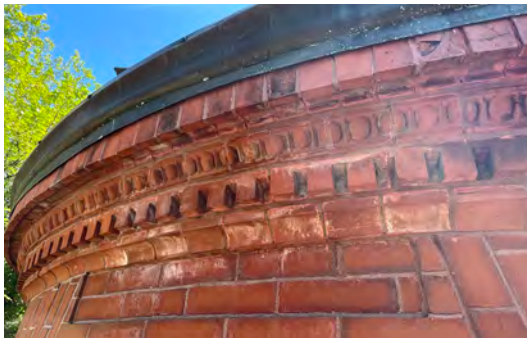
**Image A-29:** Mortar deterioration and efflorescence at decorative brick cornice caused by prior leaking gutters.

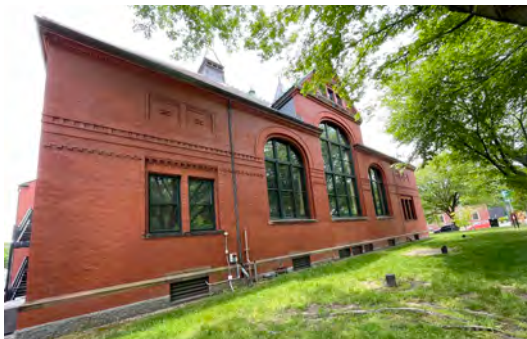
**Image A-30:** View of west elevation showing varying types brick banding that circumvent the Town Hall.

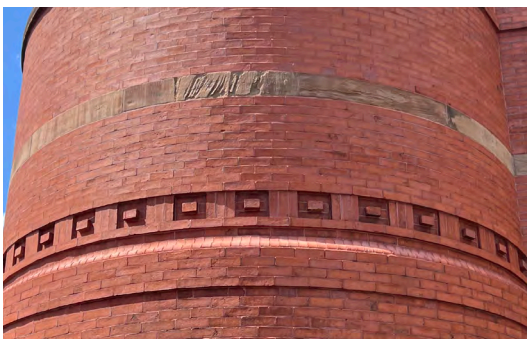
**Image A-31:** View of brownstone and brick banding at the turret. Note the erosion at the brownstone band.

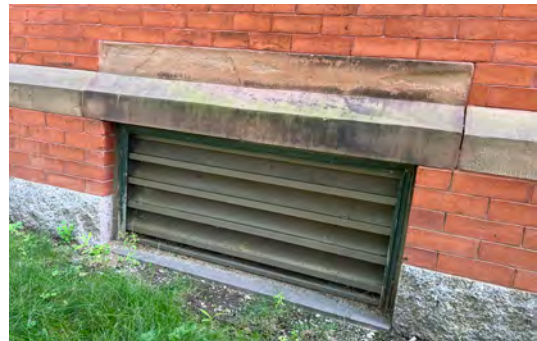
**Image A-32:** Staining, scaling, and open joints at brownstone watertable typical across the building.

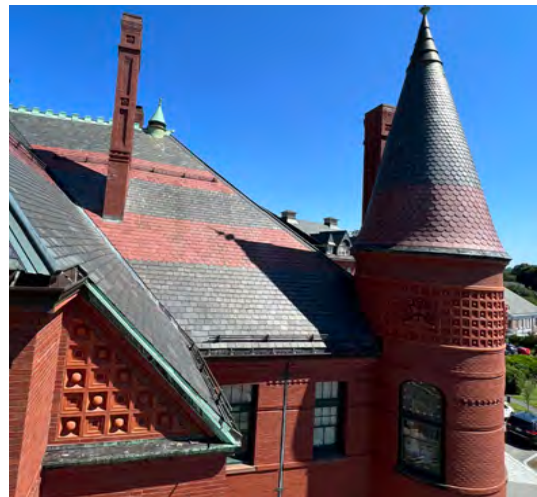
**Image A-33:** Aerial view of the southeast corner of the building showing different geometric terra-cotta decorations.

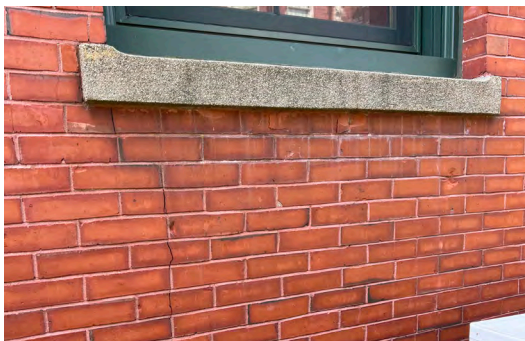
**Image A-37:** Vertical cracks in brick masonry below the first floor cast stone window sills at the north elevation.

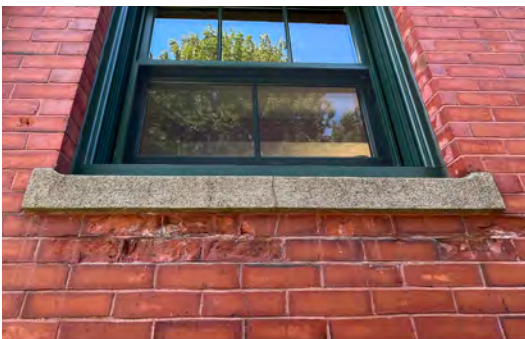
**Image A-38:** Spalling at brick masonry below the cracked first floor cast stone window sills at the north elevation.

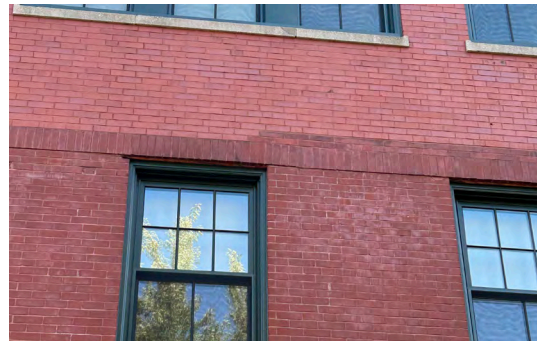
**Image A-39:** Area of bulging brick masonry at second floor window at north elevation due to rust jacking.

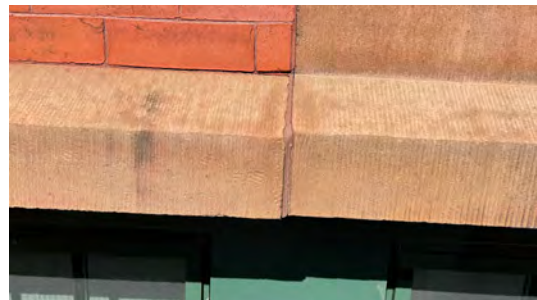
**Image A-40:** Movement at the modified brownstone lintel at the south elevation due to rust jacking

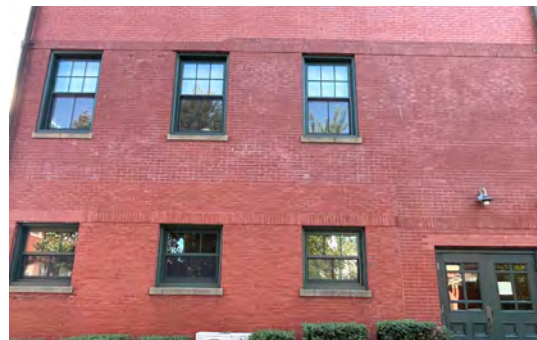
**Image A-41:** Efflorescence appears to be more prominent at second phase of addition.

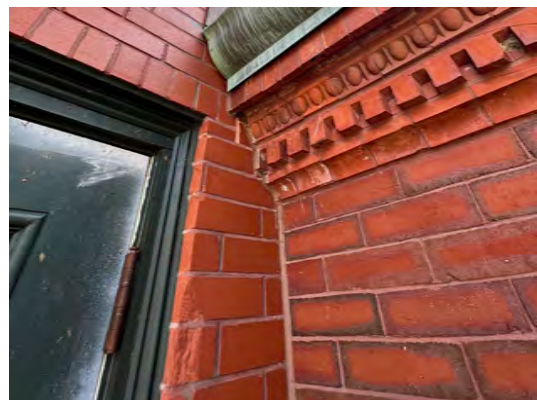
**Image A-42:** Spalling and deterioration of the masonry opening around the door to the fire escape.

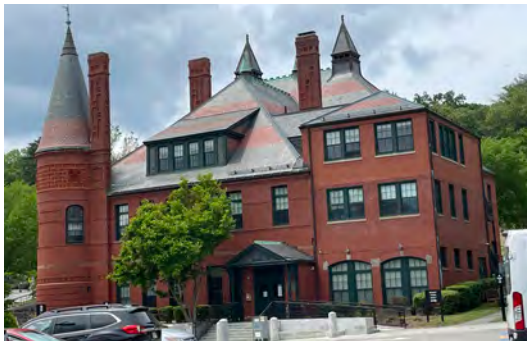
**Image A-43:** View of the east elevation where showing the various types of new aluminum windows on the building.

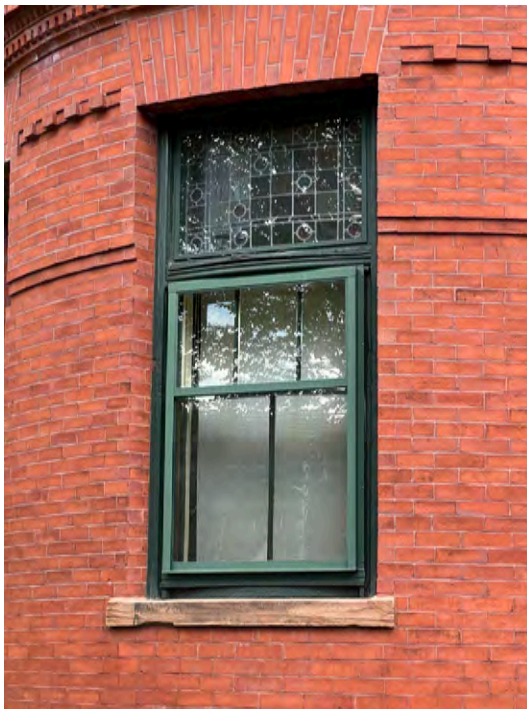
**Image A-44:** View of original wood window at south projecting window bay with stained glass transom.

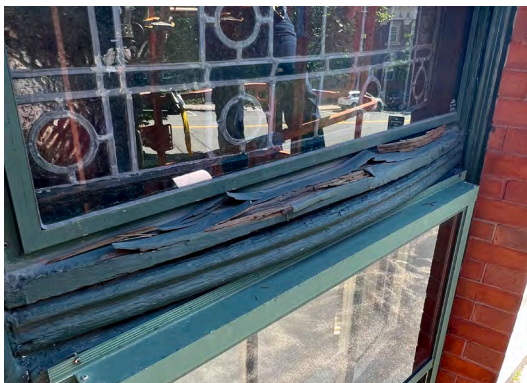
**Image A-45:** Spalling at brick masonry below the cracked first floor cast stone window sills at the north elevation.

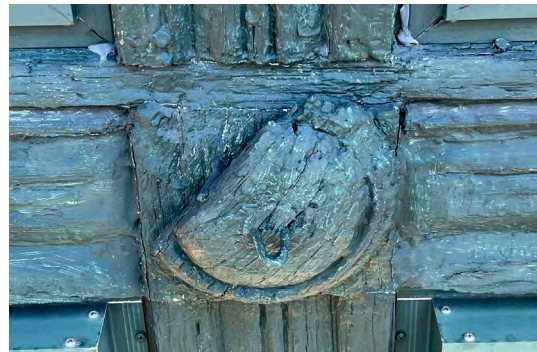
**Image A-46:** View of the deteriorated wood trim and bullseye rosettes at the south gable end's stained glass

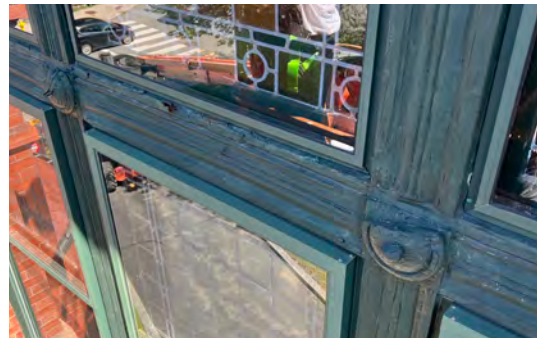
**Image A-47:** View of the deteriorated wood trim and bullseye rosettes at the south gable end's stained glass

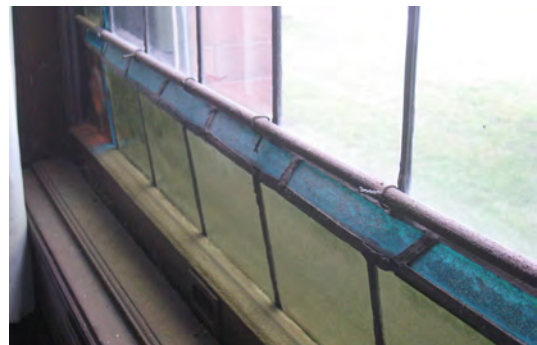
**Image A-48:** Buckling and deteriorated lead joints at large stained glass windows at the west elevation.

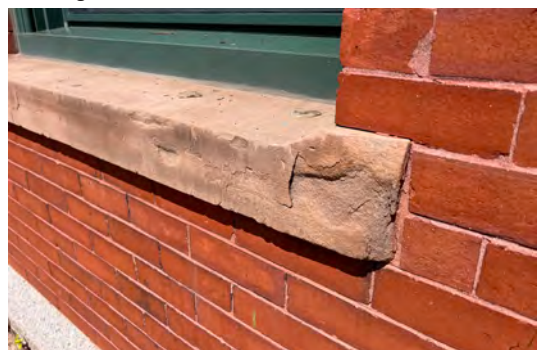
**Image A-49:** Deterioration of brownstone sills across the Belmont Town Hall.

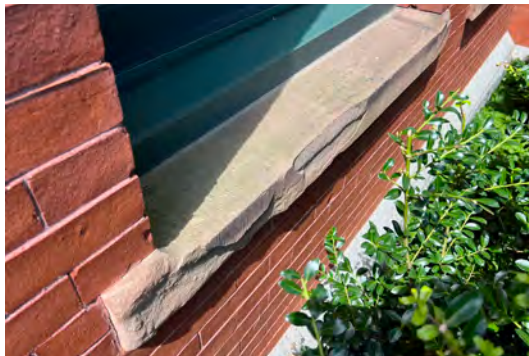
**Image A-50:** Cracking and spalling caused by the pressure of the load traveling down the edges of the masonry openings.

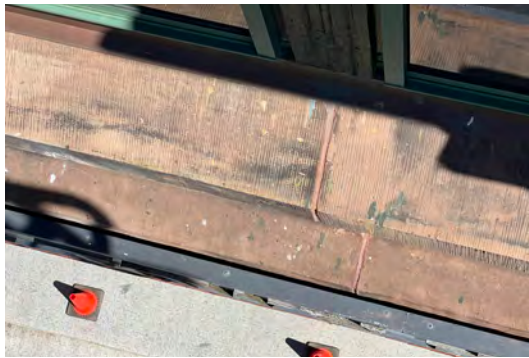
**Image A-51:** Sky-facing joints at large brownstone sills are susceptible to water infiltration and deterioration.

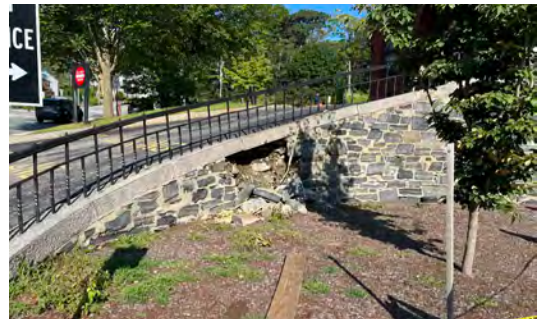
**Image A-52:** Collapsing retaining wall between the driveway and the courtyard at the southeast corner of the building.

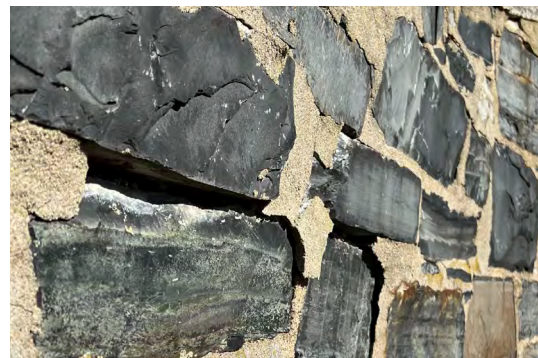
**Image A-54:** Bulging stone masonry at south retaining wall. Mortar is cracking and falling away from the stone.

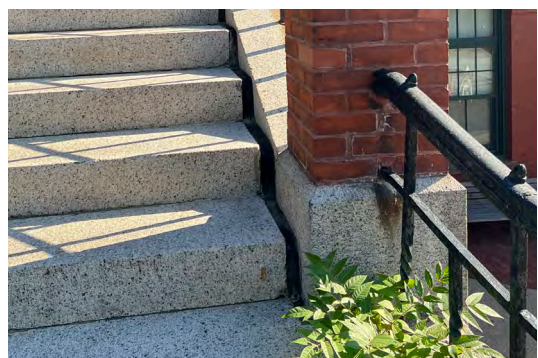
**Image A-55:** Wide cracking joint between the cheek wall and the granite steps at south portico infilled with sealant.

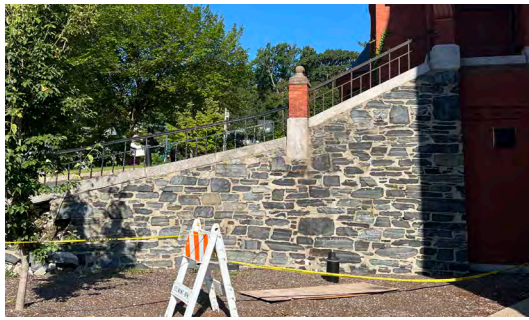
**Image A-56:** View of the cheek wall at the south portico integrated with the retaining wall.

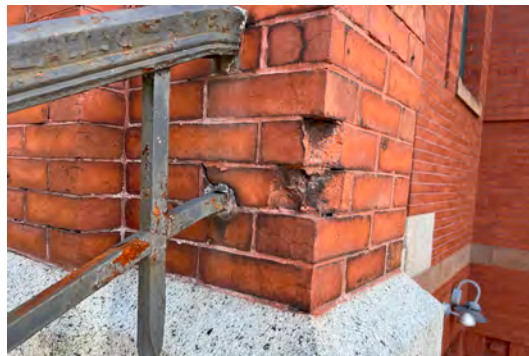
**Image A-57:** brick deterioration caused by twisting metal handrails as a result of the failing retaining wall.

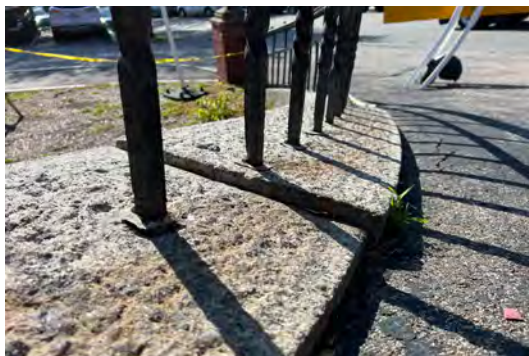
**Image A-58:** Original metal handrails embedded in the granite coping stones at the south retaining wall.

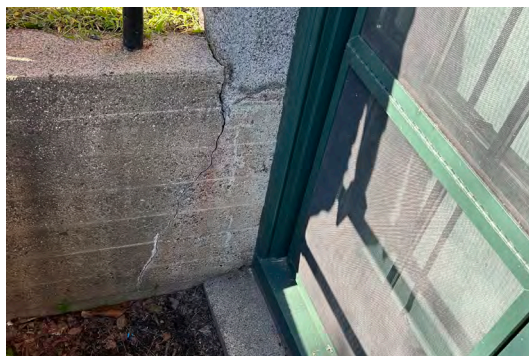
**Image A-59:** Crack at the concrete window well wall at the foundation on the south elevation.

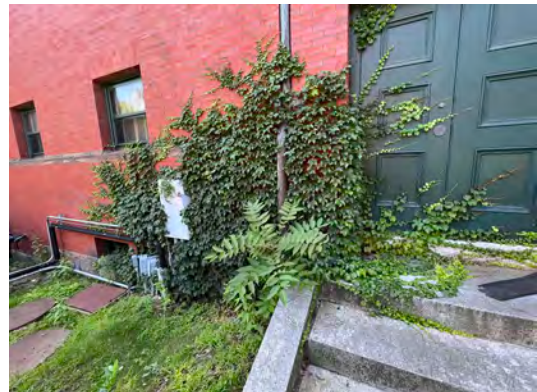
**Image A-60:** Vine overgrowth at brick masonry and granite stairs along the north elevation.

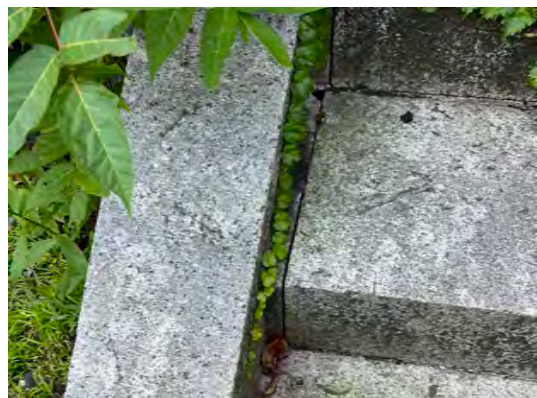
**Image A-61:** Wide cracking joint between the cheek wall and the granite steps. Vegetation is growing through the cracks.

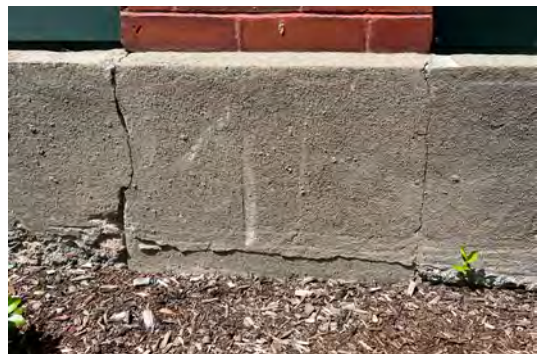
**Image A-62:** Cracks in the parge coat at the concrete foundation where the bay doors were infilled.

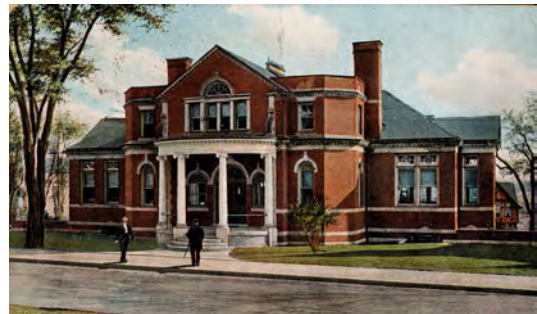
**Image B-01:** Belmont School Administration Building, then Underwood Public Library, circa 1915

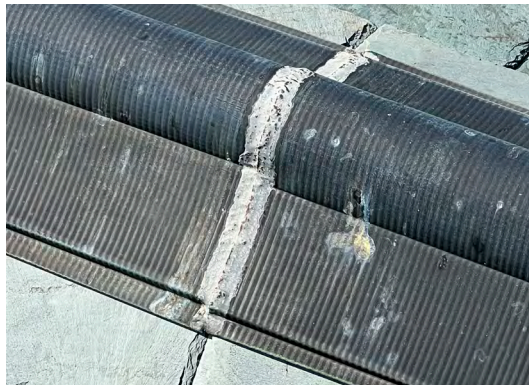
**Image B-05:** Broken solder seam at ridge cap. Copper appears to be in otherwise good condition.

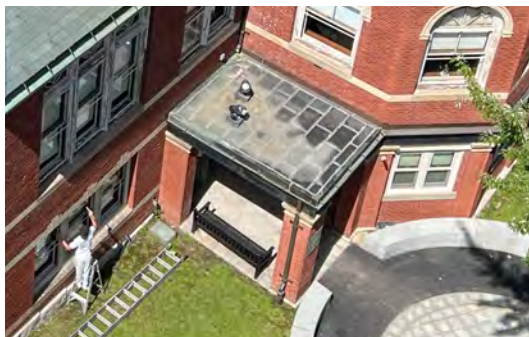
**Image B-06:** Flat seam copper roof over east portico. Evidence of ponding present around spotlights.

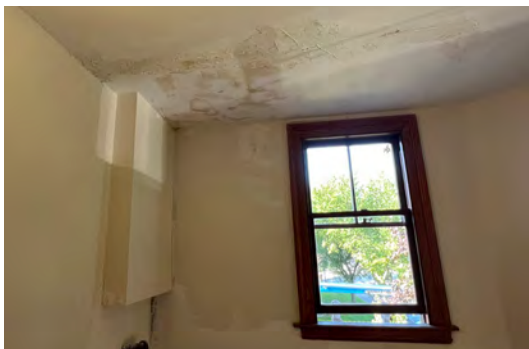
**Image B-08:** Interior damage at southwest stairwell caused by chronic roof leaks.

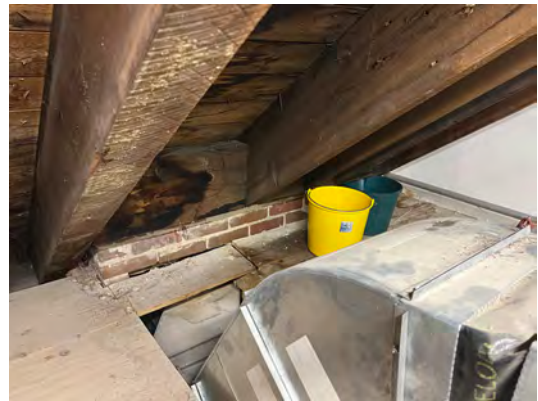
**Image B-09:** Interior leaks at attic level of School Admin Building. Buckets are used to capture leaks.

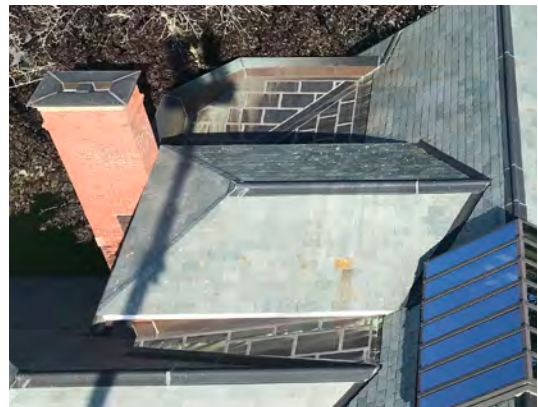
**Image B-10:** Roof of elevator override directly abutts south chimney focusing water and snow on rear chimney wall.

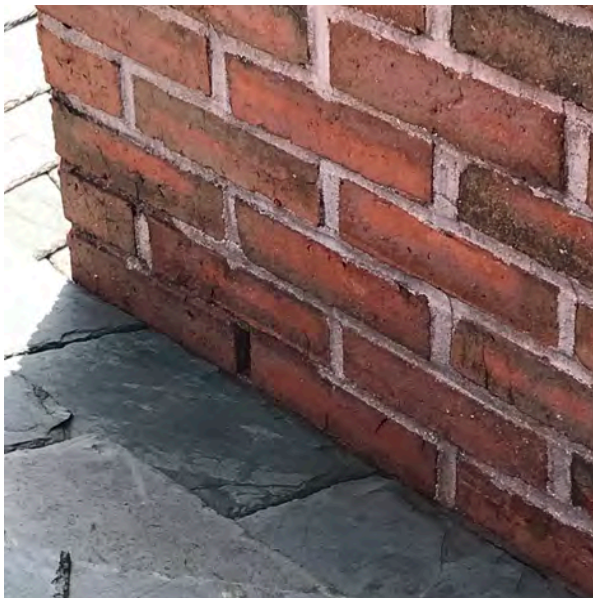
**Image B-11:** Open mortar joint at the rear face of the south chimney caused by water and snow accumulation off of the elevator override.

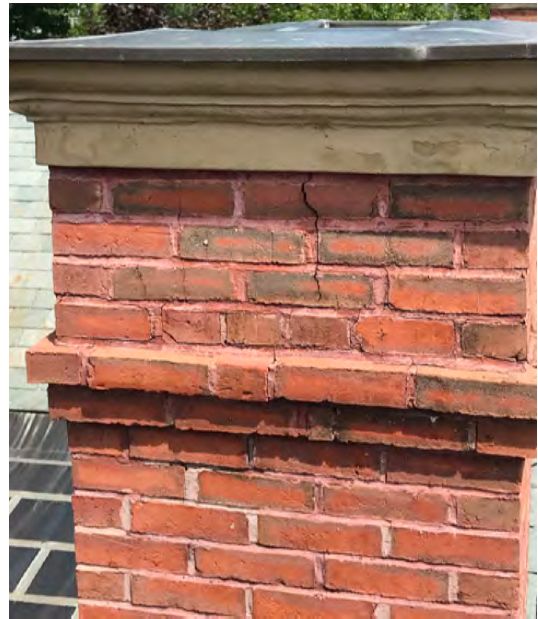
**Image B-12:** Significant structural cracking at the top of the south chimney. Note the deteriorated capstone.

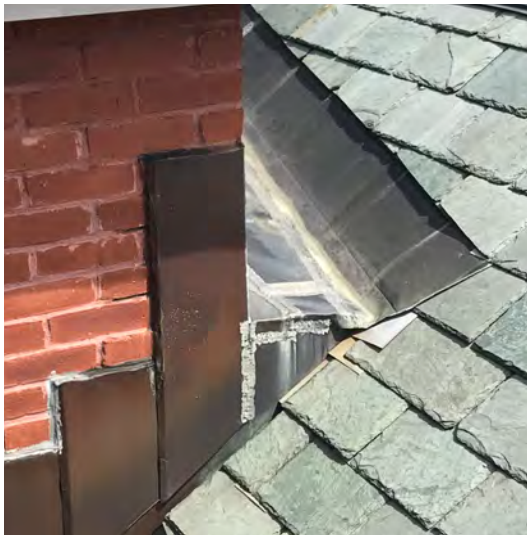
**Image B-13:** Vulnerable flashing transition at the southeast corner of elevator override. Broken seams, open joints, etc.

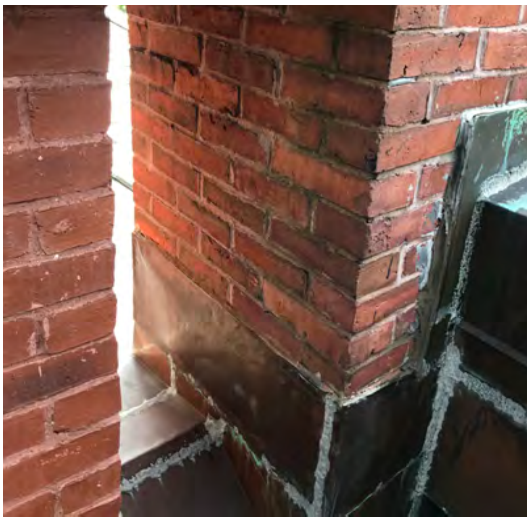
**Image B-14:** Poorly detailed copper counterflashing detail at chimney. No visible clips and new sealant joints required.

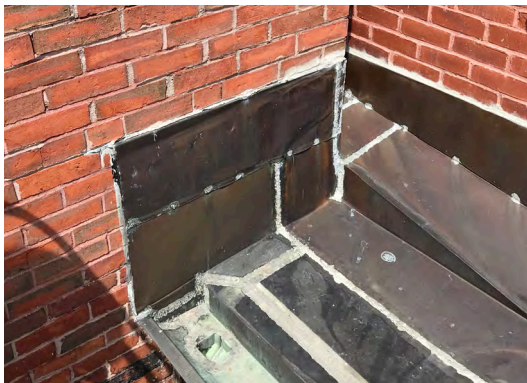
**Image B-15:** Poorly detailed copper counterflashing detail at chimney. No visible clips and new sealant joints required.

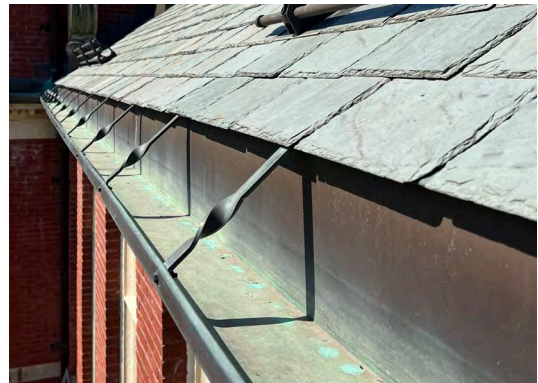
**Image B-16:** Approx 20 year old copper downspouts in good condition. No corrosion, pinholes, or metal deterioration.

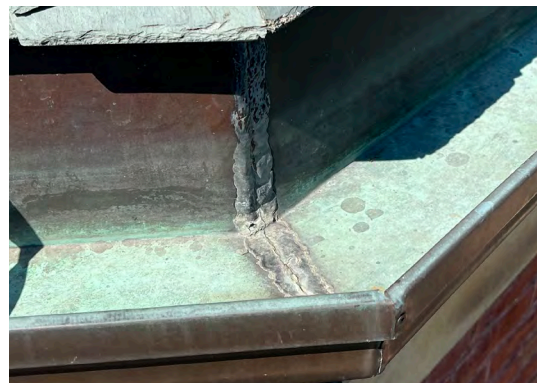
**Image B-17:** Broken solder seam at mitered corner of copper gutter.

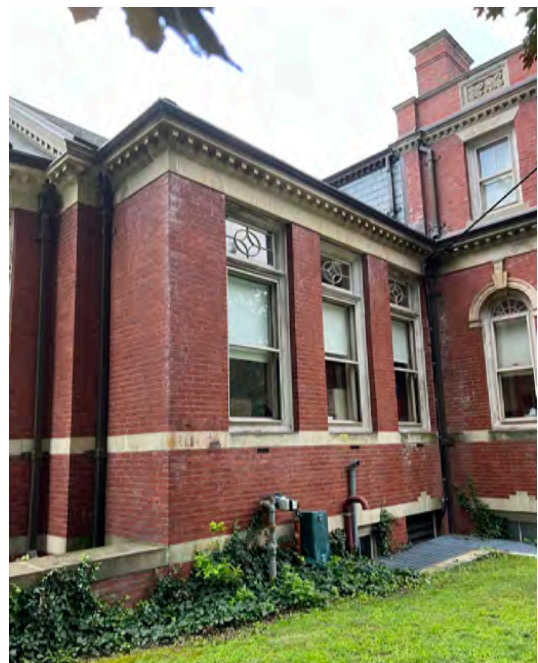
**Image B-18:** View of northwest corner of the building showing deterioration to sandstone cornice and brick masonry.

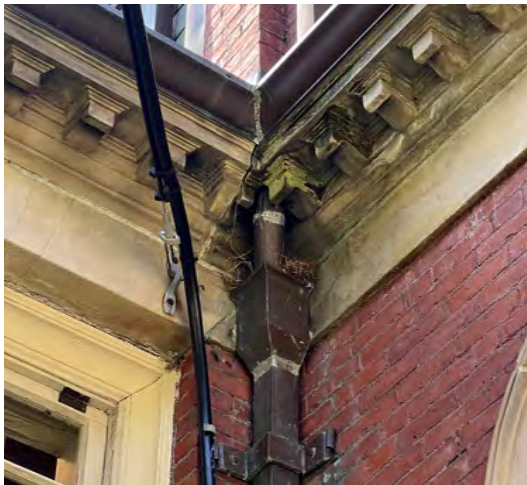
**Image B-19:** Blocked collector box at downspout causing significant damage to sandstone cornice and brick masonry.

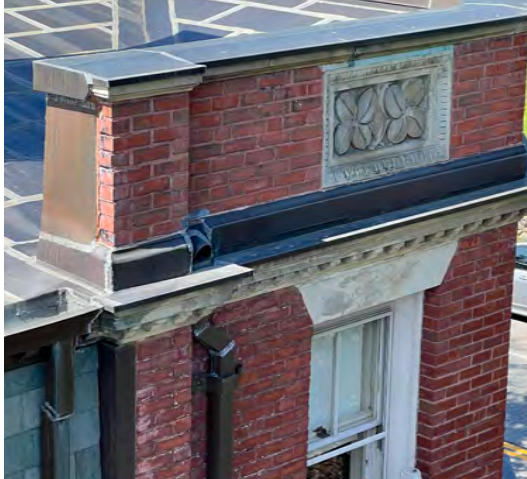
**Image B-20:** Through-parapet drainage detail suspected of compromising/damaging brick and sandstone masonry.

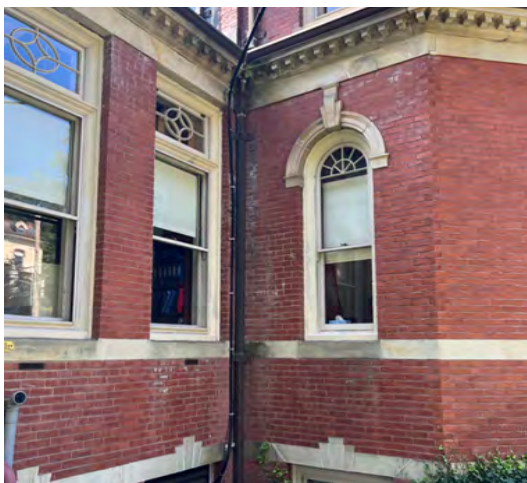
**Image B-21:** Severe brick masonry and mortar deterioration caused by ineffective copper gutters and downspouts.

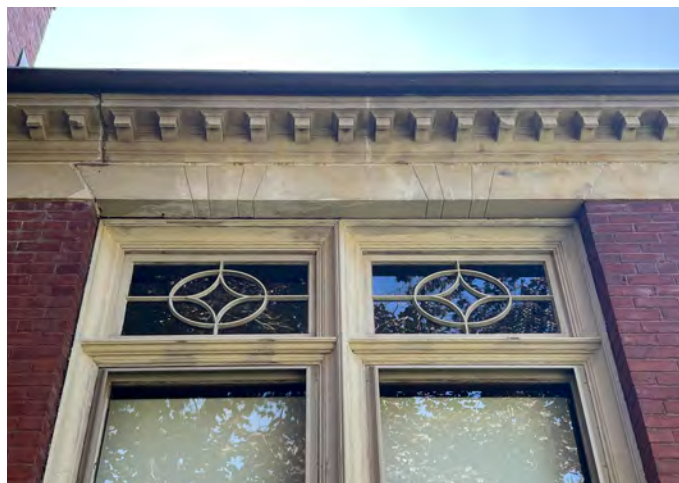
**Image B-22:** Deteriorated and cracked mortar joints at sandstone cornice caused by ineffective copper gutters and downspouts.

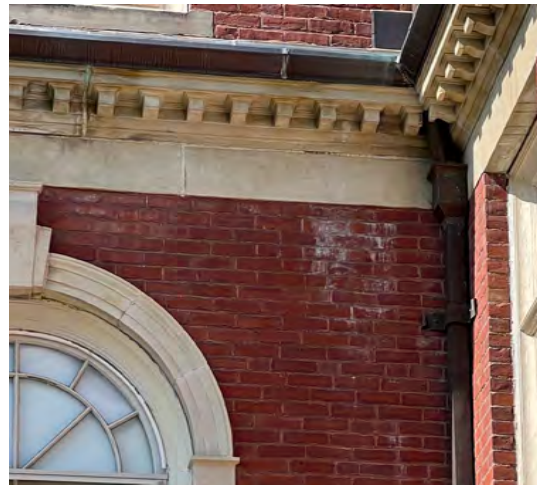
**Image B-23:** Staining and efflorescence at sandstone cornice and brick masonry caused by leaking gutter and downspout.

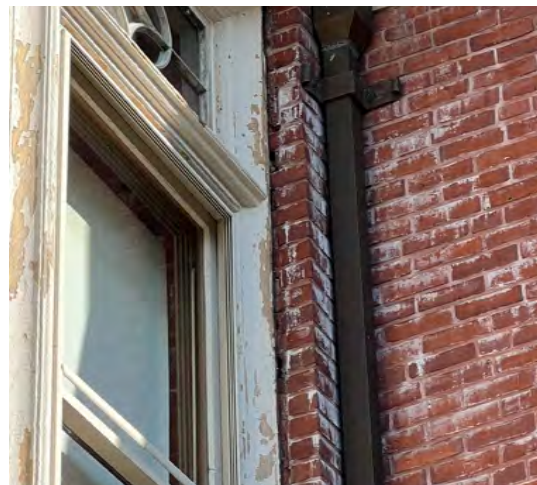
**Image B-24:** Spalled brick and eroded mortar joints at opening caused by leaking downspout and collector box.

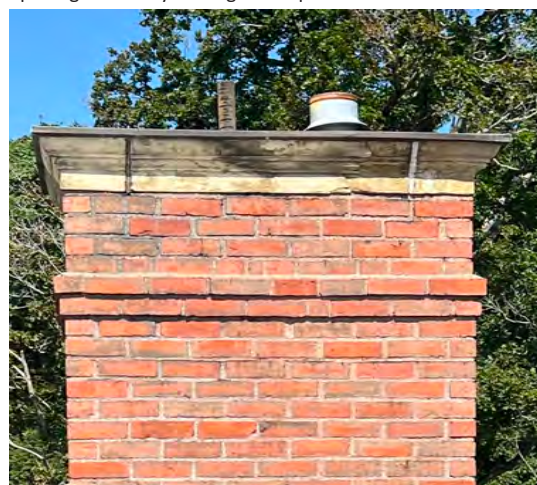
**Image B-25:** Deteriorated capstone at chimney.

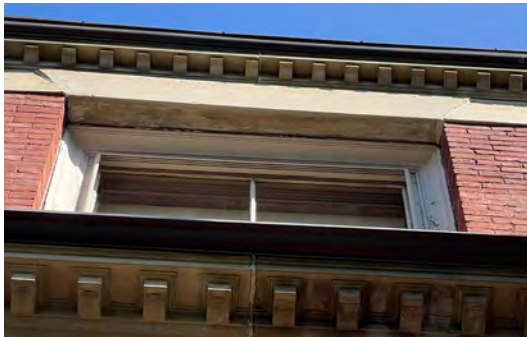
**Image B-26:** Bulging lintel at top floor or east projecting

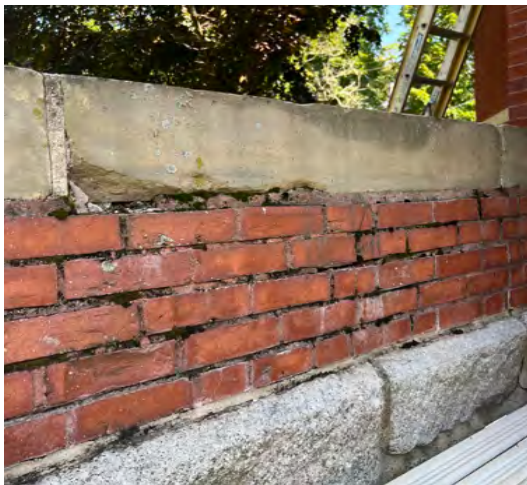
**Image B-27:** Severely deteriorated south site wall caused by water infiltration through sky-facing joints.

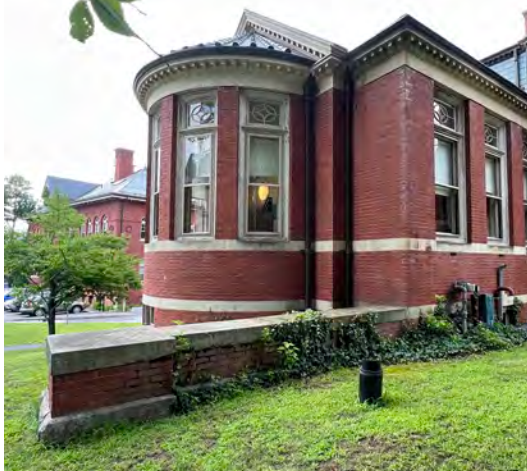
**Image B-28:** Severely deteriorated north site wall caused by water infiltration through sky-facing joints.

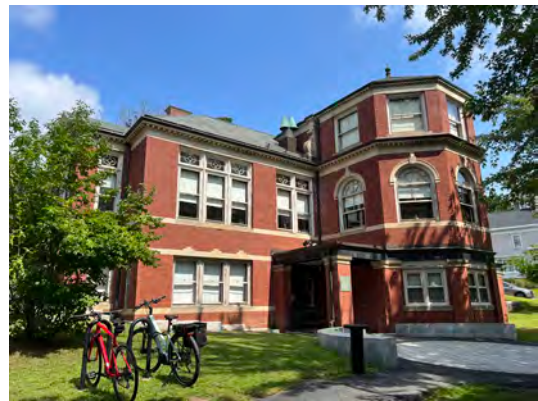
**Image B-29:** View of the southeast corner of the building showing various types of original and new windows

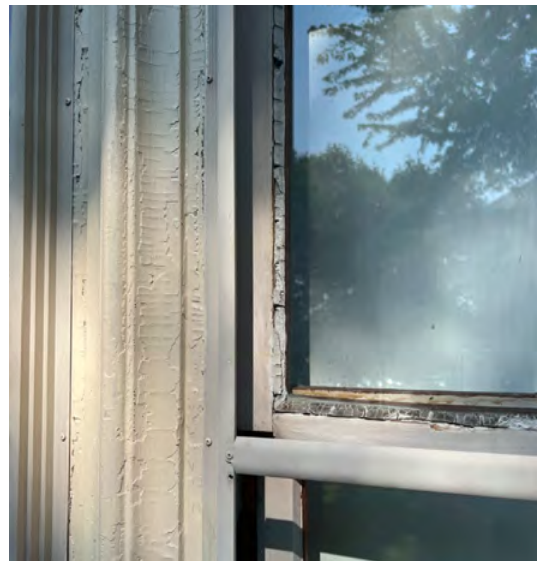
**Image B-30:** Close up of original window showing cracked glazing putty, aluminum storm window, and wood trim.

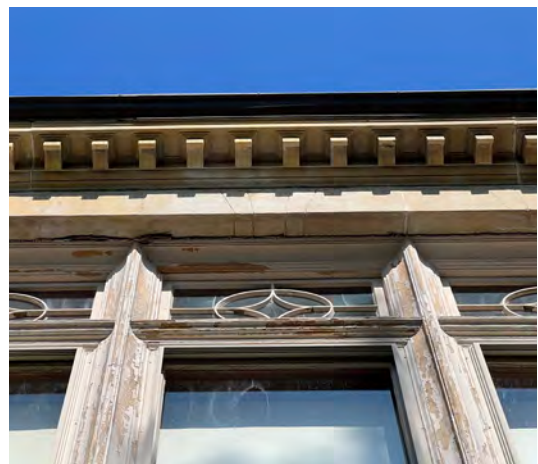
**Image B-31:** View of upper transom windows showing deteriorated caulking and brickmoulds.

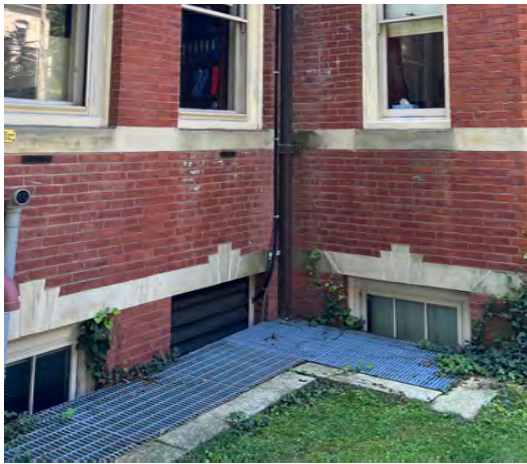
**Image B-32:** Grate over areaway leading to mechanical room.

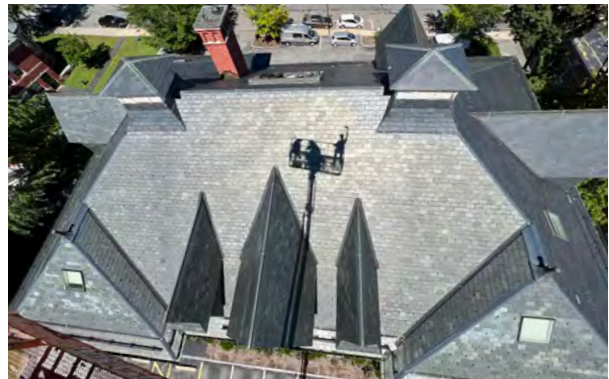
**Image C-01:** The Homer Building is comprised entirely of black slate in at least two textural varieties.

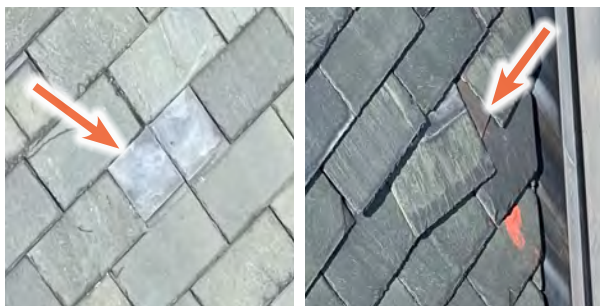
**Image C-05:** Select slates are missing entirely (or loose), often sliding down to be caught by the snowguard rails.

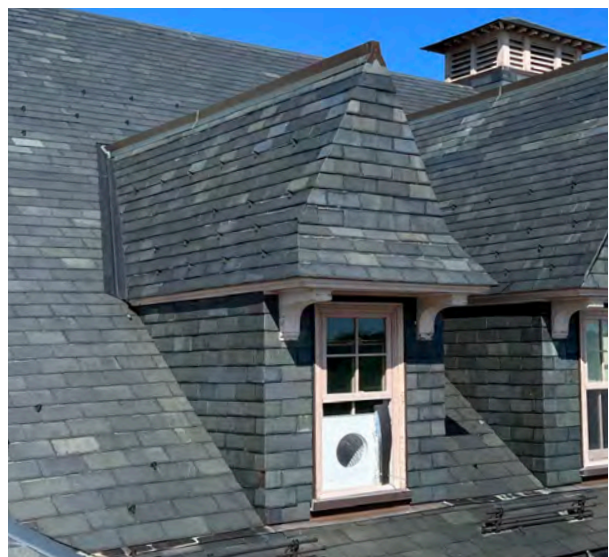
**Image C-03:** A unique, slate-clad dutch-gable dormer is a notable architectural feature on the southern facade.

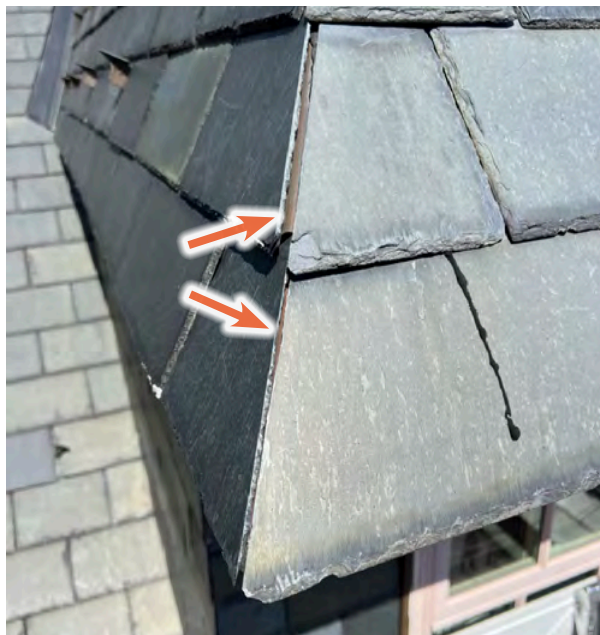
**Image C-08:** Interwoven flashing between the slate courses on the dutch gable dormer is a quality detail and water-resistant.

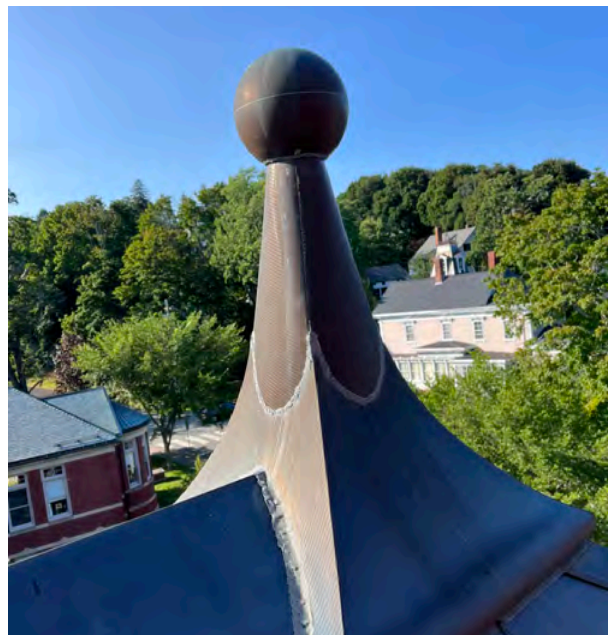
**Image C-09:** The rilled copper at ridge caps and finials are intact and in good shape..

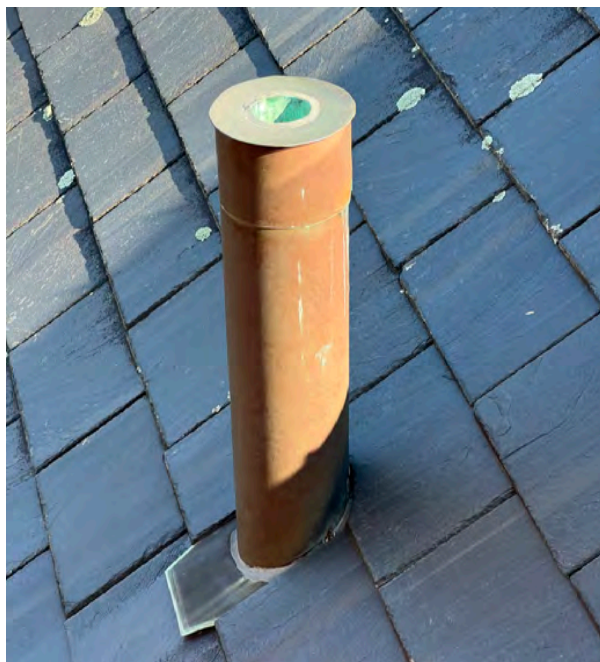
**Image C-10:** Copper vent pipes are in good shape, well-flashed, with solder joints intact.

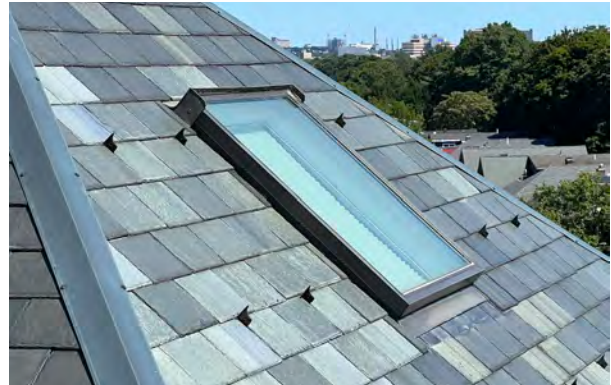
**Image C-11:** Modern skylight punctuate the slate roof in a few locations, with no reported leaking..
