EXISTING CONDITIONS ASSESSMENT

BELMONT, MA CIVIC COMPLEX

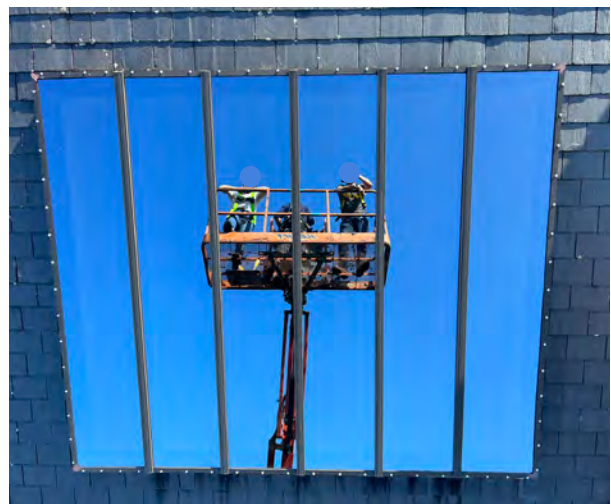
**Image C-12:** A large, generous modern skylight adorns the north roof slope, with no visible damage or compromised flashing.

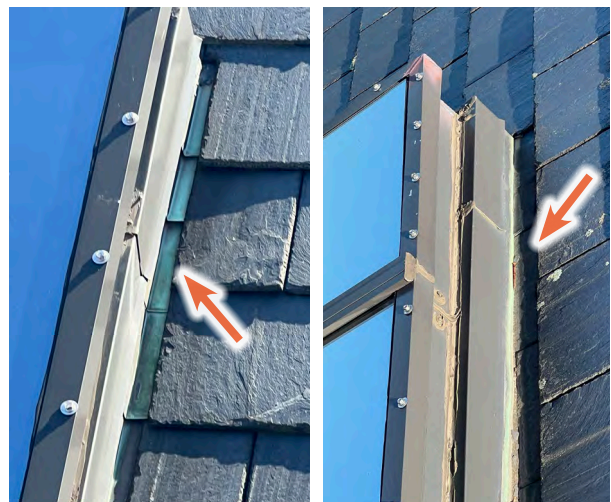
**Image C-13:** The large modern skylight appears to sit on an older copper curb, intact and without reports of leaking.

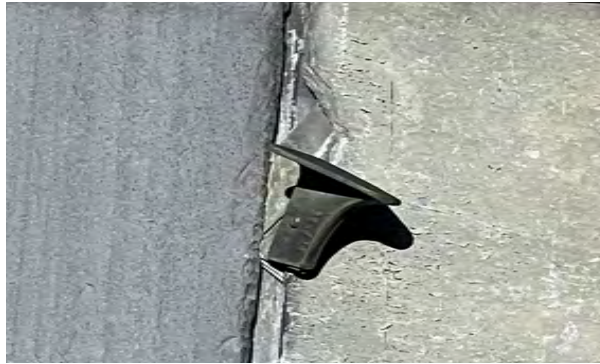
**Image C-14:** Bent retro-fit snowguard pads are prevalent and generally ineffective at snow-retention.

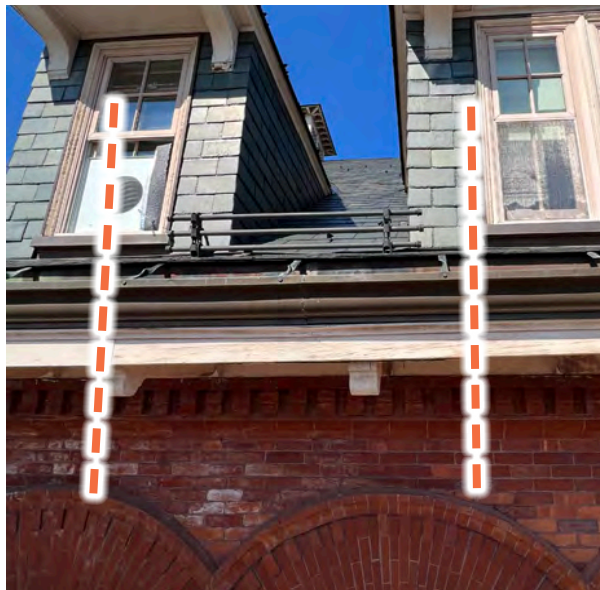
**Image C-16:** Wood and masonry deterioration appear to related directly to snowguard fences in areas between dormers.

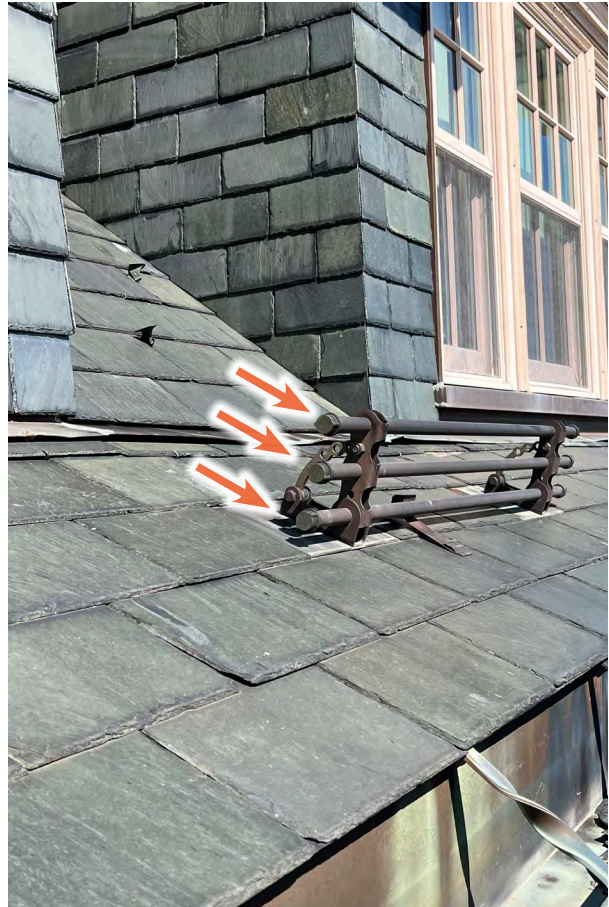
**Image C-17:** The 3-pipe snowguard fences can be easily detached without removing their brackets.

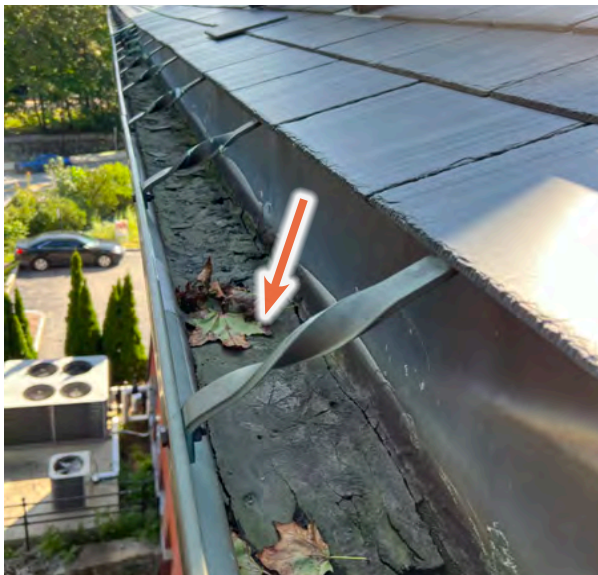
**Image C-19:** Compact gutter sediment and debris suggest improper pitch, allowing collection over time.

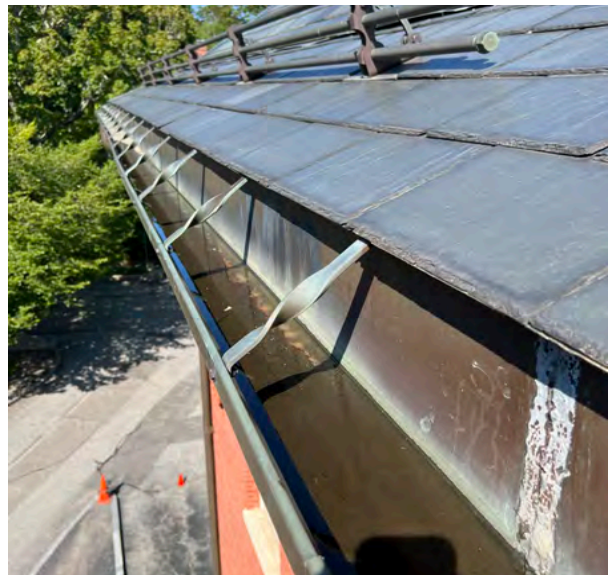
**Image C-18:** Ponding water in the gutters suggest improper drainage pitch.

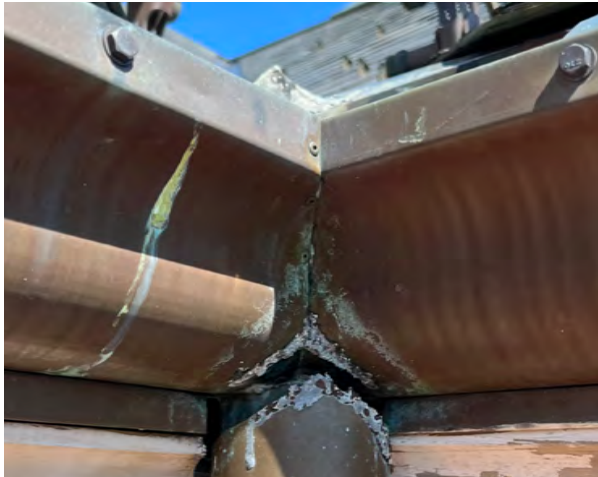
**Image C-20:** Aside from the discoloration, the copper is relatively recent and retains most of its sectional mass.

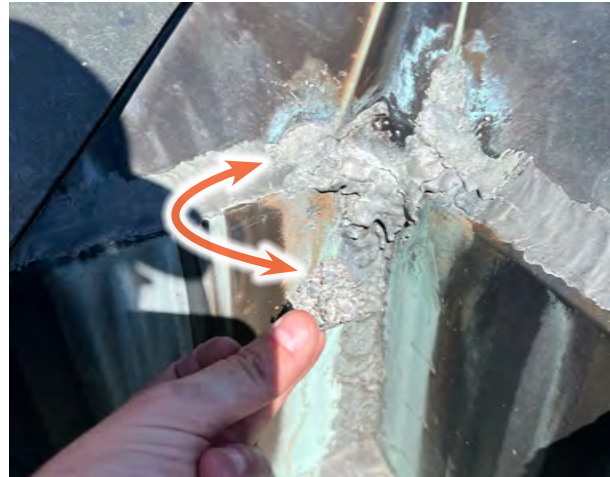
**Image C-23:** Large chunks of broken-off solder are indicative of unskilled application.

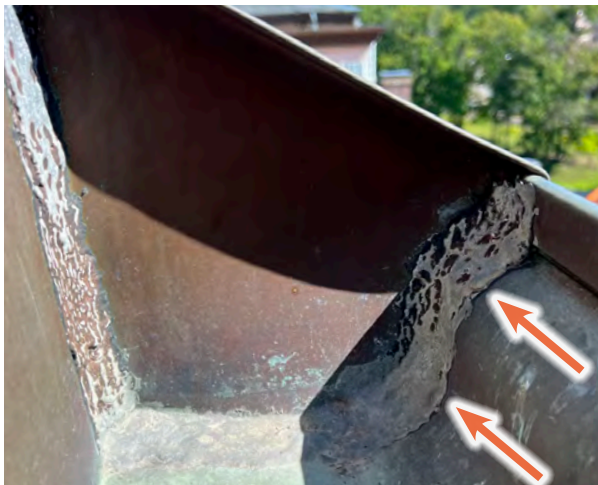
**Image C-21:** Hairline cracks at solder joints are a site for water to infiltrate the wood cornice below.

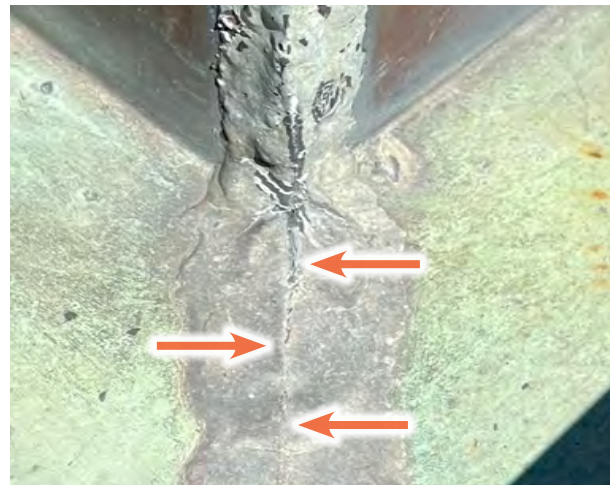
**Image C-24:** Hairline cracks at gutter miters suggest poor/inconsistent solder penetration.

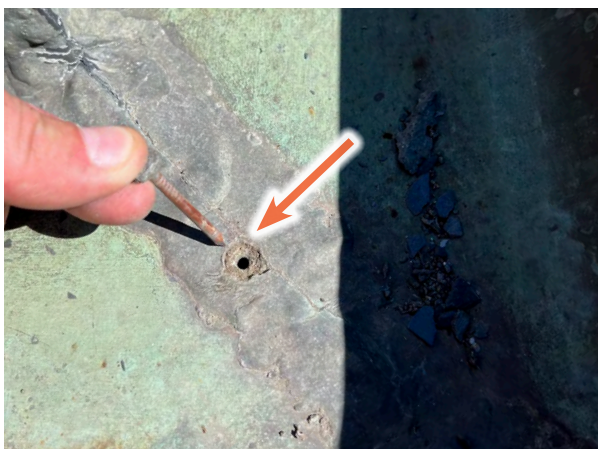
**Image C-22:** Nail holes in the solder joints render them virtually useless.

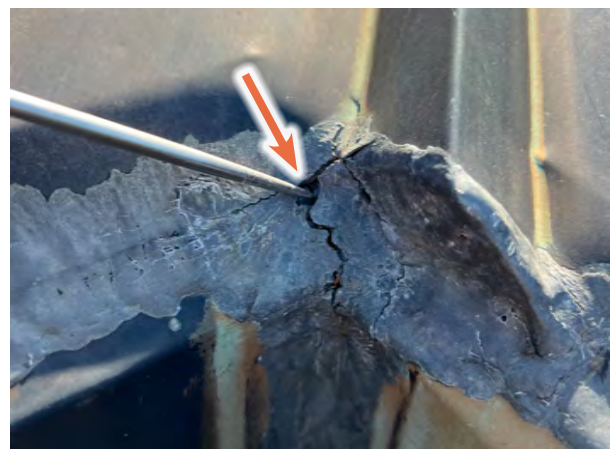
**Image C-25:** Large cracks at the intersection of copper valleys and gutters allow considerable water to enter and rot the woodwork.

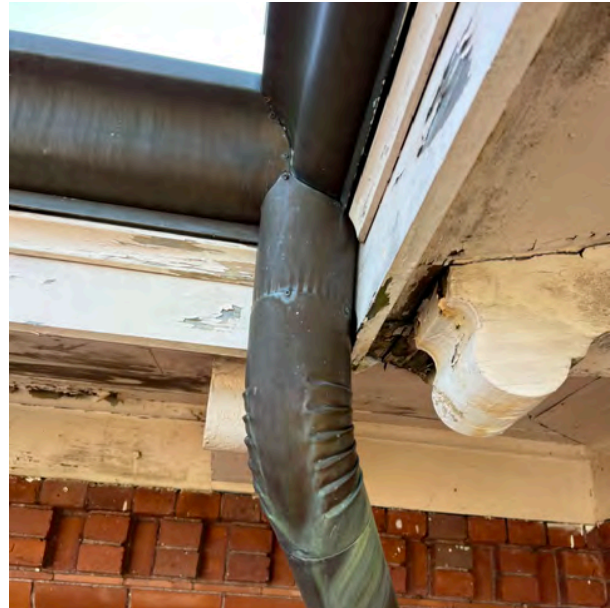
**Image C-26:** Copper downspout elbows are intact and appear to perform as they should.

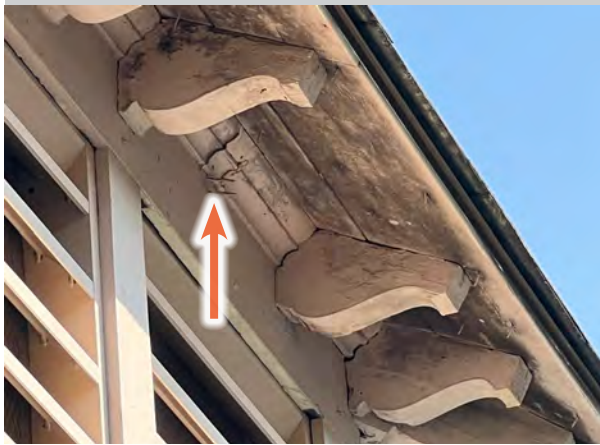
**Image C-29:** Missing brackets at the ventilator towers require replacement, and repainting overall.

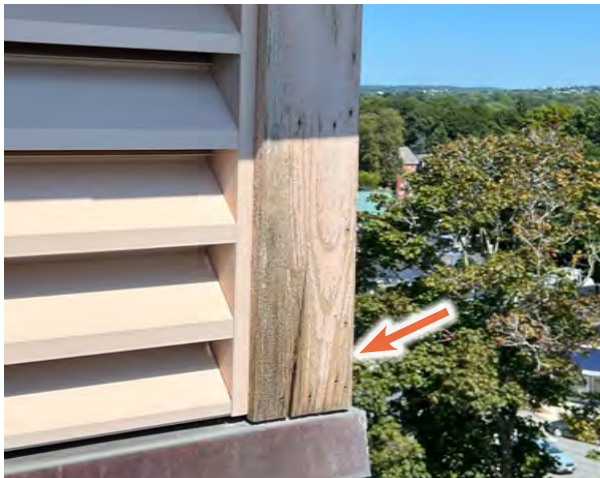
**Image C-30:** Low-quality wood corner boards have reached the end of their life.

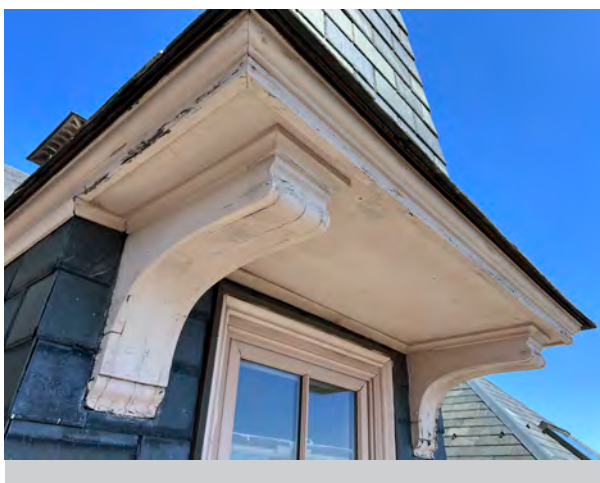
**Image C-31:** Most paint on the dormers require light scraping and a new coat.

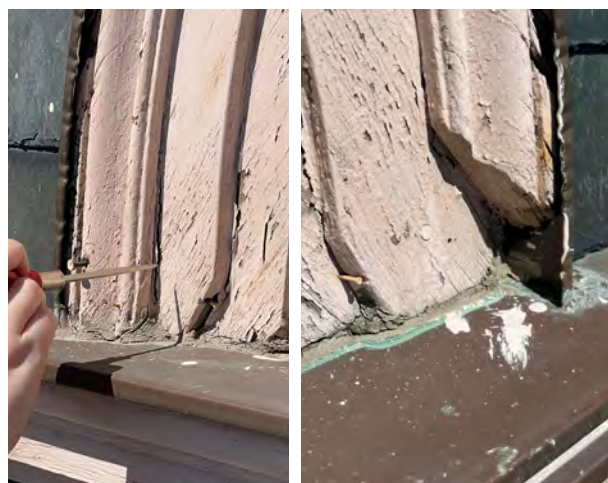
**Image C-32:** The arched dormer window casings would do well to receive epoxy consolidation for prolonged life.

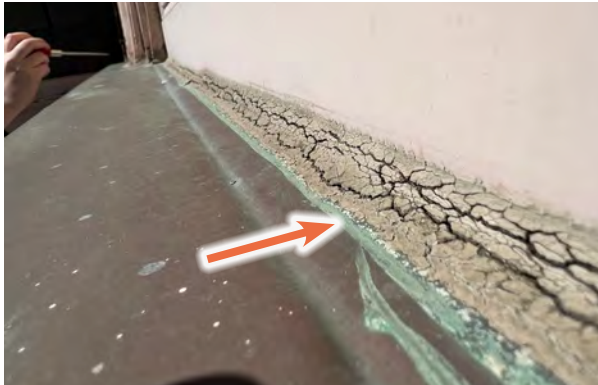
**Image C-33:** Cracked sealants between aluminum or vinyl windows and copper require replacement overall.

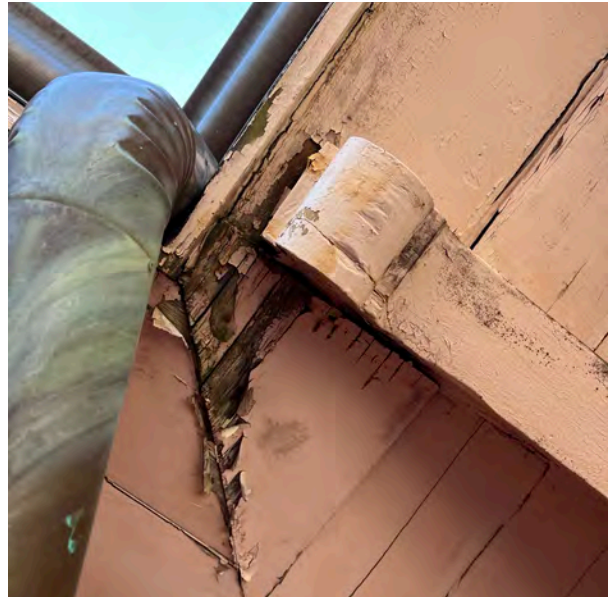
**Image C-36:** The worst of the cornice damage occurred at the inside corners of gutters where water is unimpeded.

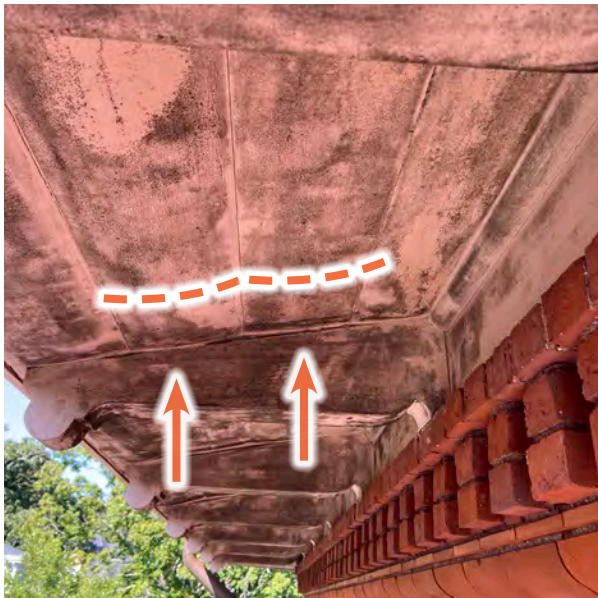
**Image C-34:** Cupping soffit boards suggest they have been damp in years past, possibly due to low-quality woods used in replacement..

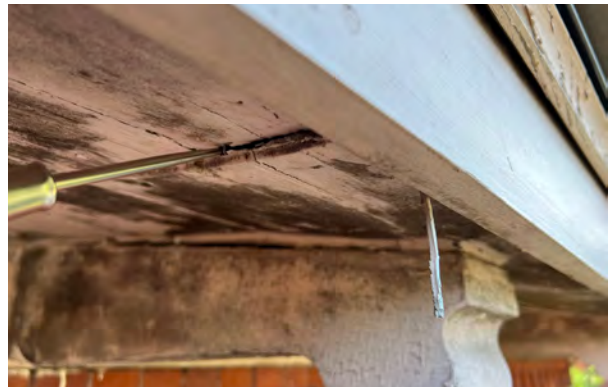
**Image C-37:** Soft end grain at soffit boards are pierced easily by an awl, suggesting they have been damp for some time.

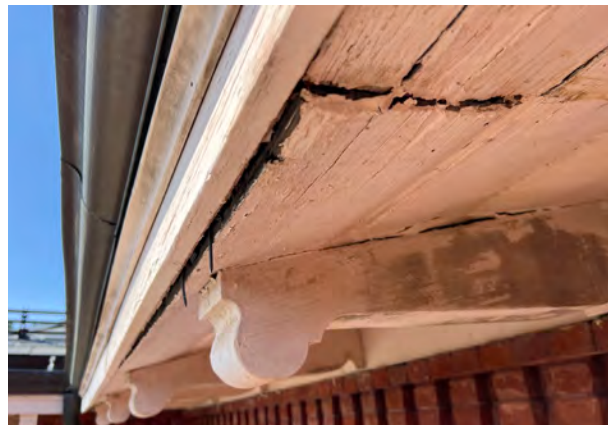
**Image C-38:** The worst of the woodwork is easily visible from below, requiring replacement.

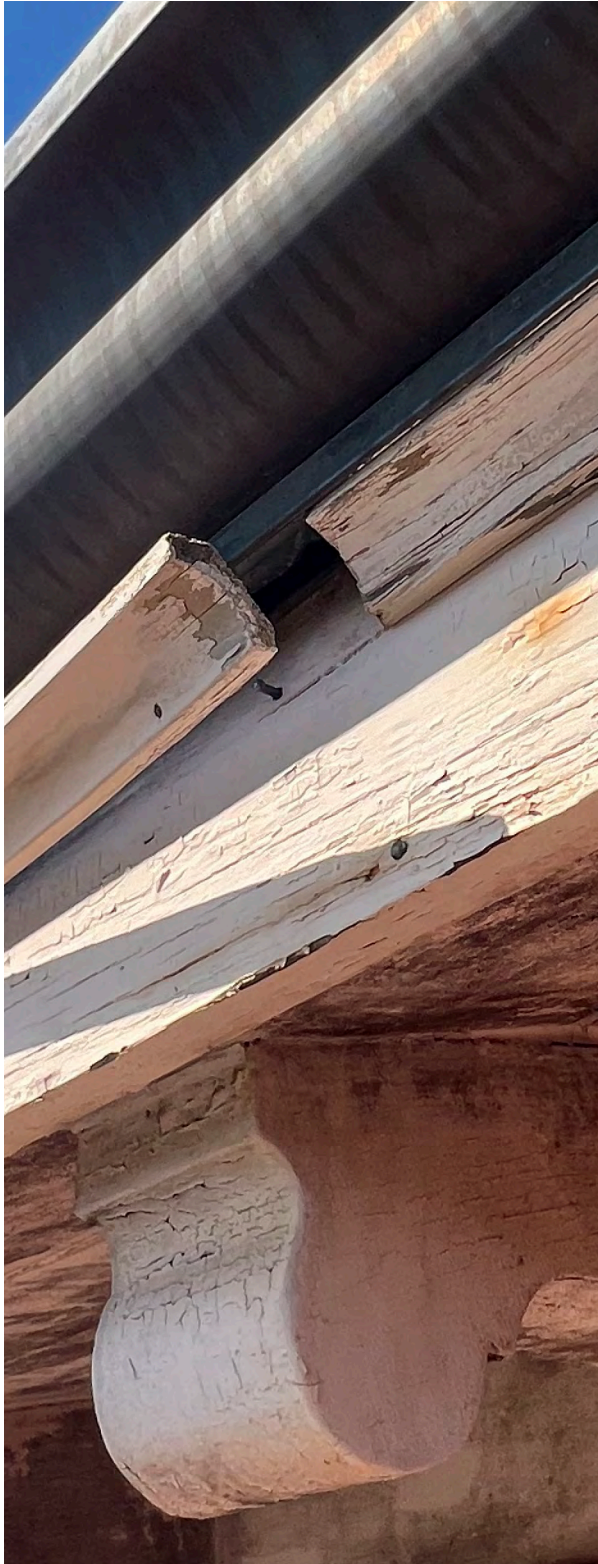
**Image C-39:** Thin and inexpensive bedmoulds for the gutters have not stood the test of time since gutter installation.

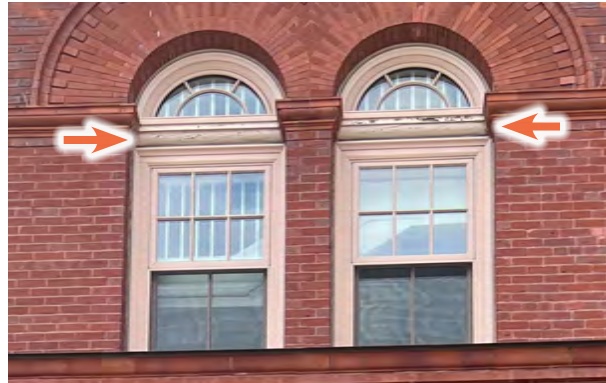
**Image C-40:** Two pairs of windows retain the sole visible woodwork, long since replacement by modern units.

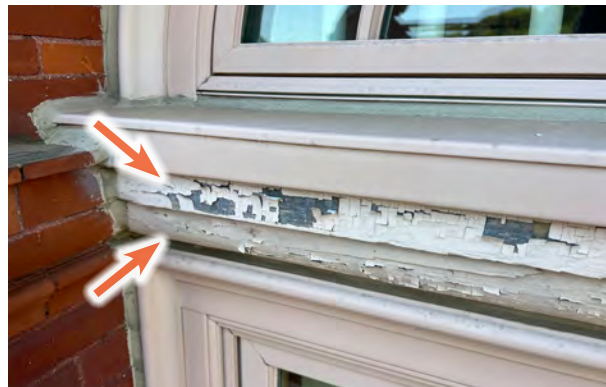
**Image C-41:** Though small, the remaining window wood transoms should be cared for and repainted.

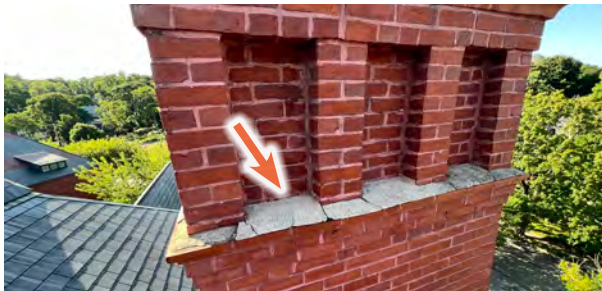
**Image C-44:** A deteriorating mortar wash at the chimney should be replaced to ward off standing water.

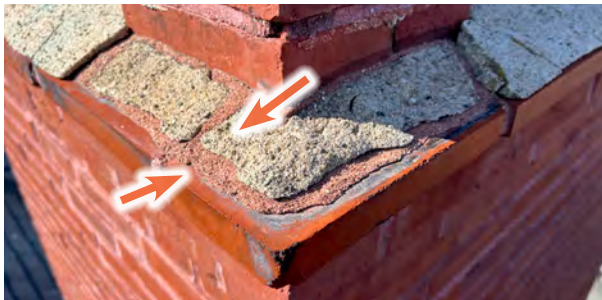
**Image C-45:** An earlier red-tinted mortar wash and the chimney should be re-applied.

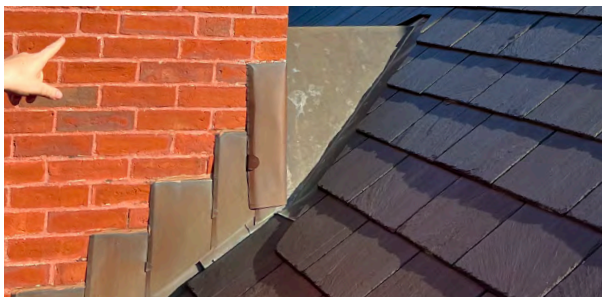
**Image C-46:** Base and stepped counter flashing, and a copper cricket, are all in good shape.

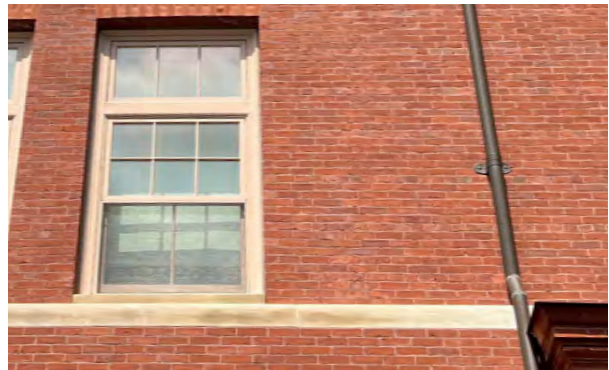
**Image C-47:** Overall, the building benefits from well-maintained masonry, all in excellent condition.

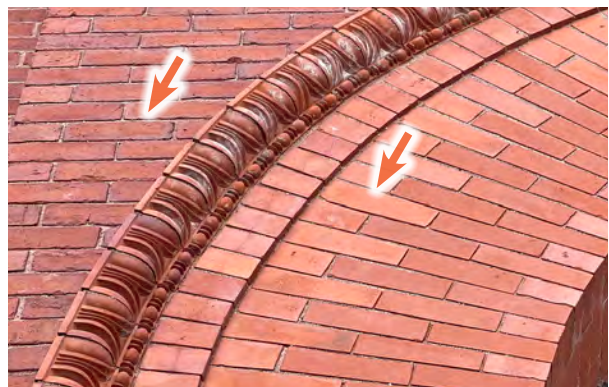
**Image C-48:** Standard brick units (left) stand in contrast with gauged and rubbed bricks at arches (right).

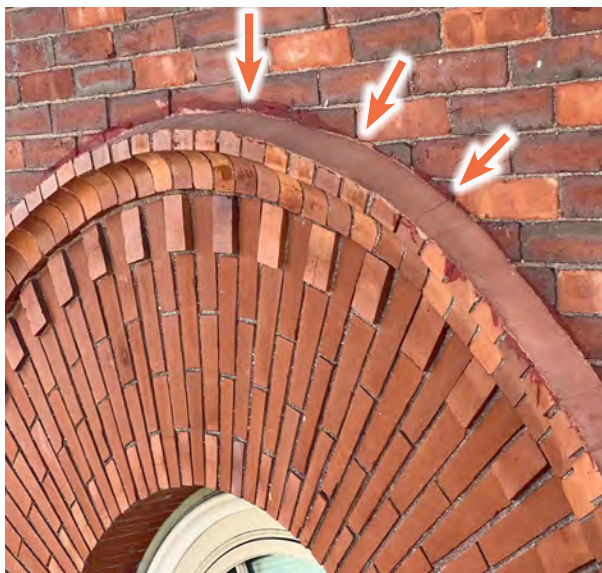
**Image C-52:** Red-tinted, smooth mortar at the upper archway surfaces appear to perform well..

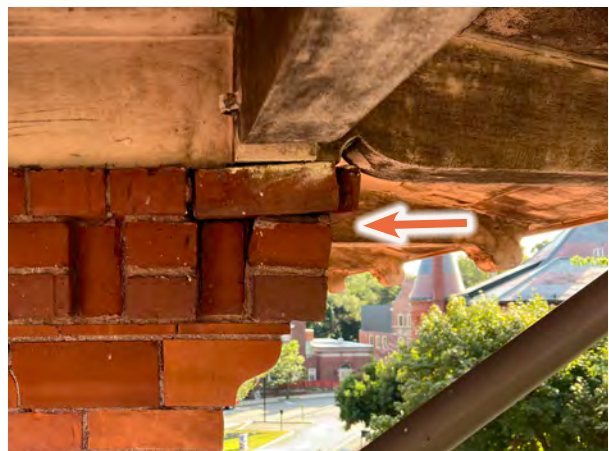
**Image C-51:** Loose bricks, notably at outside corners, require re-setting.

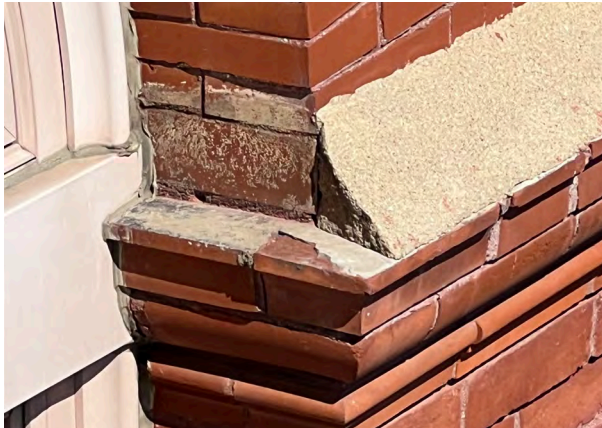
**Image C-53:** Although some in intact, chunks of the steep wash are randomly missing, mostly at the inner arch returns.

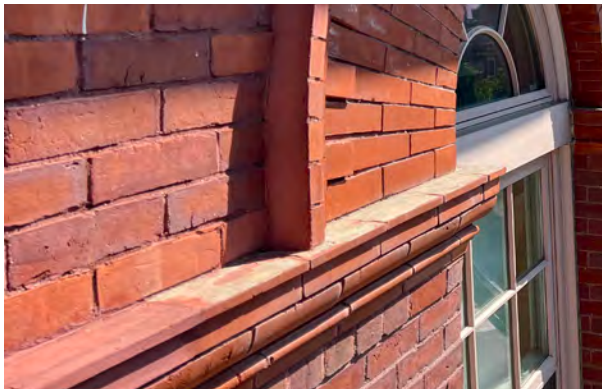
**Image C-54:** Elsewhere on the same projecting stringcourse, a missing mortar wash should be reestablished.

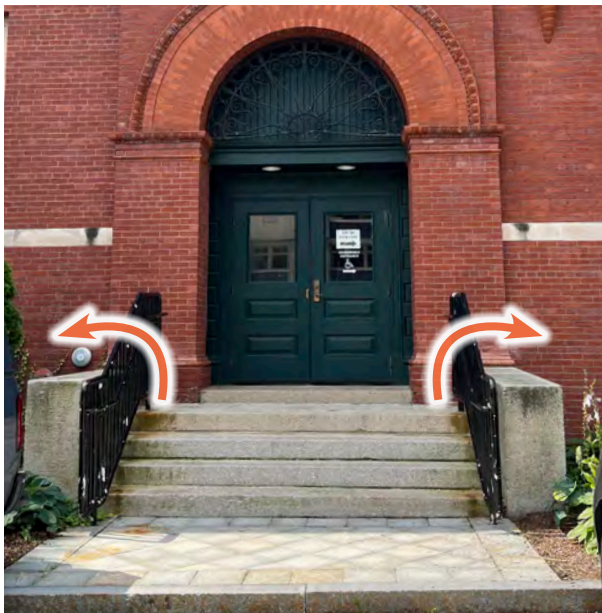
**Image C-55:** Rotating granite cheek walls at the north entry have slowly wreaked havoc on their adjacent bricks at the building.

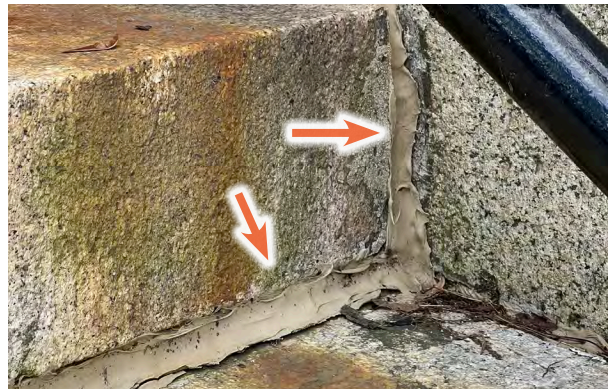
**Image C-56:** The slow shifting of granite treads are filled with sealants, wider and wider with each application.

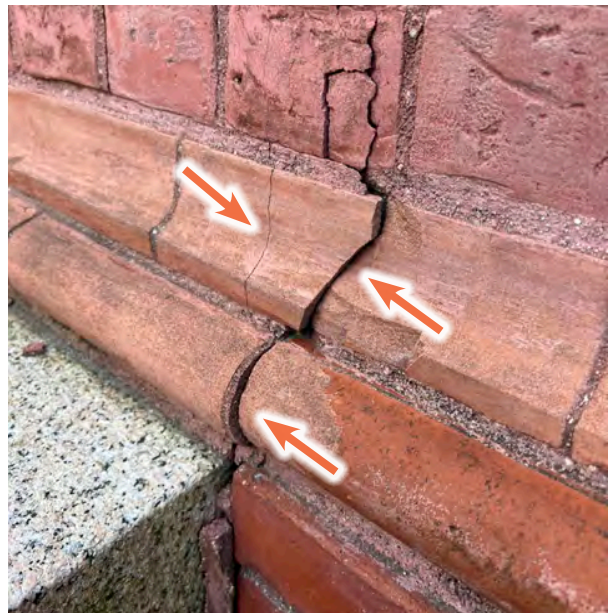
**Image C-57:** Upward thrust of the rotating granite cheek walls have cracked the brickwork at the intersection, consistently.

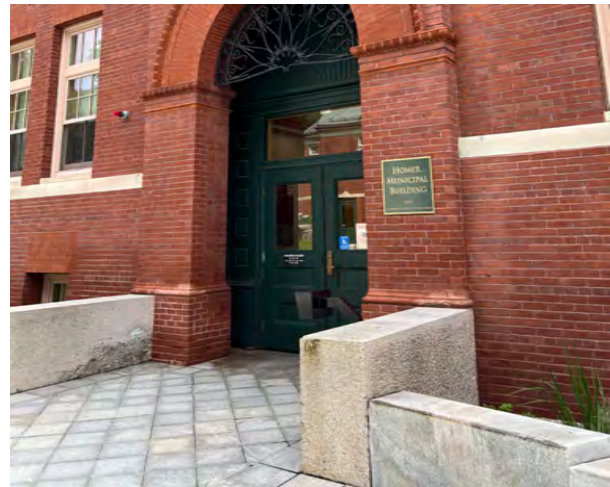
**Image C-58:** Similar rotating granite cheek walls have damaged the west entry brickwork as well..

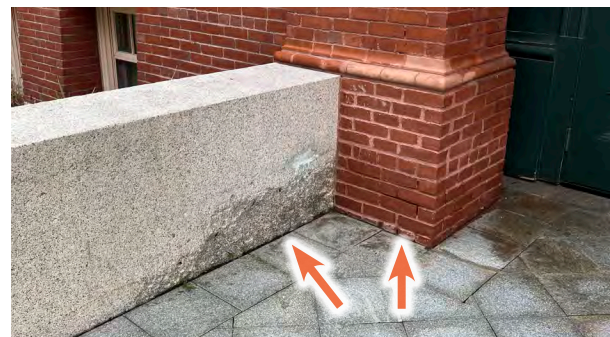
**Image C-59:** Excessive salts and de-icers at the high-traffic pavers have likely damaged both brick and granite.

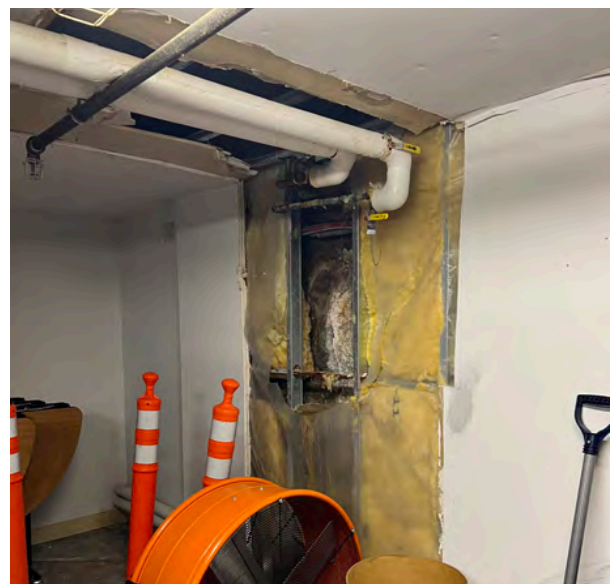
**Image C-60:** Internal leaks below the west entry suggest that water both ponds and enters the foundation..

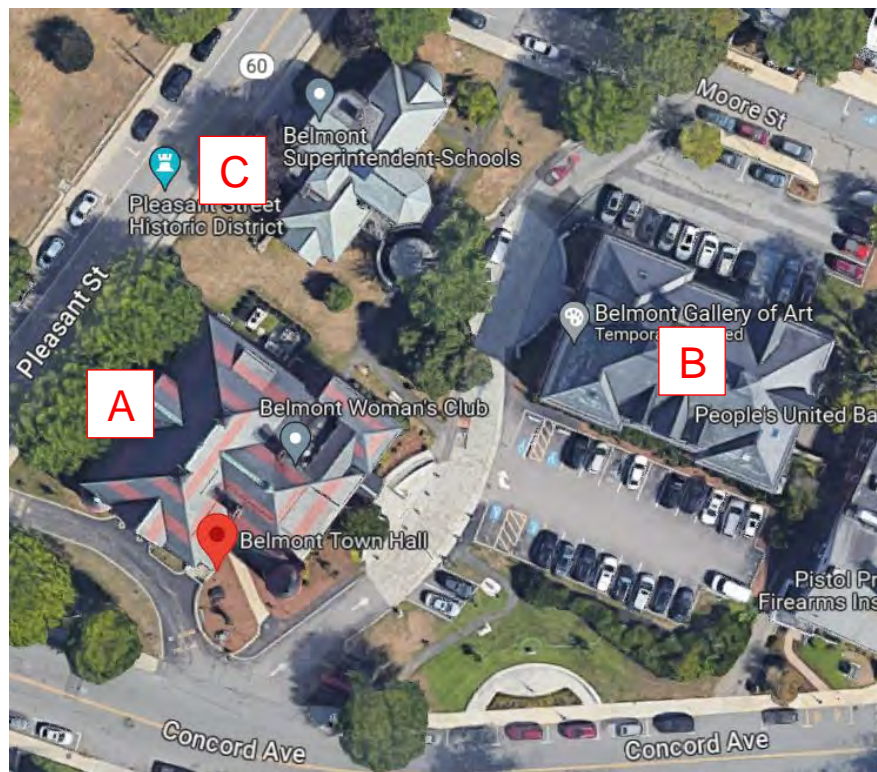
Figure 1: Overall View of Town Buildings

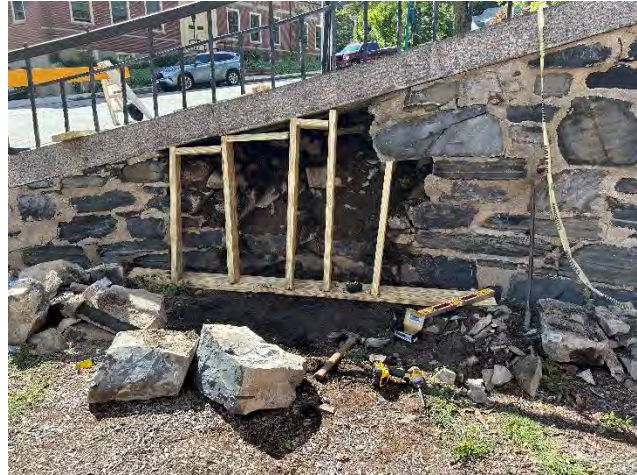
are directing water towards the walls, causing it to become trapped, freeze/thaw, and ultimately push the stones outward. A temporary support has been put in place to support the facing where the stones have fallen out.

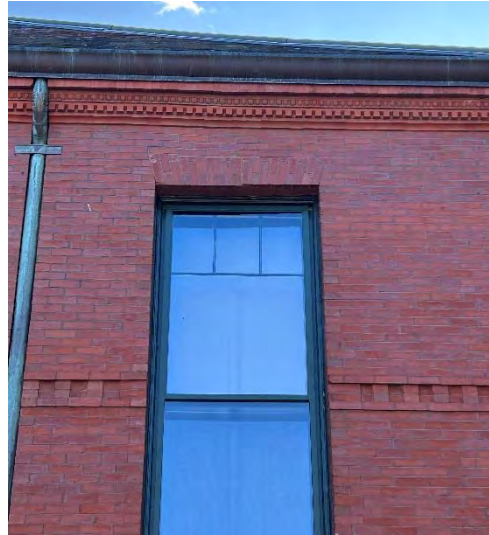
- There are several areas of spalling brick and efflorescence at splash-back zones where water, often laden with deicing salts, splashes against an adjacent wall surface and soaks into the brickwork. Under dry conditions, the water then evaporates back out of the brickwork and the salts crystalize just under the outer brick surfaces (a process called cryptoflorescence) and cause the units to spall. Where the brick is not deeply spalled, the mortar joints can be cut and repointed and a breathable water repellent coating can be applied to slow down this process. *Where bricks are significantly eroded, the bricks must be replaced with visually matching, but harder fired bricks that can better survive these effects.*

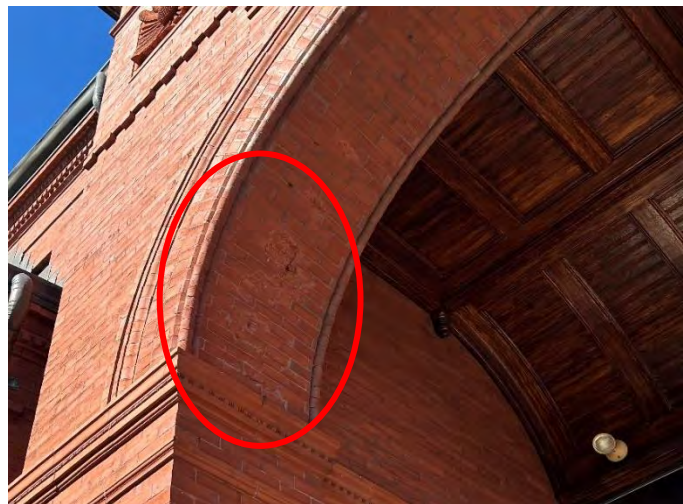
their bottom, outer surfaces to spall off during repeated freeze-thaw cycling. *As it is both difficult and expensive to replace the bricks in these large arches, the best course of action is to try to slow down the water, most practically through cutting and pointing, flashing and sealing and/or*

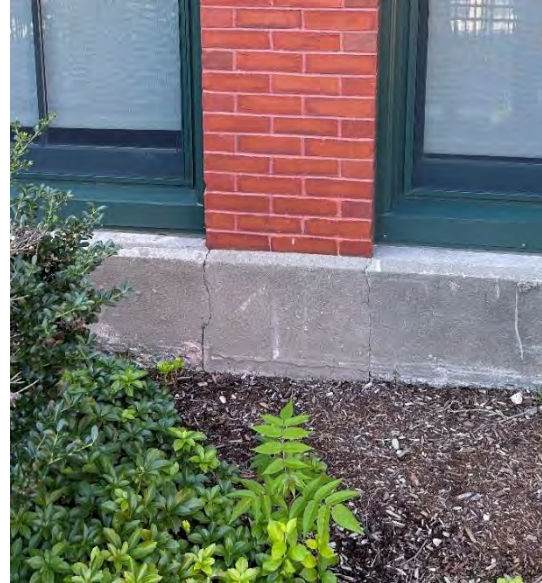
- We found three areas where the masonry appears to be bulging slightly. Two locations are at the second floor level windows on the east elevation and the other is at the same level on the north elevation. These areas should be probed further to determine the cause, which is most likely rust jacking of the outer steel lintel that runs over the openings and is causing the wall to bend outward. *If found to be significantly rusting, the lintel should be removed and replaced with galvanized steel, along with proper flashing.*

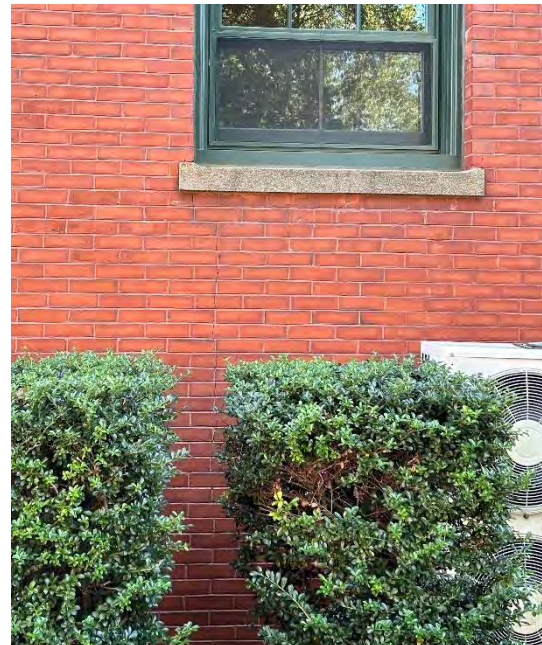
- We found a vertical crack at the first floor level of the north elevation along with cracked stone sills. Though further investigation is also needed, it is likely that the visible deterioration and resulting expansion of unloaded brick masonry below the windowsill has caused it to crack and bend upward. This expansion has also caused the brickwork to crack. *The sill and deteriorated brickwork should be dismantled with the sill being repaired with stainless steel pins and epoxy or it should be replaced.*

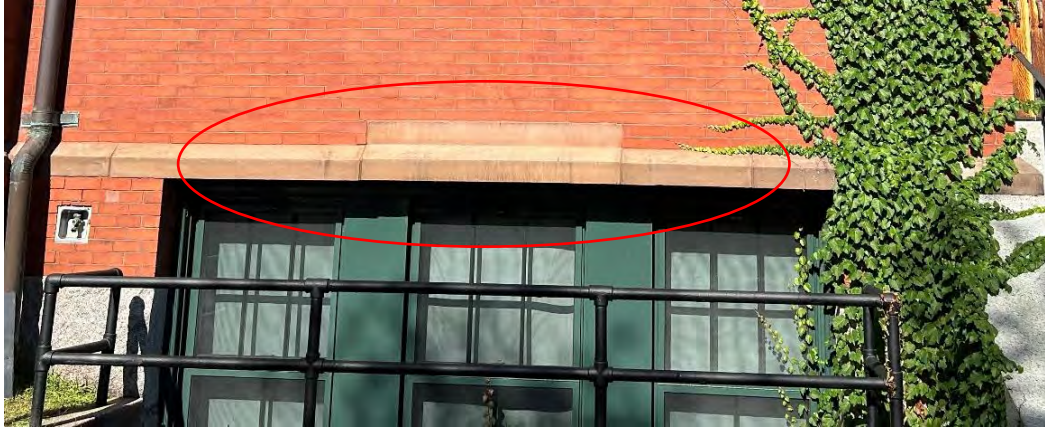
**B. The Town Hall Annex:**

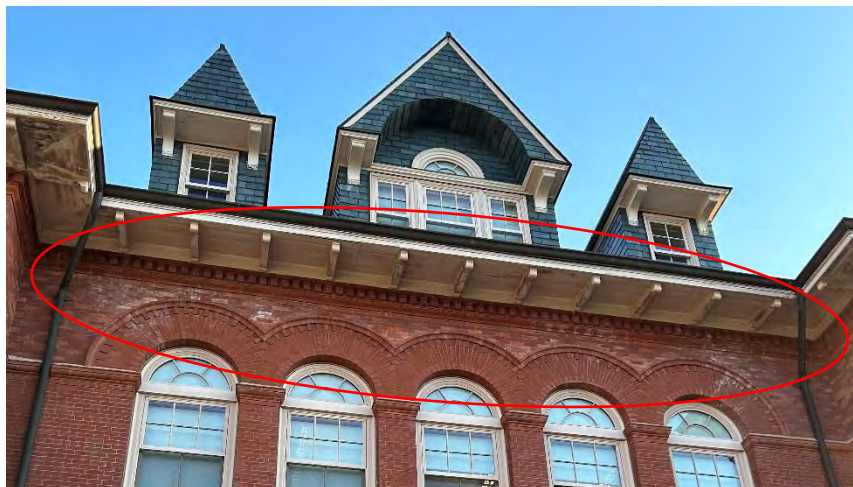
- One of the wooden soffit of the cornice appears uneven *and should be checked as to its attachment to the supporting framing from which it is suspended.* (See photo on following page)

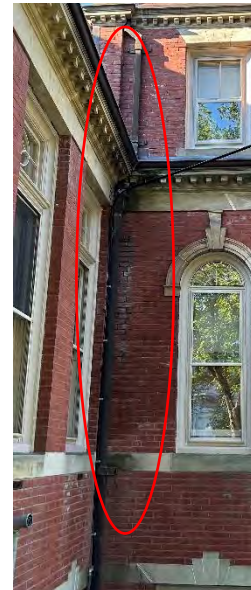
- We also found a few stones, both lintels and sills, that had chips or spalls in them *that should be patched with a matching stone repair mortar.*
- There are two brick masonry walls on the north and south sides of the Administration building that are starting to fail, more so on the south elevation than the north. The brick walls have precast coping stones on top, with deteriorating mortar joints. Water is penetrating into the wall, through the sky facing mortar joints and starting to bulge the masonry and erode the mortar. *Both walls will need to be rebuilt, with either a through wall flashing system or lead weather caps incorporated into the design to prevent water infiltration.*

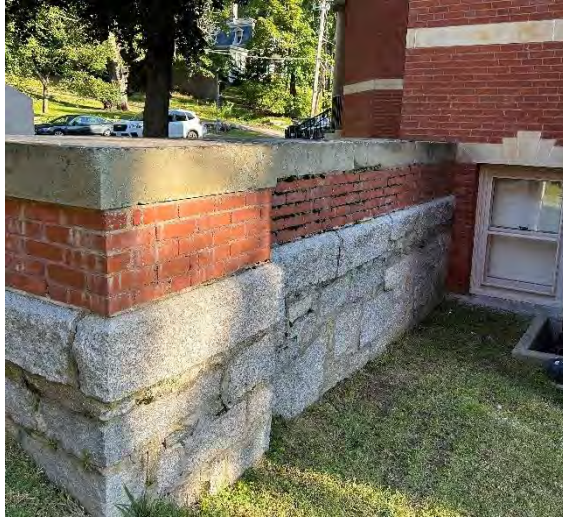
Thank you for the opportunity to evaluate this beautiful collection of Belmont's town buildings. Please reach out to our office should there be any questions or concerns.

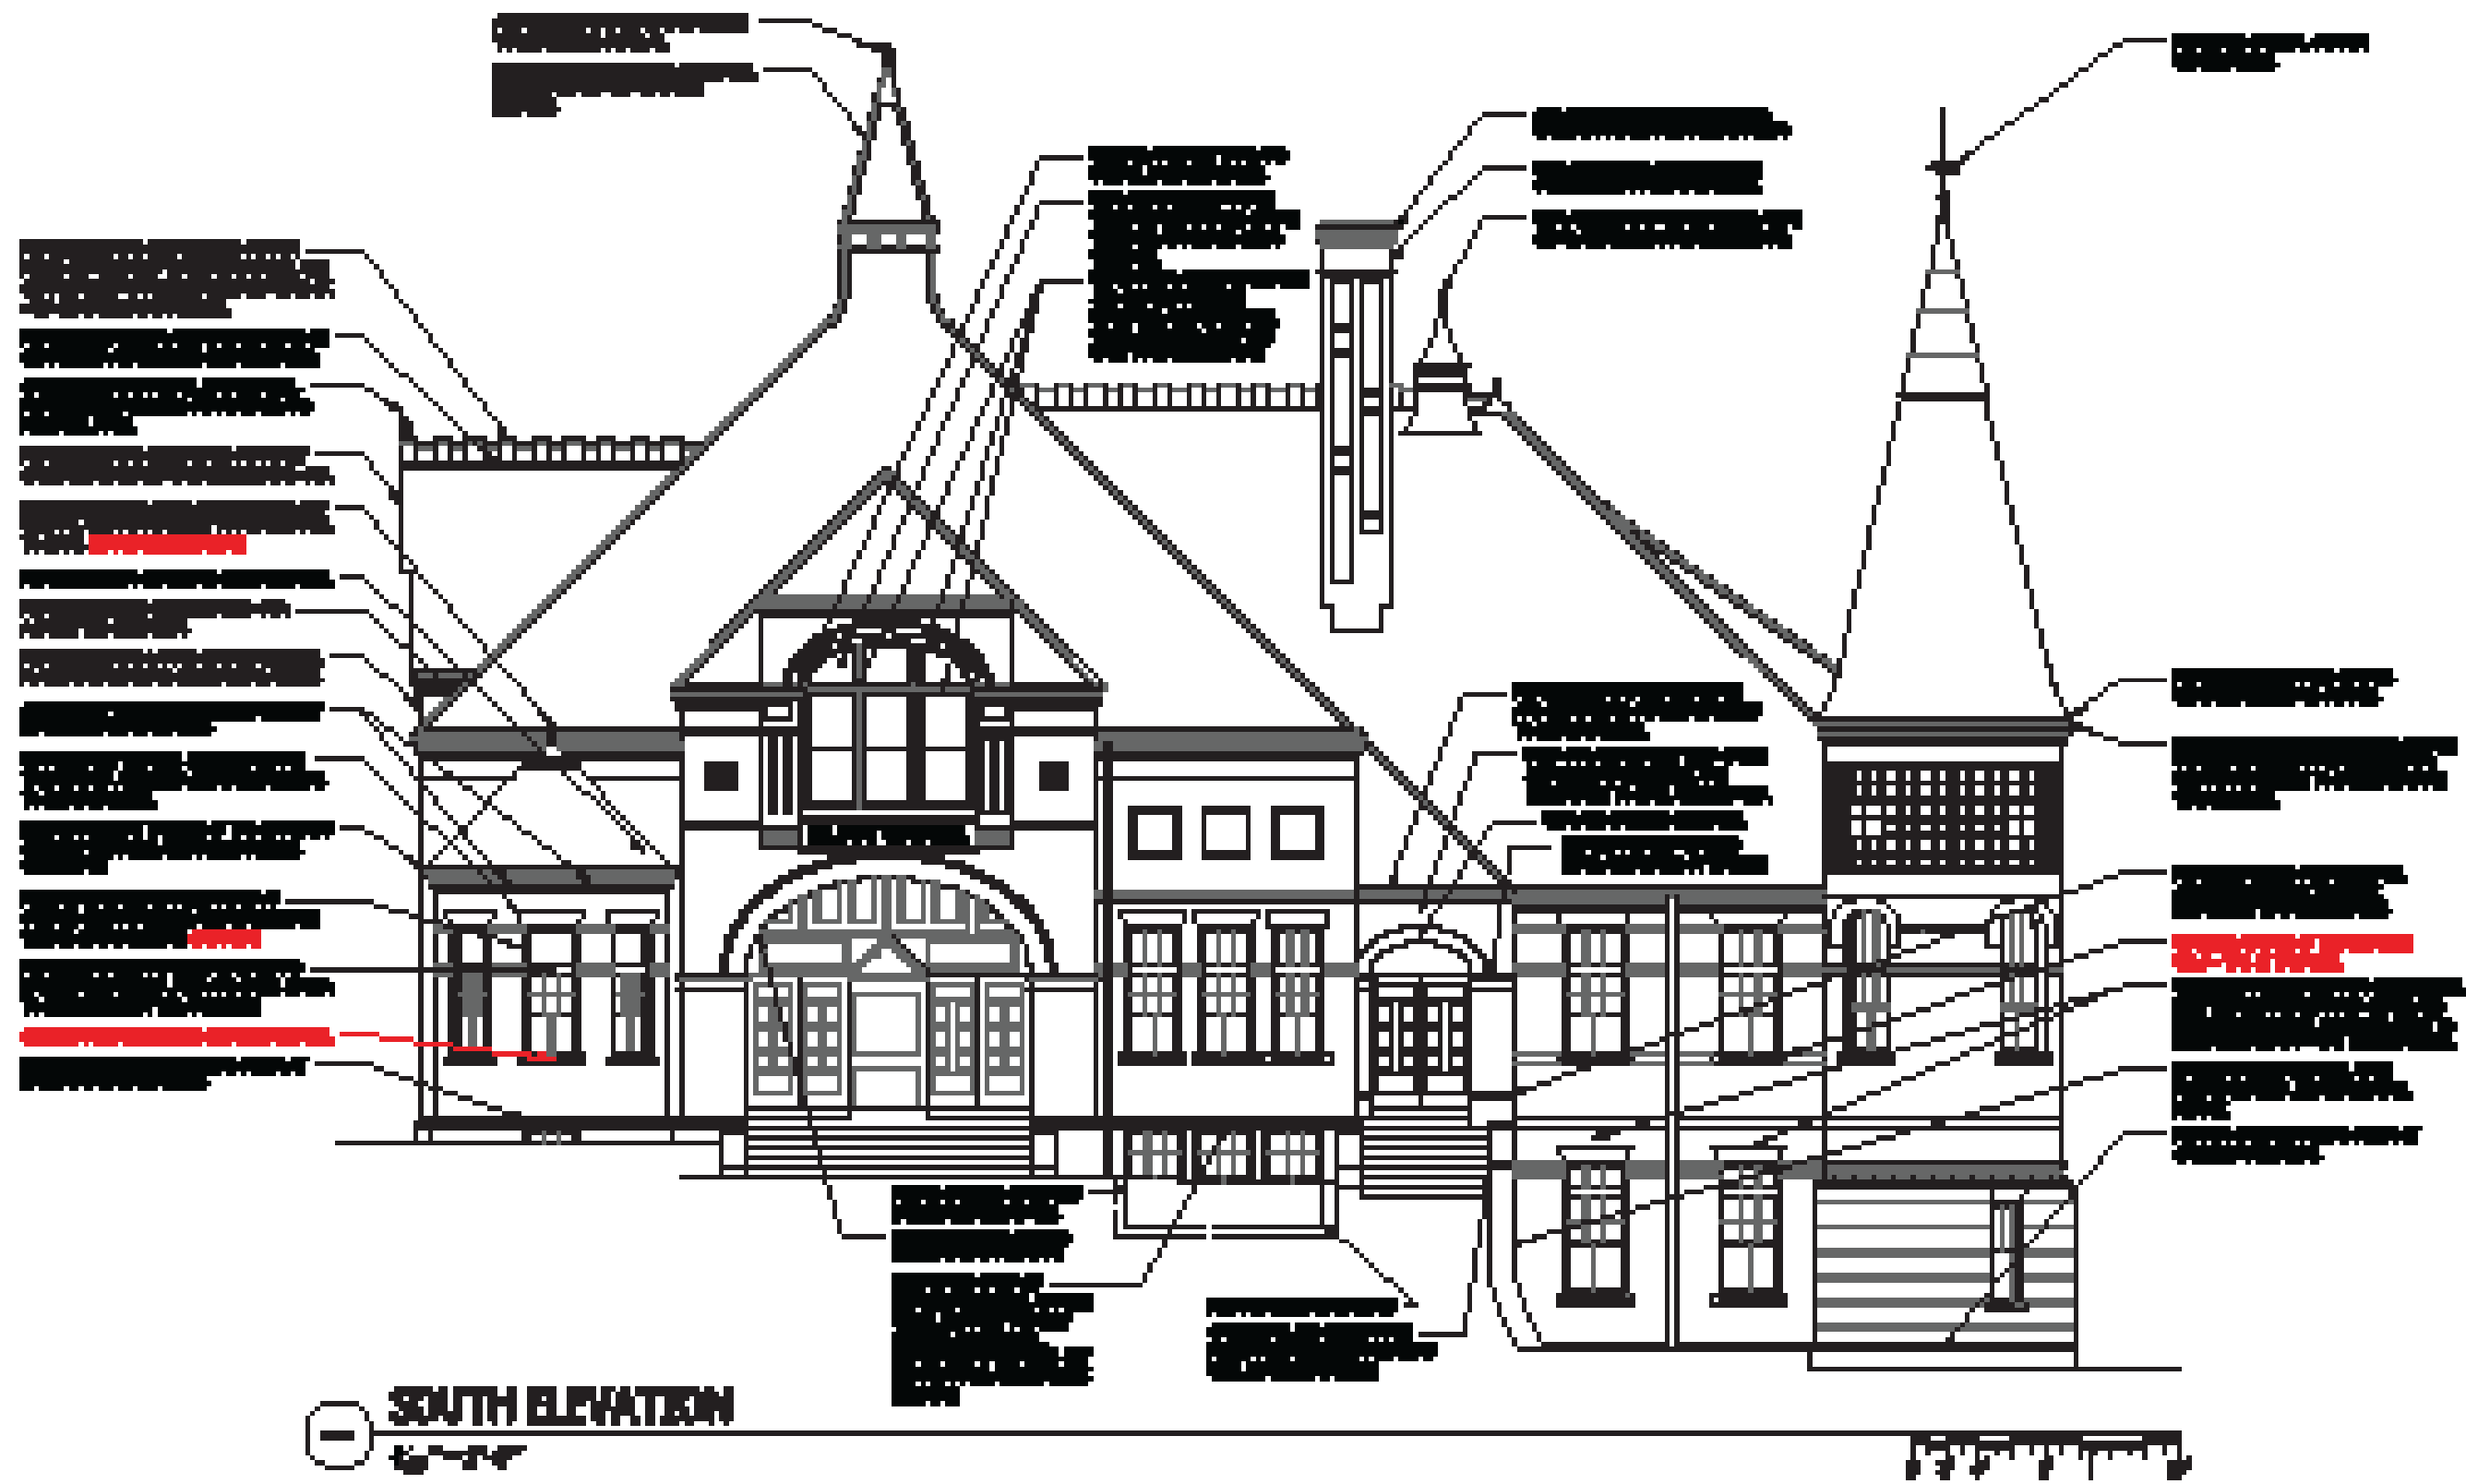
**SOUTH ELEVATION**  
1/4" = 1'-0"
