EXISTING CONDITIONS ASSESSMENT

BELMONT, MA CIVIC COMPLEX

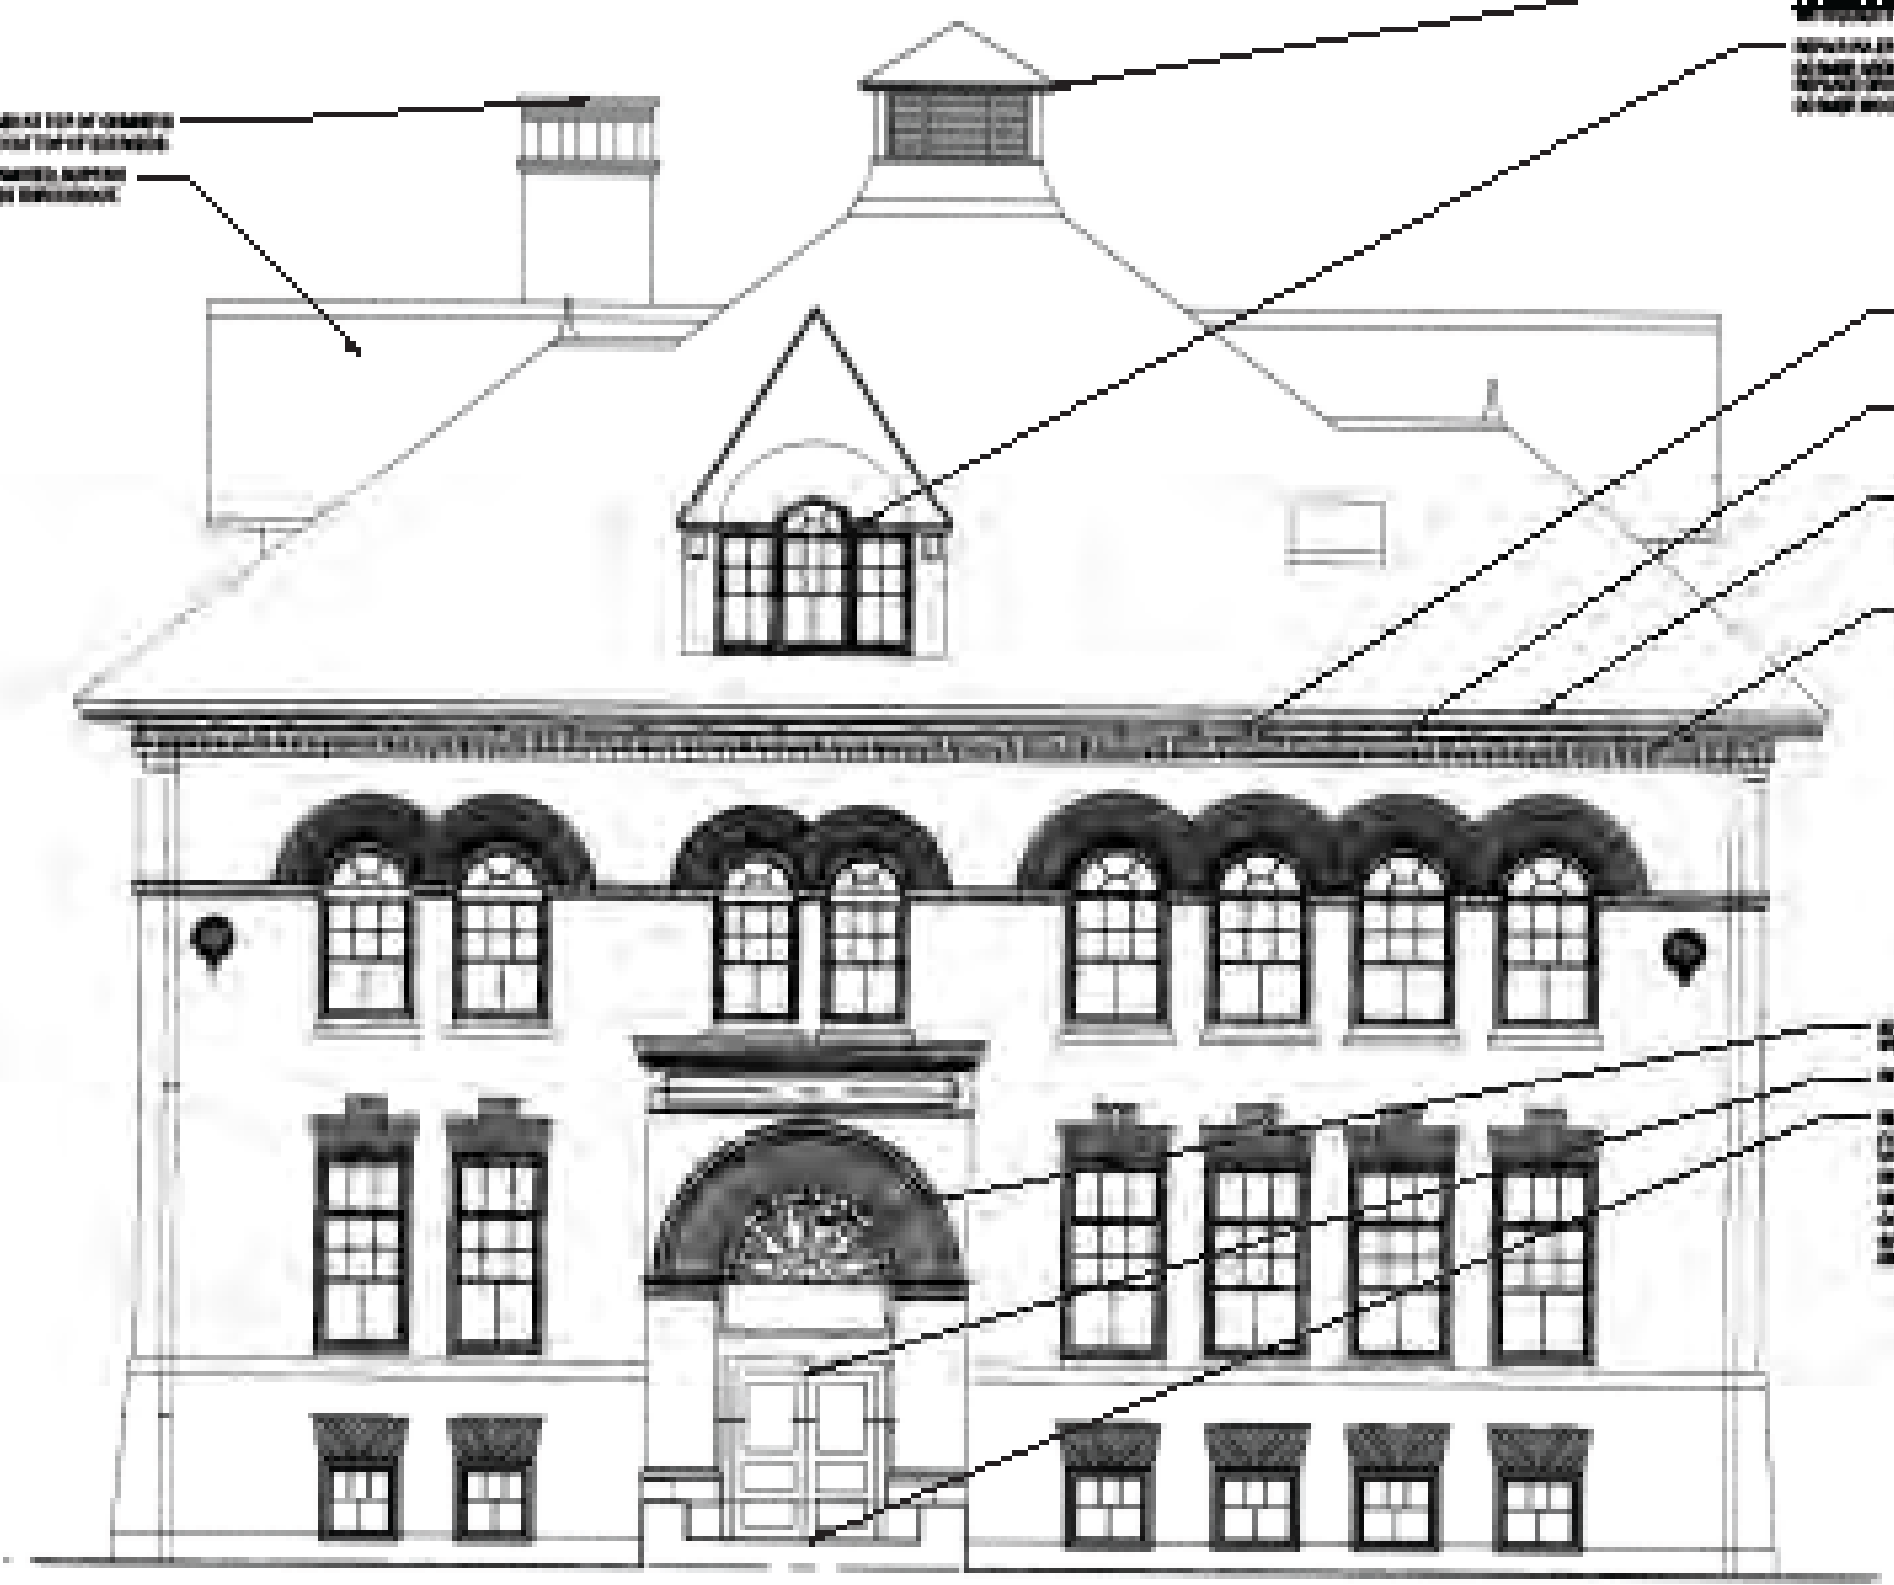
**WEST ELEVATION**  
 6'-5"

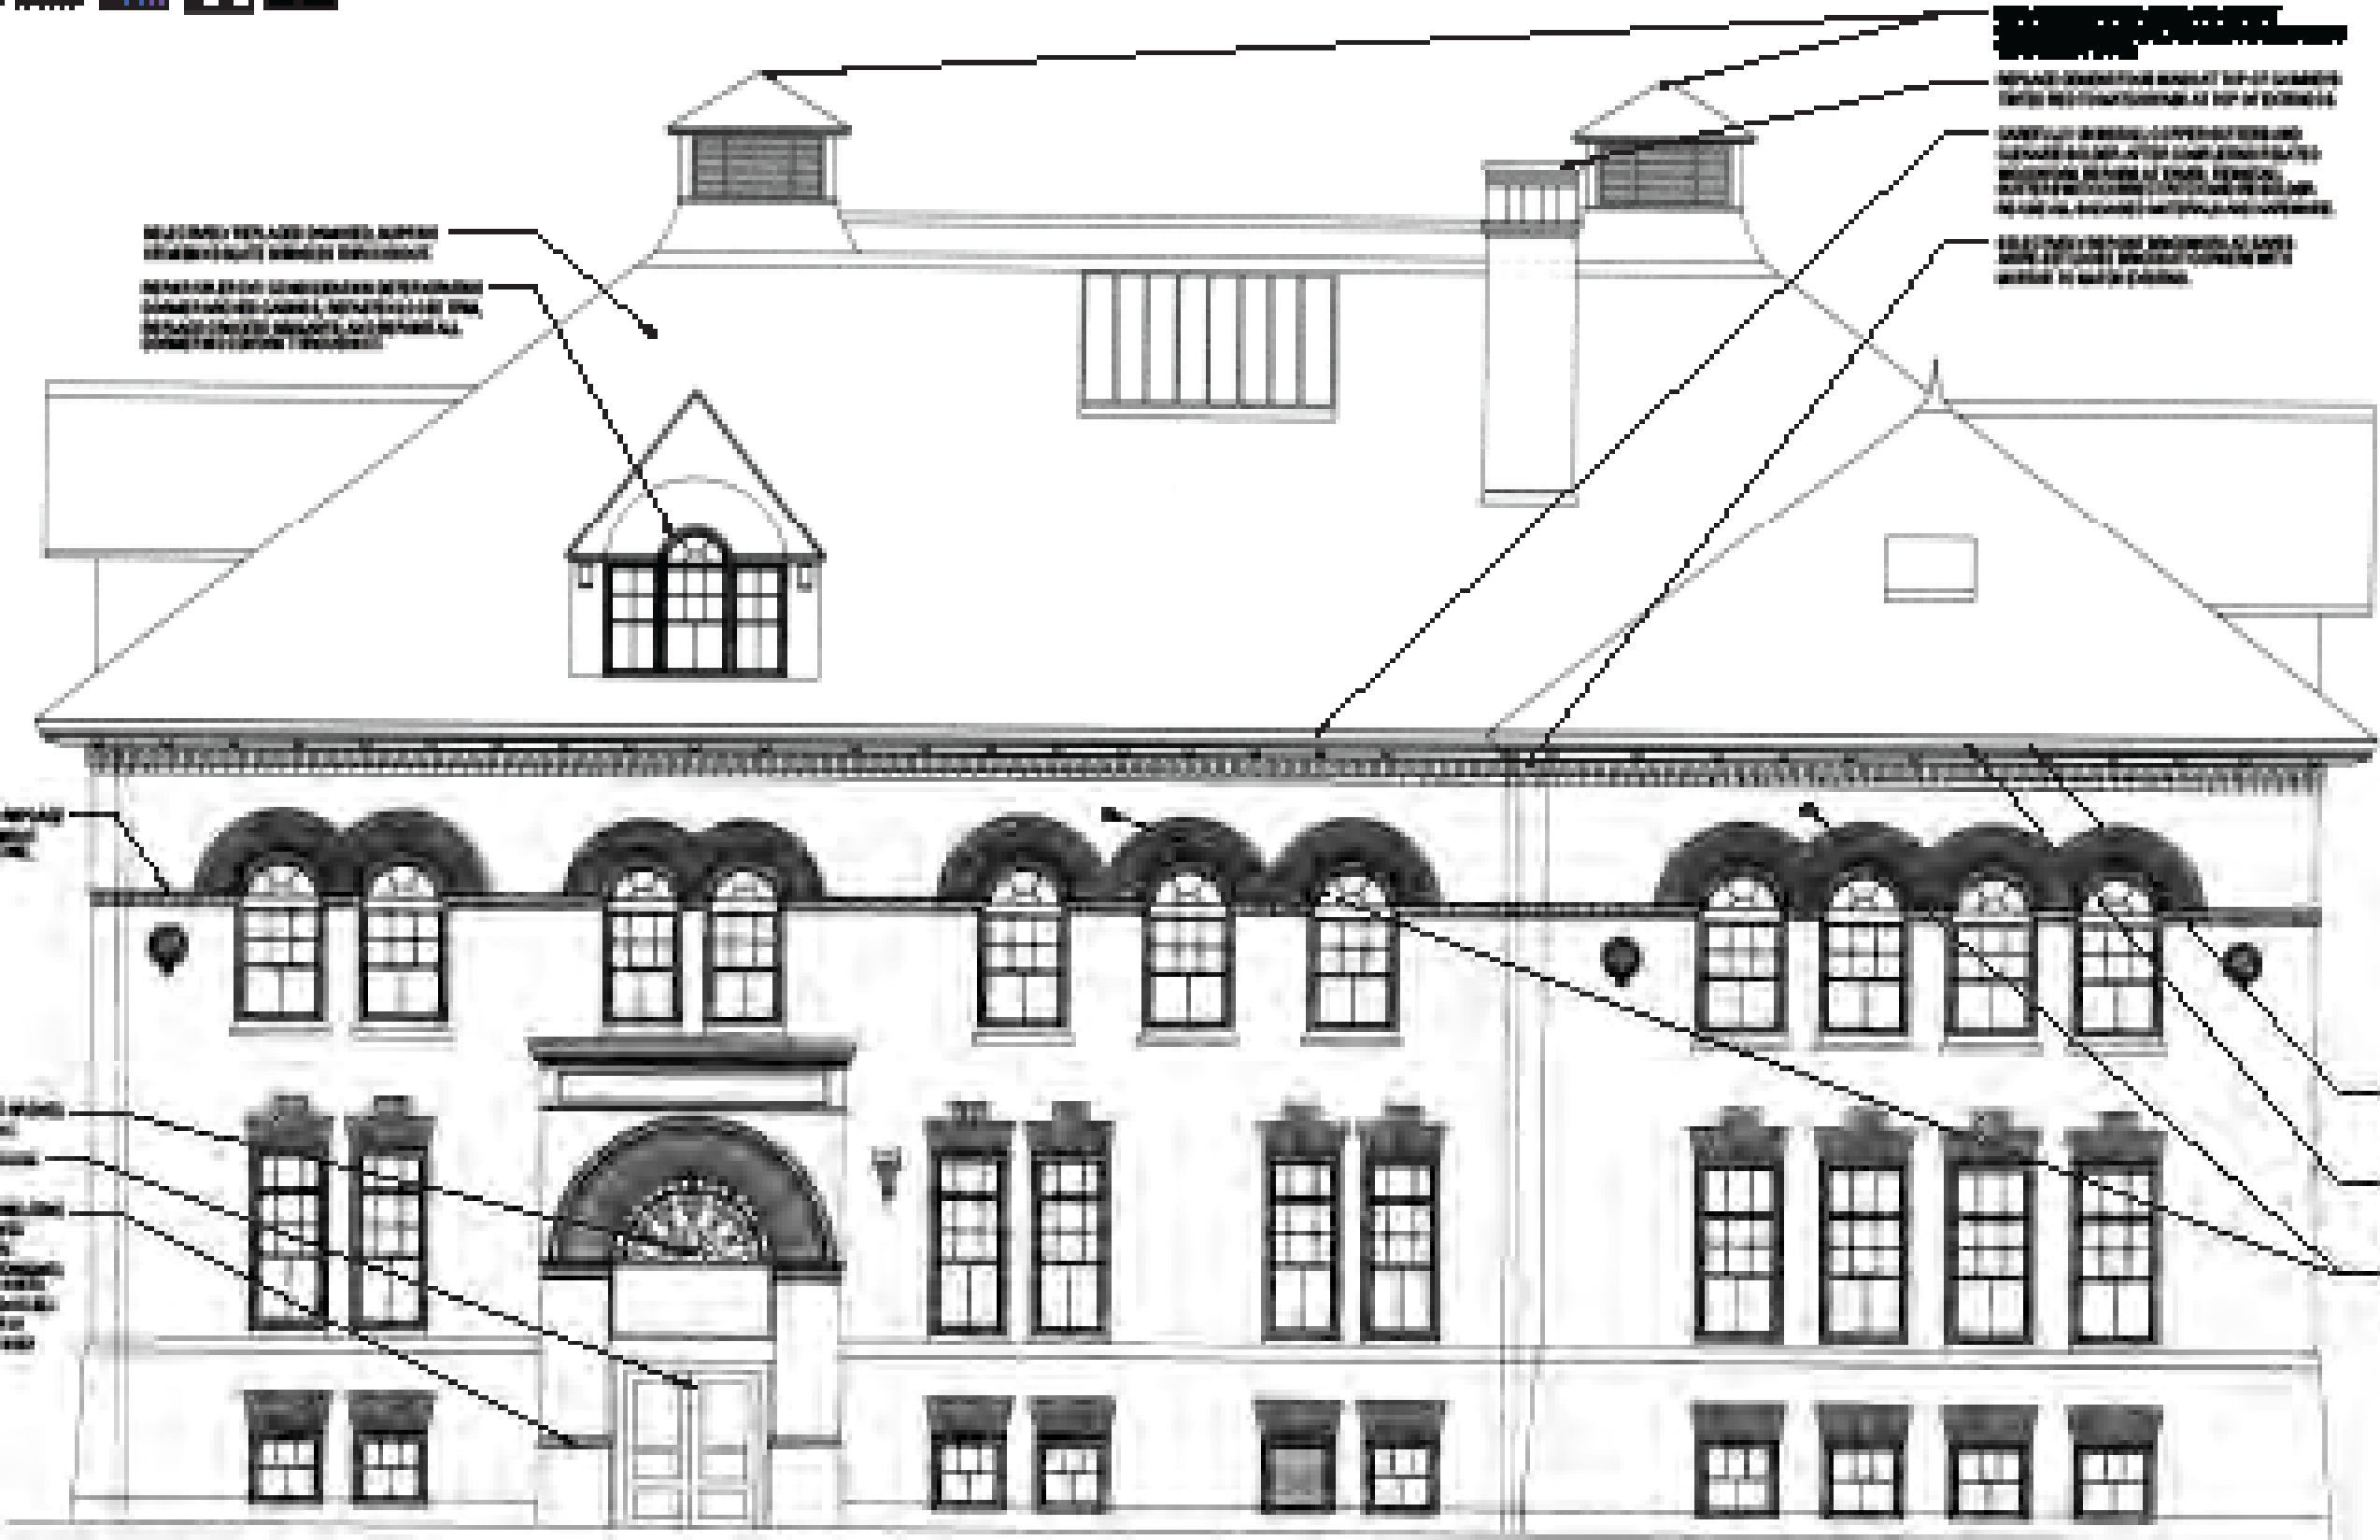
REPLACE EXISTING CORNICE ABOVE  
SECOND-FLOOR WINDOW ELEVATION  
REPAIR EXISTING CORNICE MATERIAL  
REPLACE CORNICE MATERIAL WITH  
REPLACEMENT MATERIAL

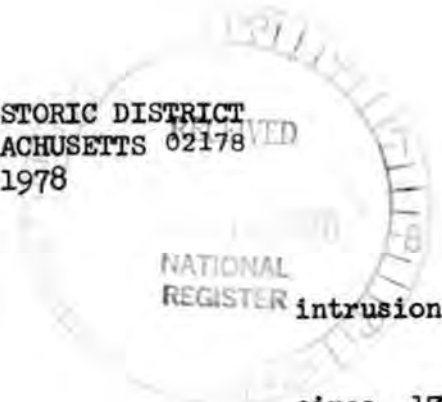
1. *u/s* Mr. & Mrs. John A. Dunn, Jr.  
6 Stella Road intrusion
2. "Capt. Stephen Frost House"  
Mr. & Mrs. Guensey Frost  
467 Pleasant Street circa 1763
3. "The George V. Fletcher House"  
Mrs. Samuel W. Garfin  
483 Pleasant Street 1868

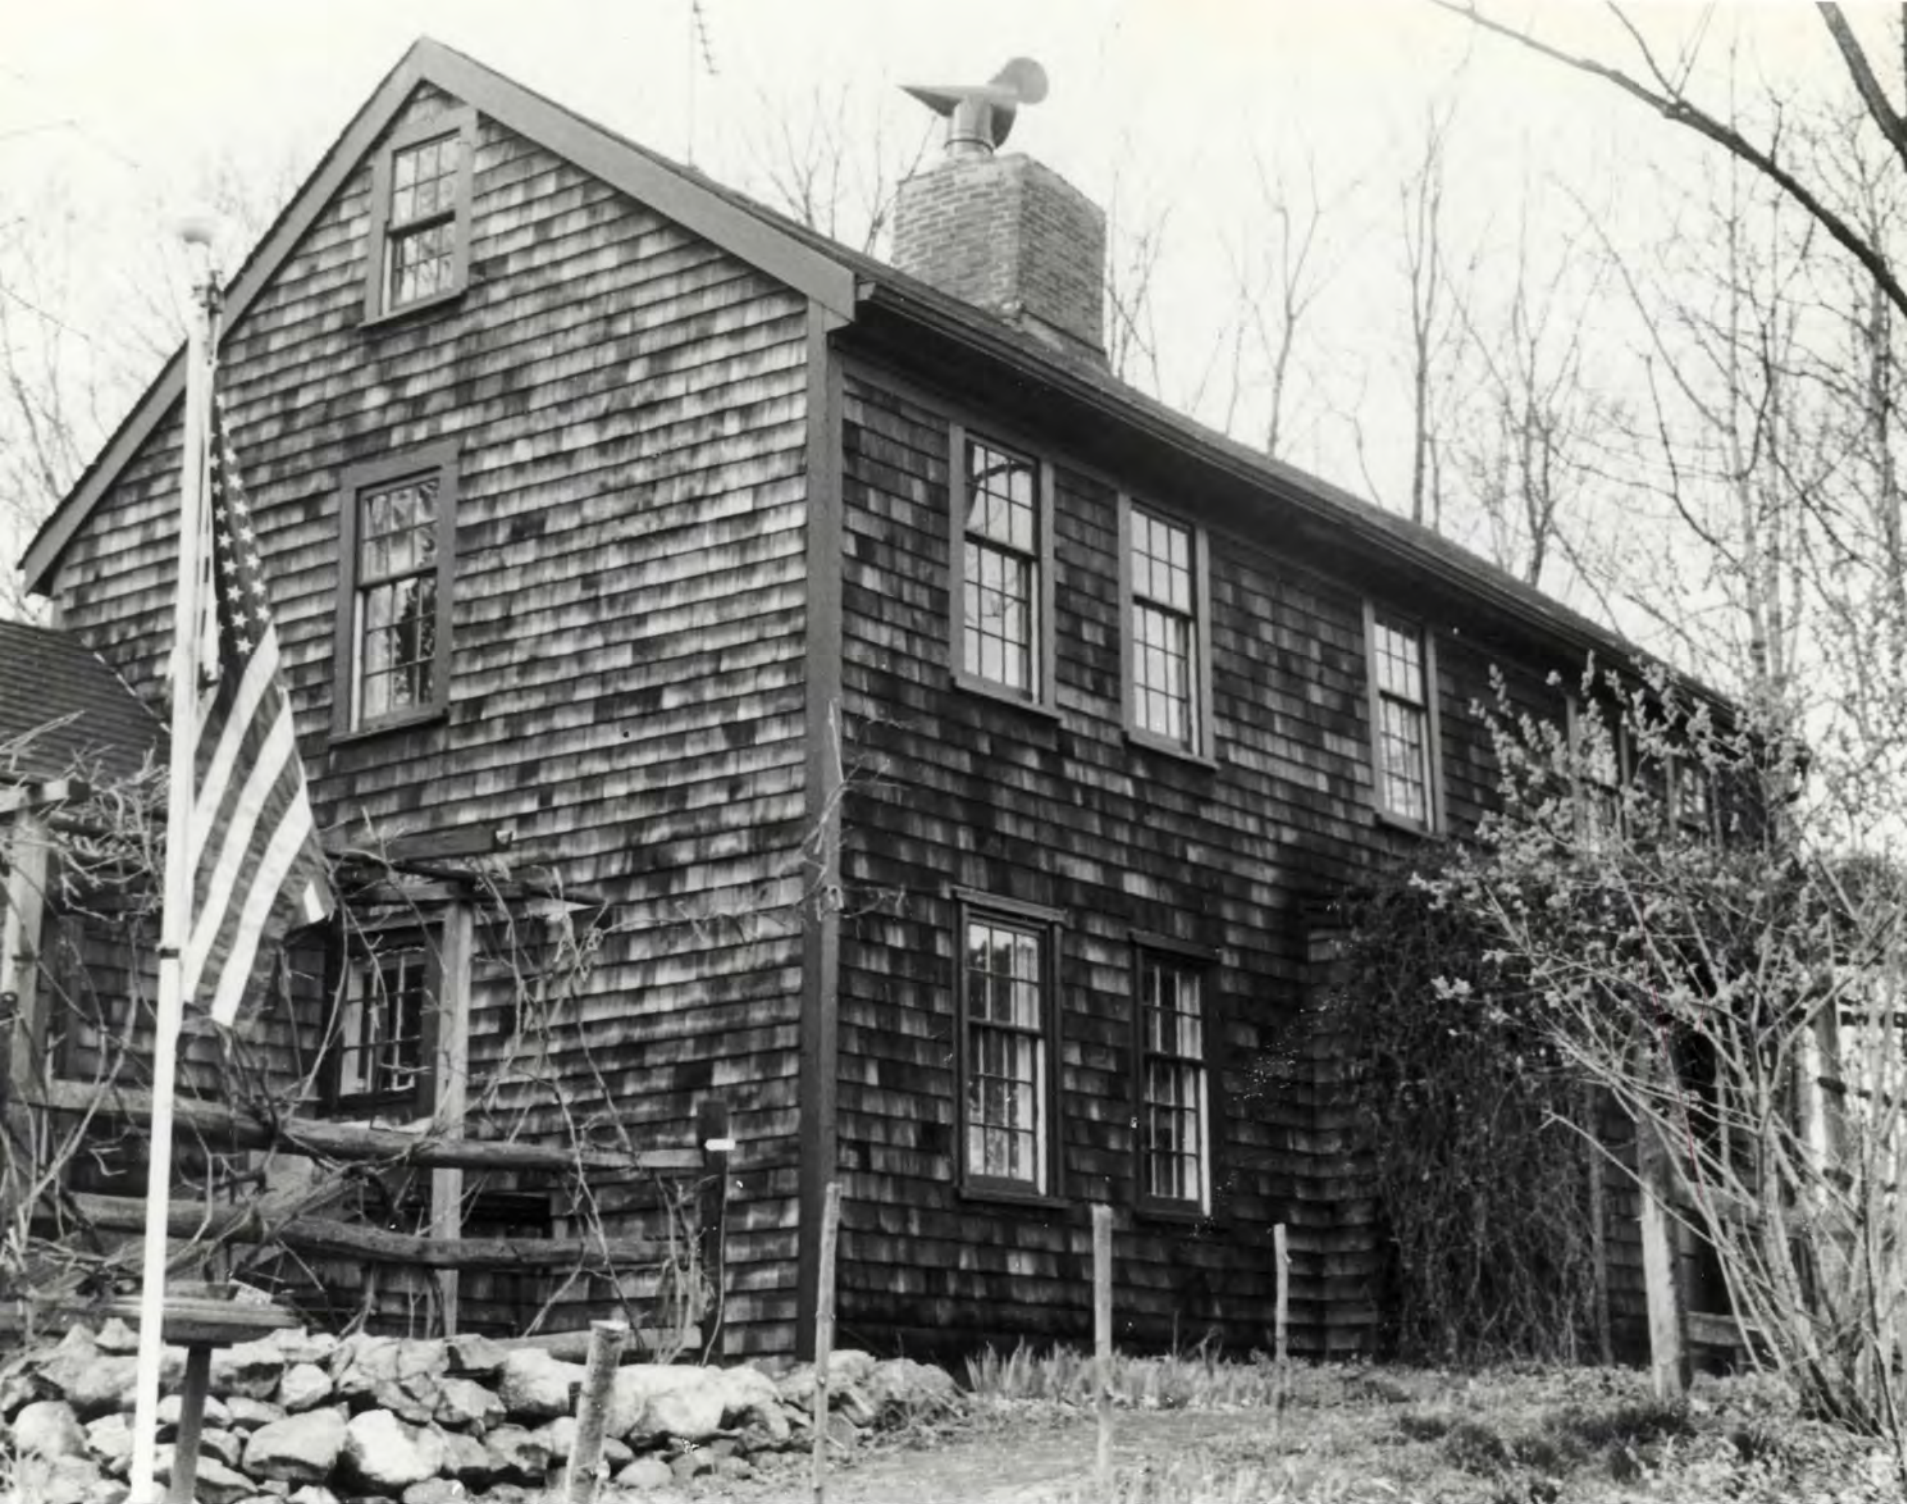
11. Captain Stephen Frost House (#2), looking northwest. (Photograph: Camilla L. French, 1977)

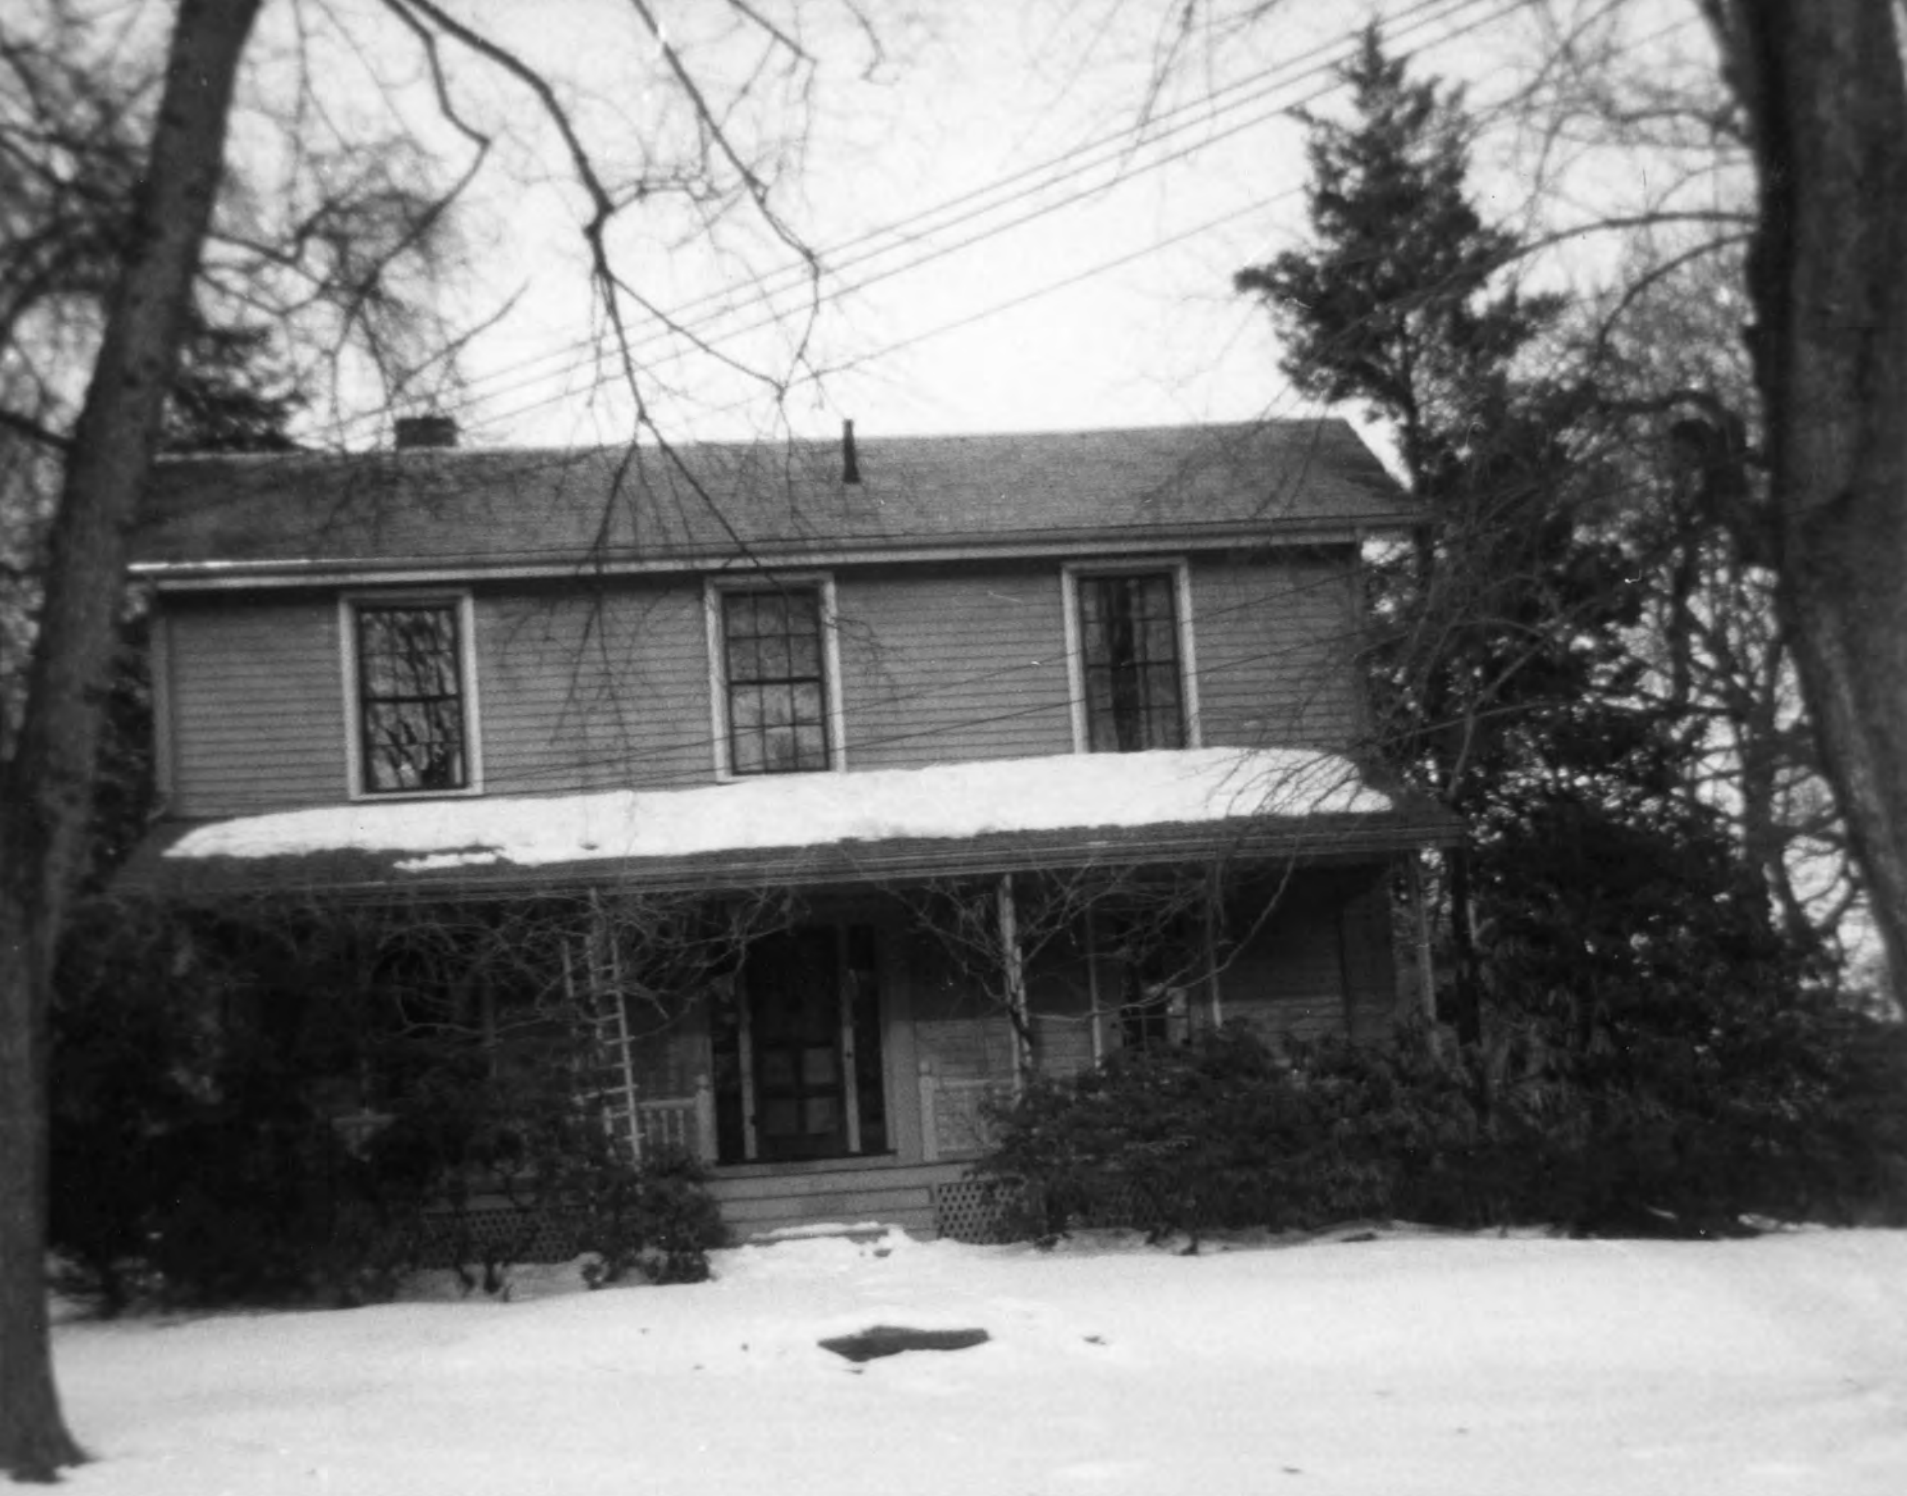
12. Widow Parks Cottage (#30), looking north. (Photograph: Camilla L. French, 1977)

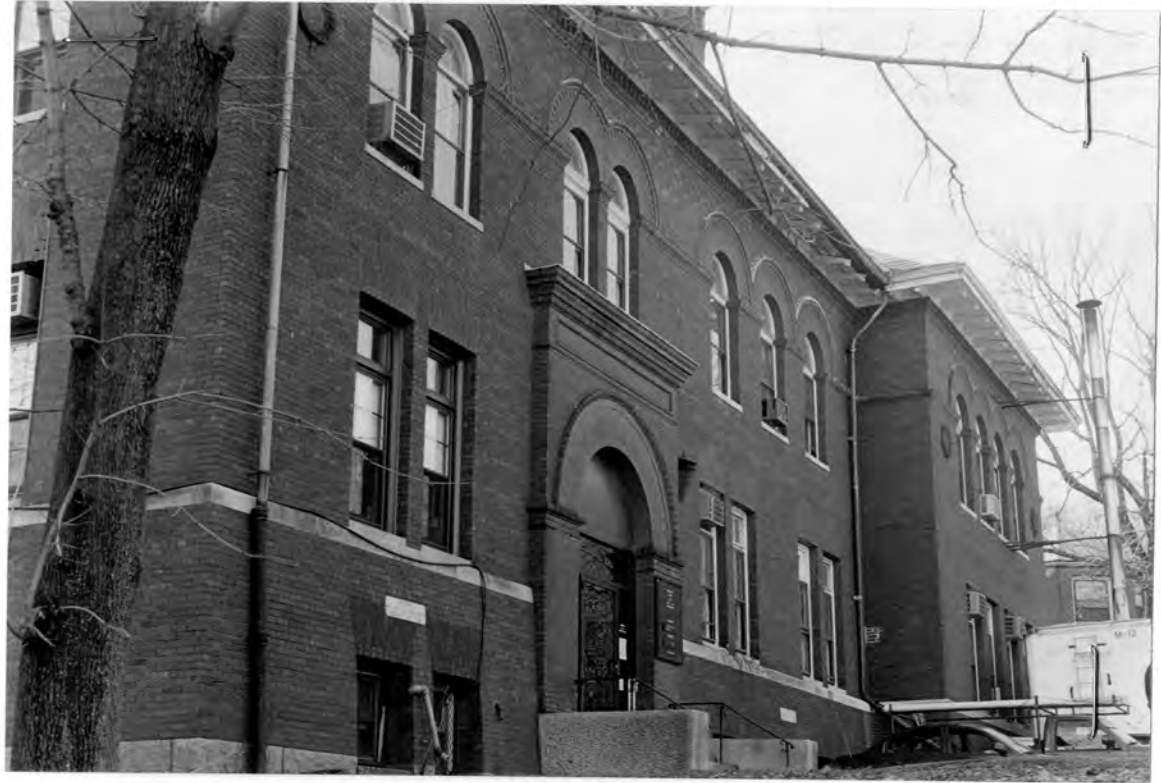
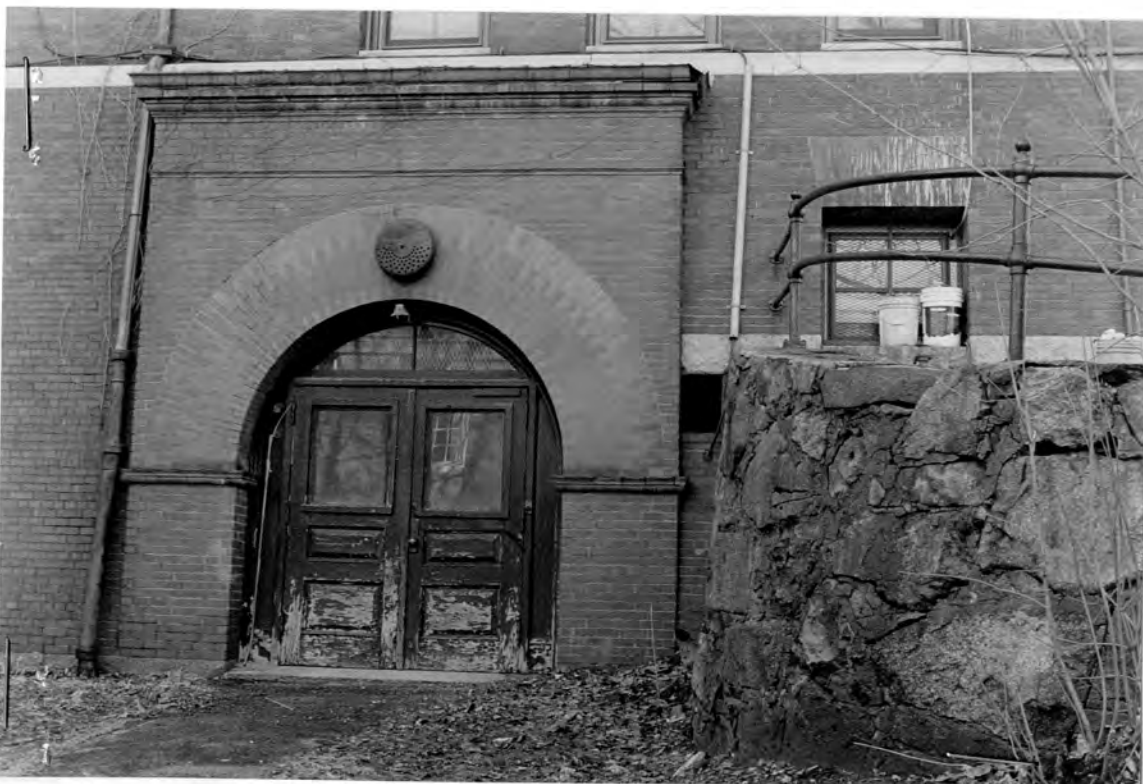
**INVENTORY FORM CONTINUATION SHEET**

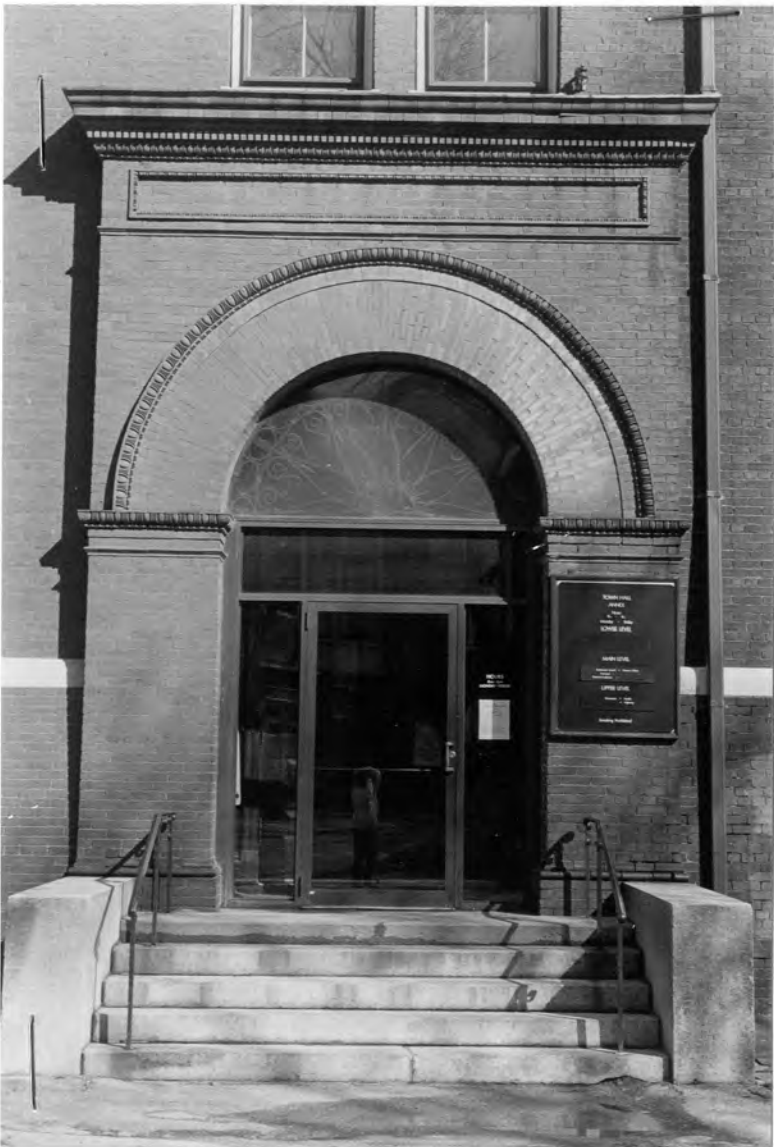
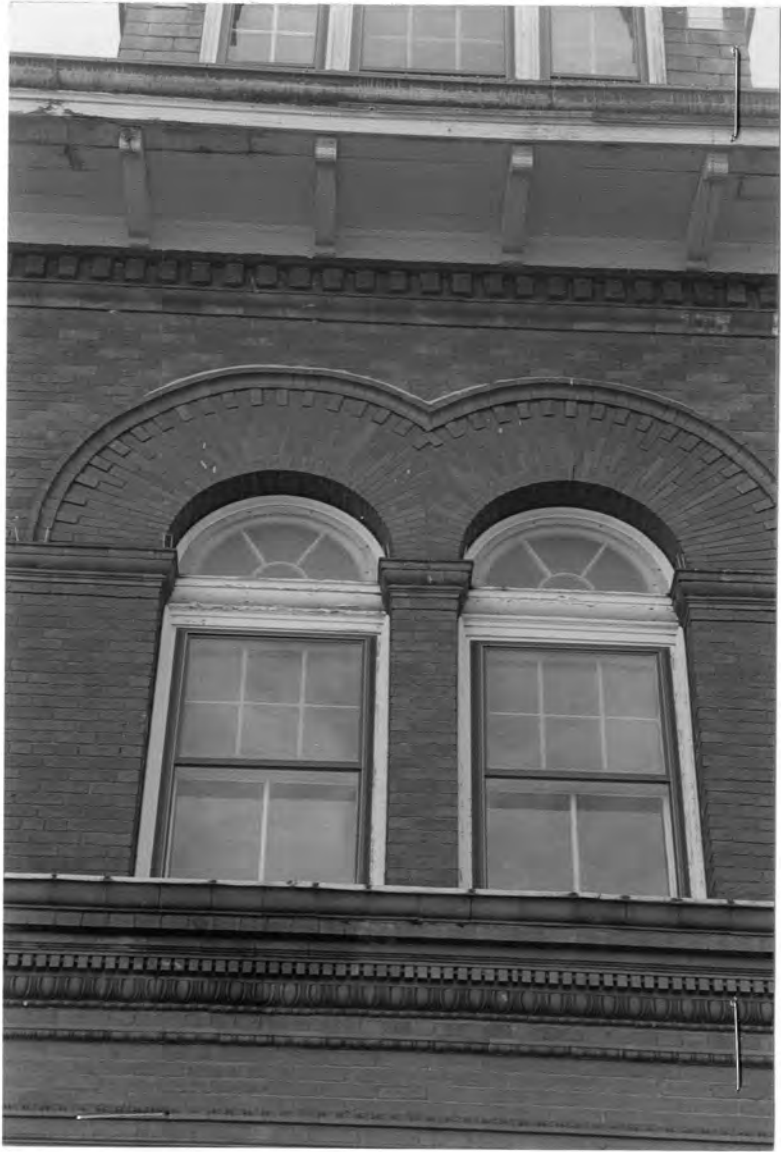
Area (s) *AT, 4* Form No. *31-2 126*

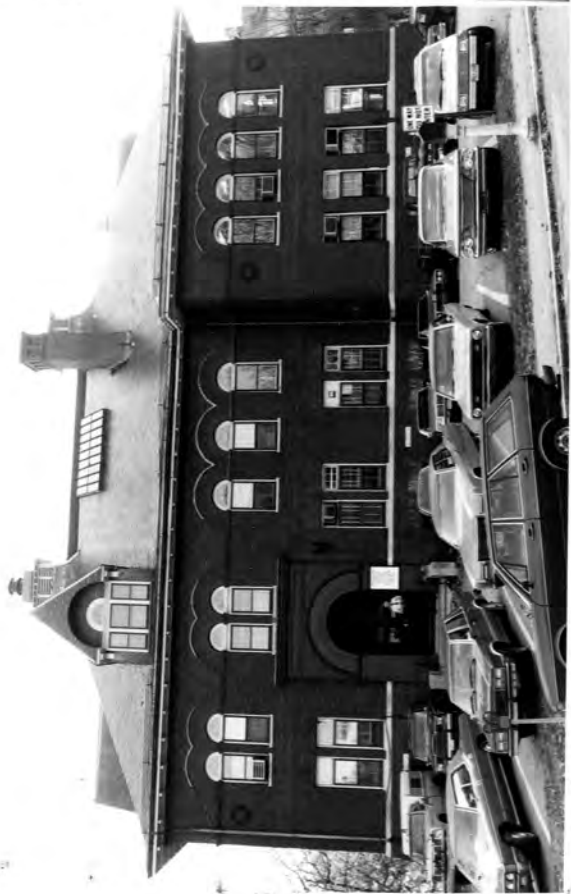
The Belmont Town Hall Annex meets criterion C as a distinguished work of architecture in the Queen Anne style with several important Romanesque Revival features. The building is the product of the finest craftsmanship of its day, built to last with the highest quality of masonry materials available, that still stands in remarkable good condition today. It is also an important component of Belmont Center which developed at the crossroads of the Concord Turnpike and Pleasant Street. Along with the Town Hall (Queen Anne, 1882) and School Administration Building (former library; Classical Revival, 1902), it forms an impressive civic center that borders the primarily residential Pleasant Street Local Historic District and the commercial spine of Leonard Street. Together, the three town buildings comprise an imposing and well-integrated municipal group.
