William Flagg Homer House
Belmont Woman's Club
Building Survey and Investigation

Wolf Architects, Inc.
MacLeod Consulting, Inc.

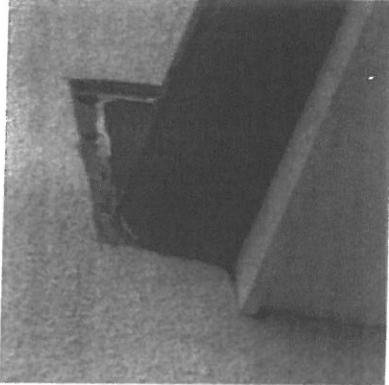
Split brownstone sill and peeling paint

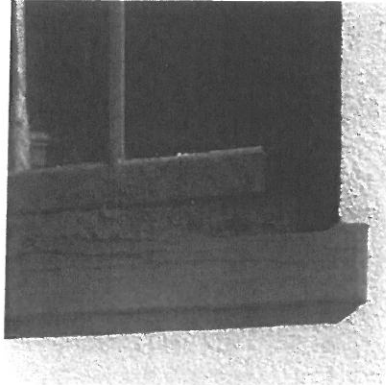
Deteriorated mortar; open joints at foundation

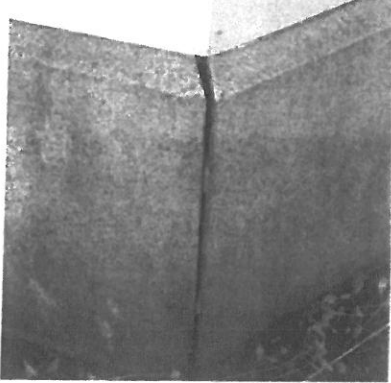
Split brownstone sill

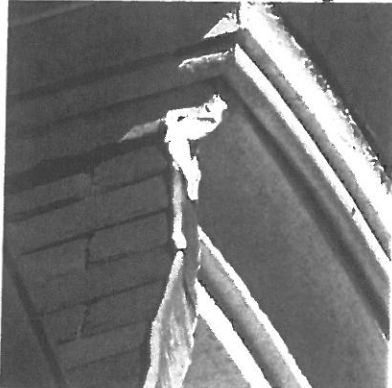
Brick replacement and repair

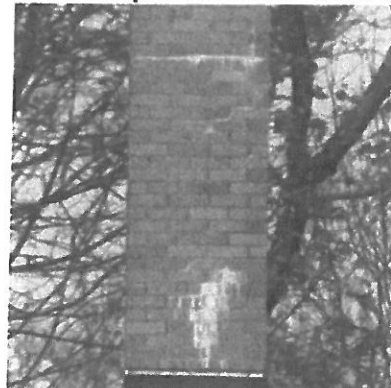
CONDITIONS OVERVIEW: TYPICAL CONDITIONS

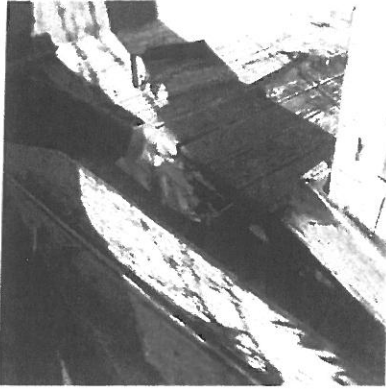
Broken and damaged scrolls

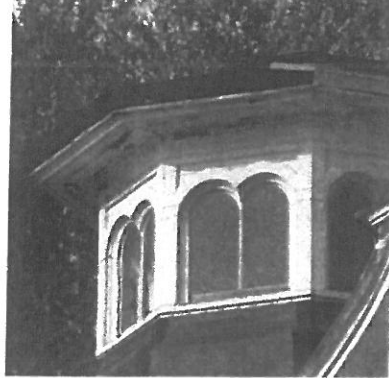
Drive cracking and patching

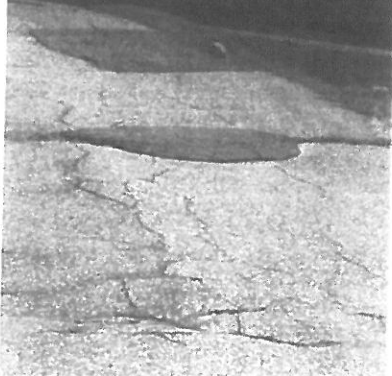
CONDITIONS OVERVIEW: TYPICAL CONDITIONS

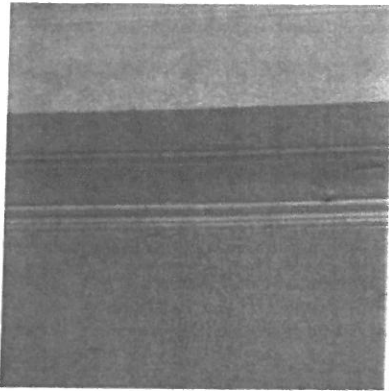
Possible evidence of settling

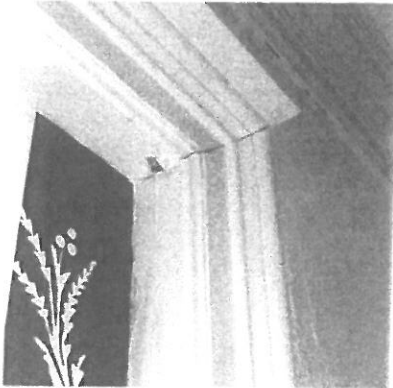
Peeling paint due to moisture

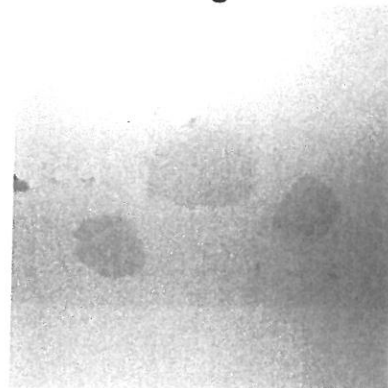
**William Flagg Homer House
Belmont Woman's Club
Conditions Assessment**

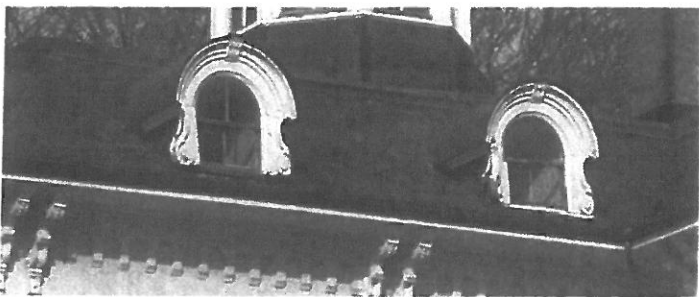
Front, South-facing Slope

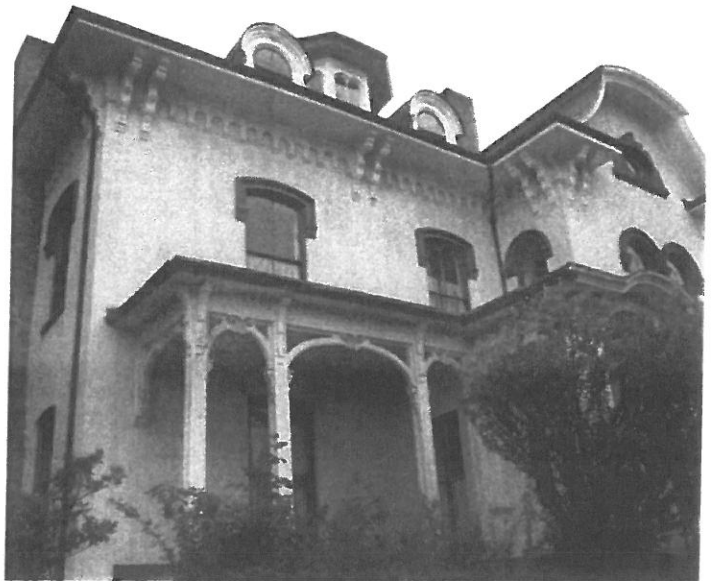
Soffit, brackets and cornice

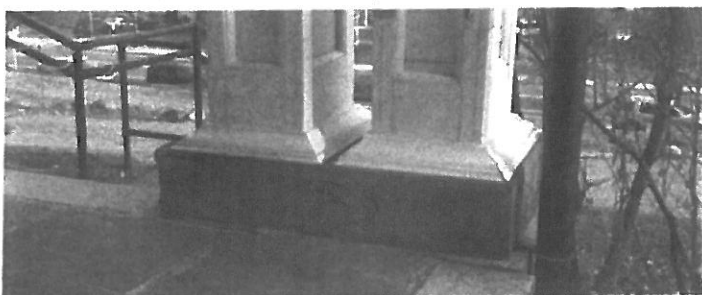
Front Vestibule and Entry Porch

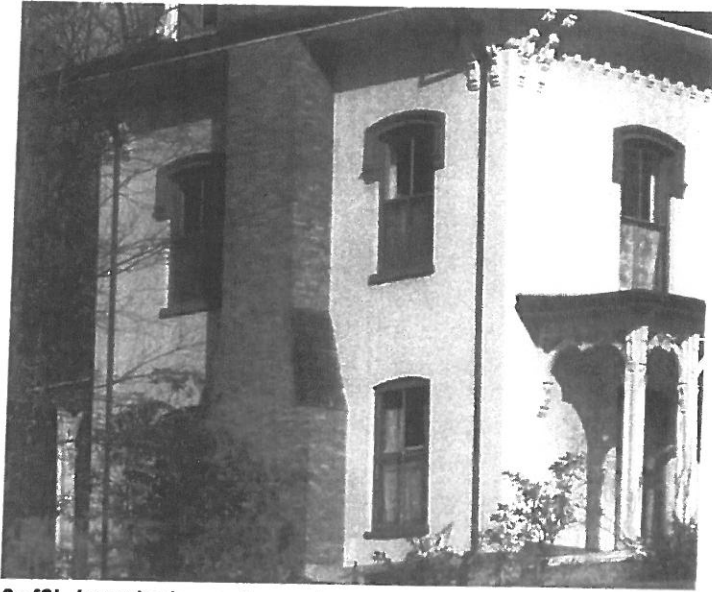
Soffit, brackets and cornice

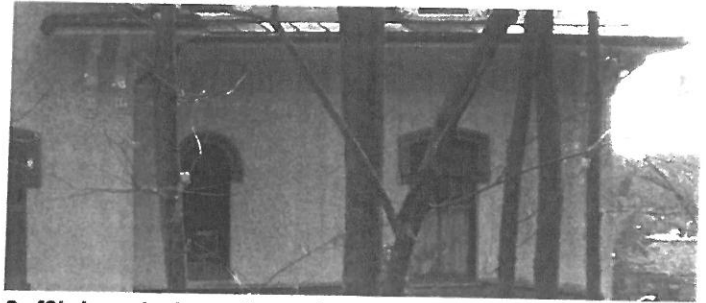
Soffit, brackets and cornice

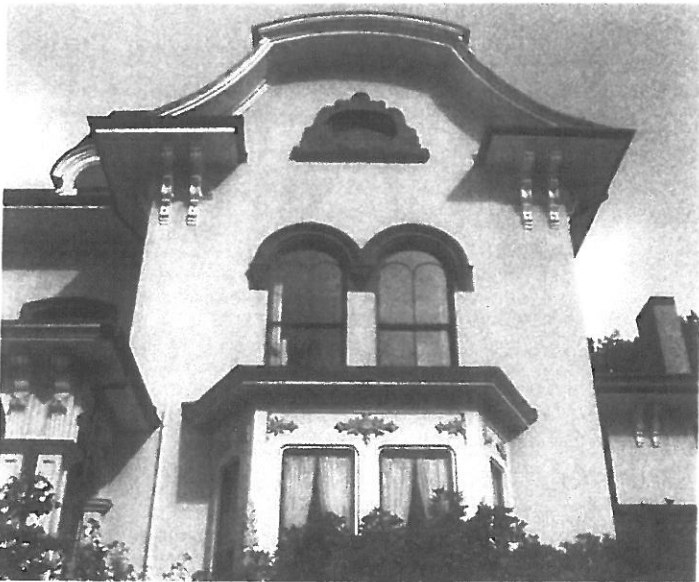
Soffit, brackets and cornice

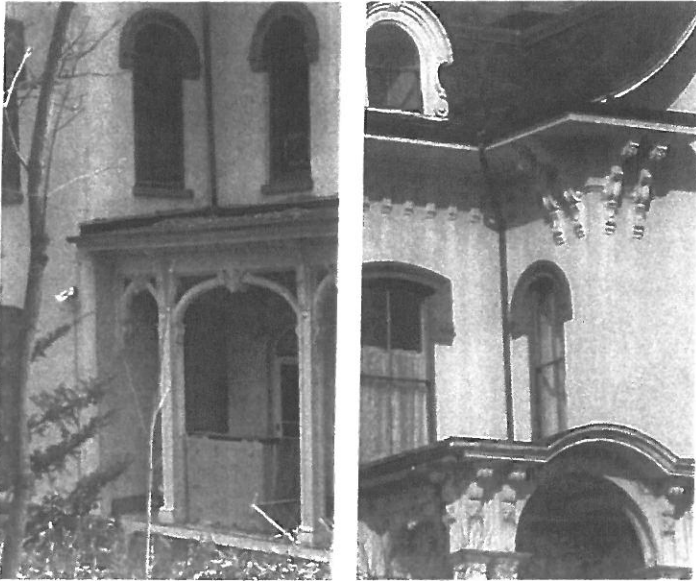
Soffit, brackets and cornice

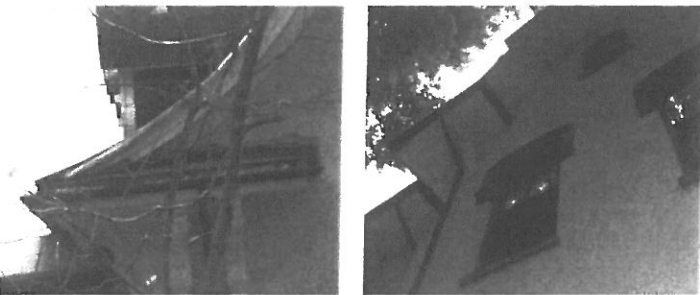
Flashing at wall of house

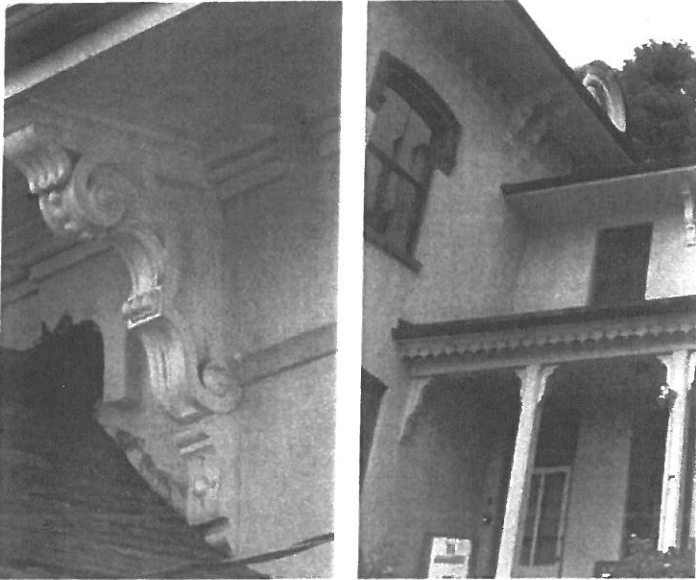
Soffit, brackets and cornice

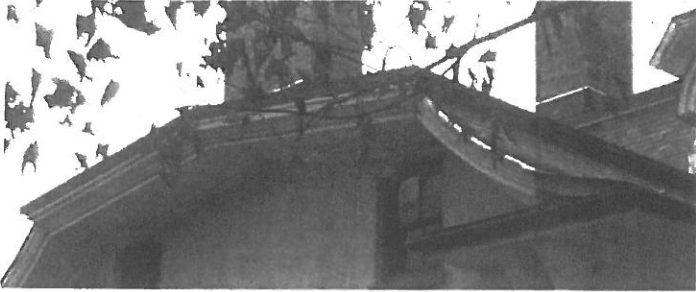
Flashing at perimeter

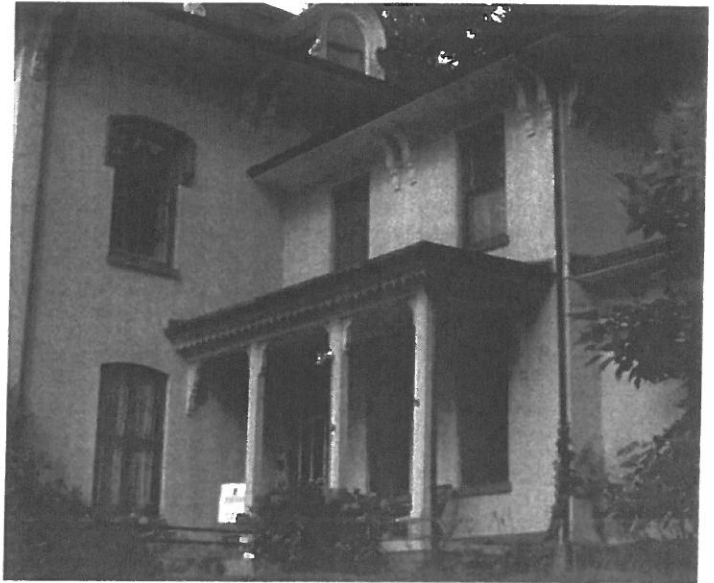
Soffit, brackets and cornice

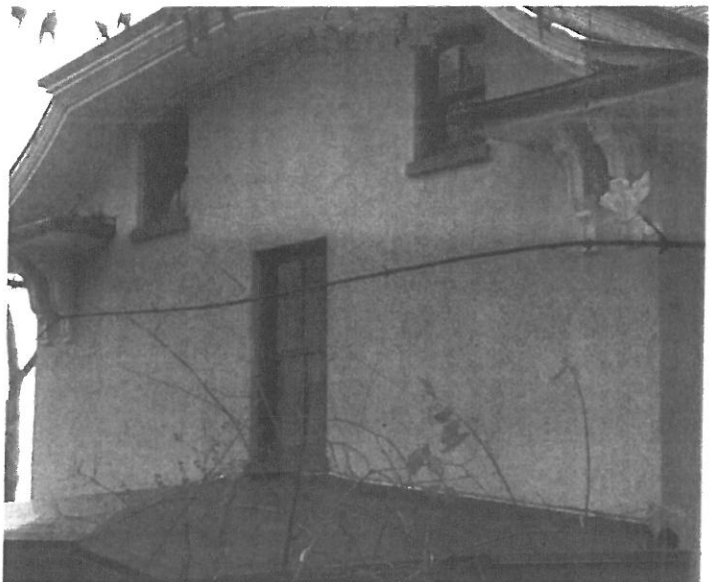
Soffit, brackets and cornice

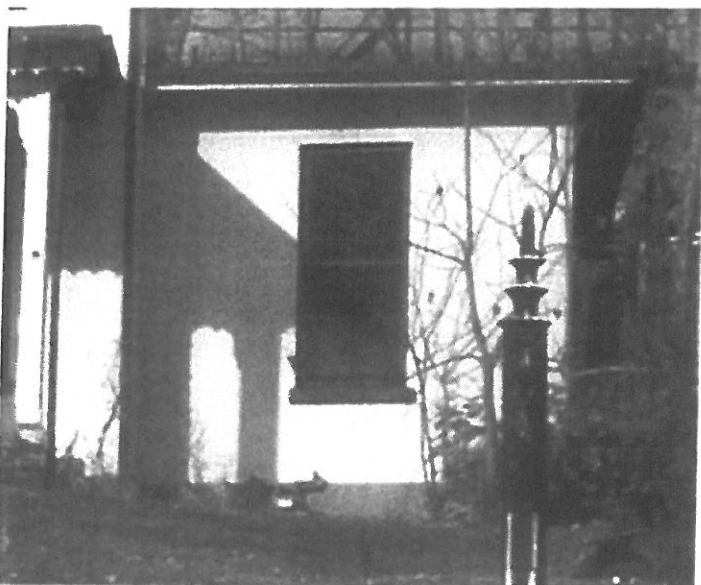
Soffit, brackets and cornice

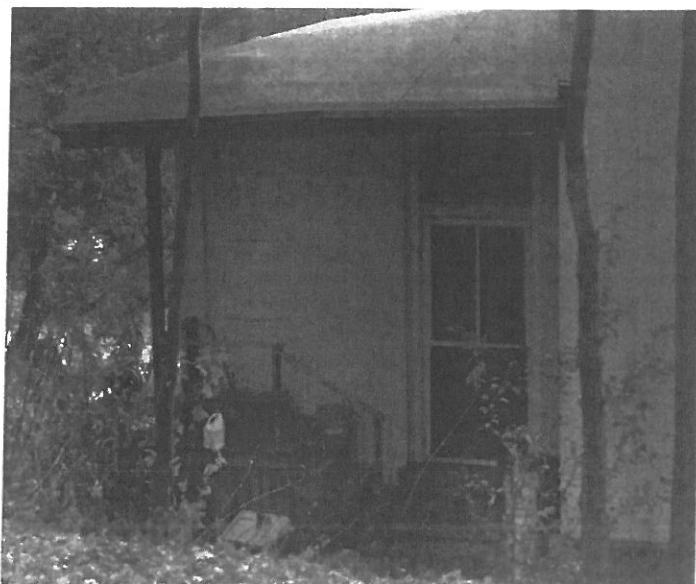
Soffit, brackets and cornice

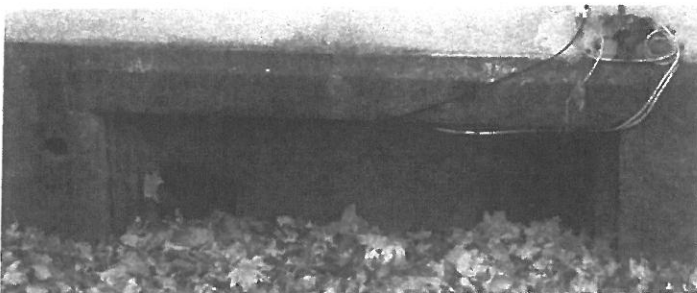
- Miscellaneous windows broken, missing, ajar.
- Miscellaneous brick partition walls have holes crudely broken through them for access, piping, etc.
- General debris, dirt, etc.
- Note: Miscellaneous storm windows, screens, doors, etc. stored here.
- Old insulation—which is likely asbestos-containing—is on some pipes and on mechanical equipment.
- Crawl space at NW corner is inaccessible.

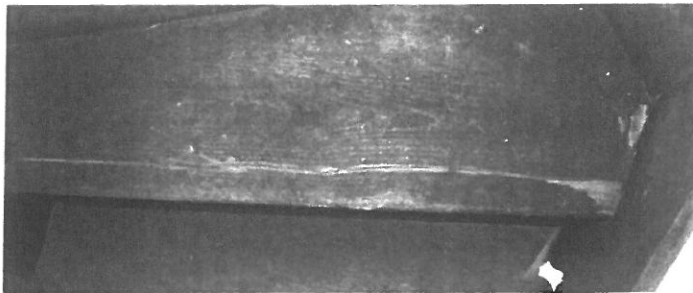
- Broken stair treads.
- Windows not operable; no venting capacity.

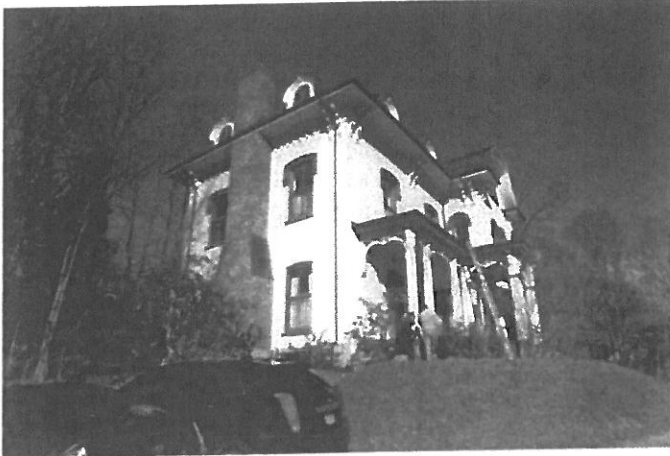
2. Belmont Woman's Club
viewed from the southeast.

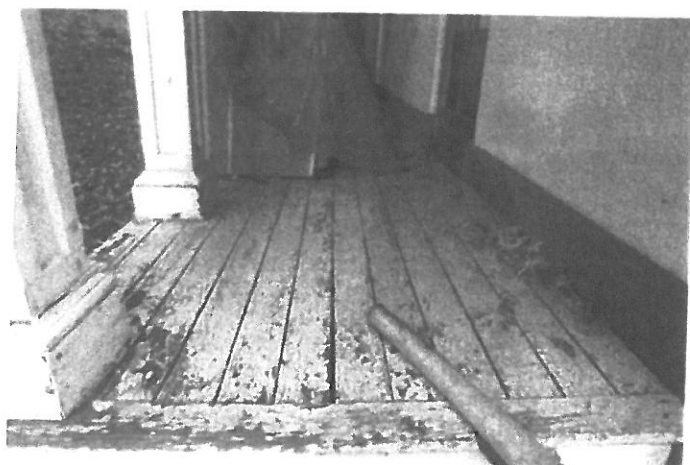
5. Rear piazza deteriorated deck
condition.

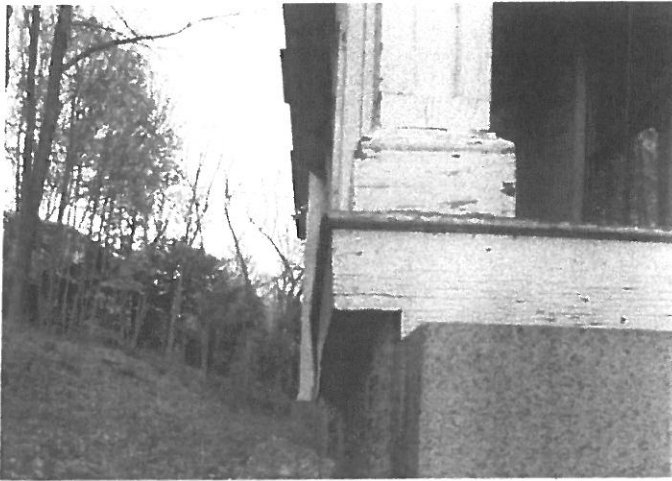
6. Dislocated foundation at rear piazza.

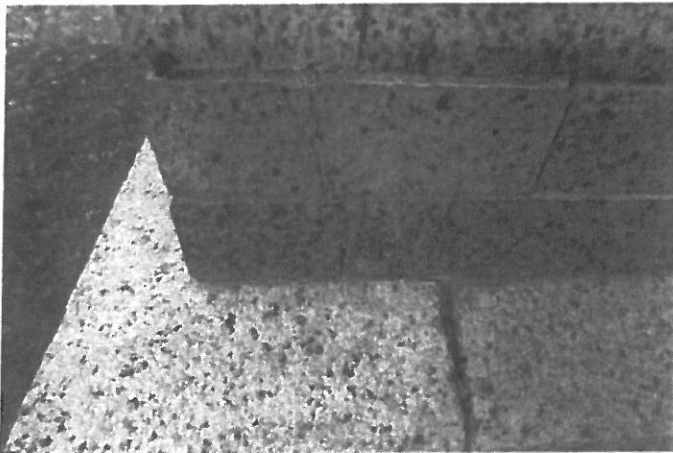
7. Cracks in brick in west chimney where granite foundation facing has opened up at head joint.

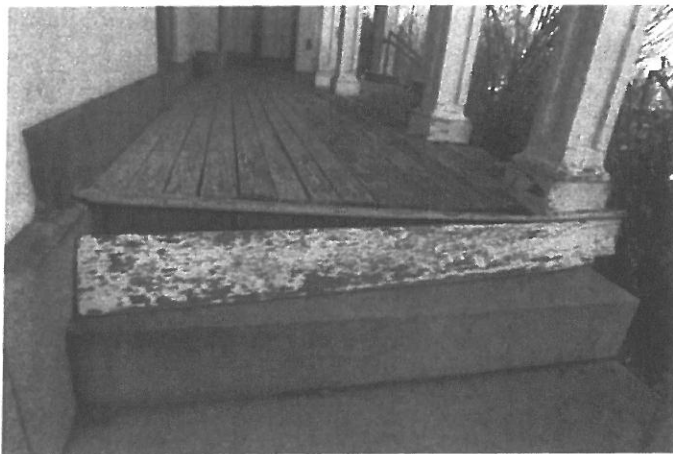
8. Front west piazza deteriorated deck condition.

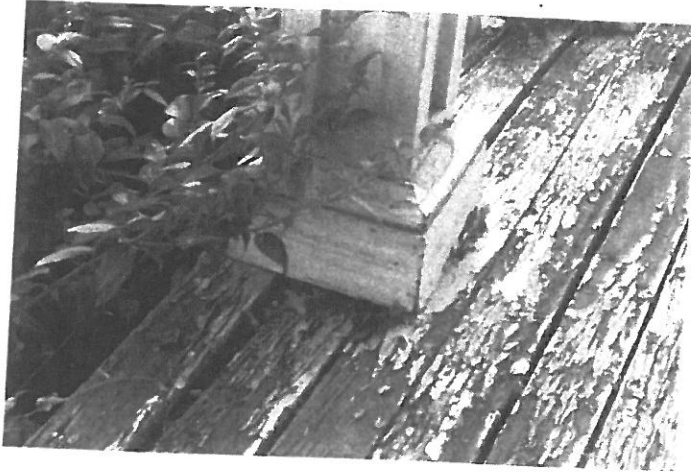
9. Front west piazza column bases.

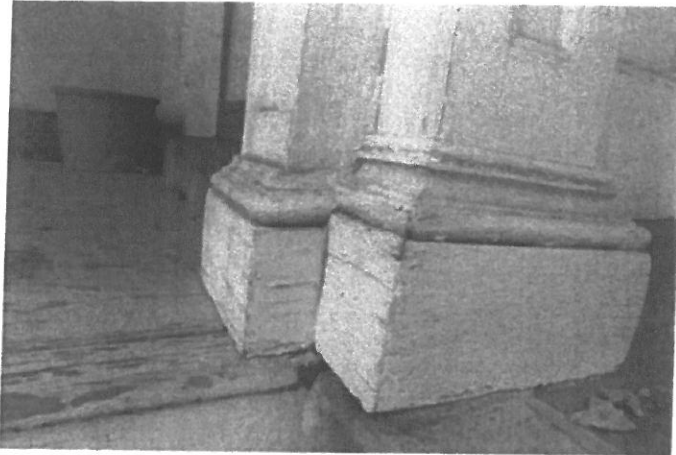
12. Old repairs to column bases disregard alignment at bases.

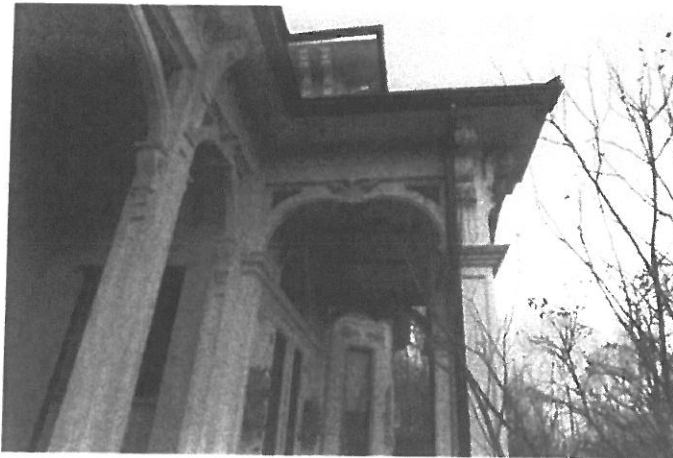
13. Roof over porch has settled along with settlement of porch landing. Columns moved with foundation to out of plumb position.

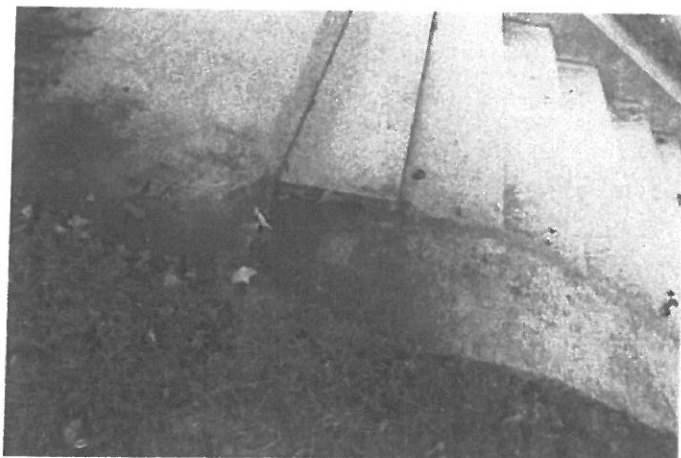
14. Cheek walls to front stairs have settled. West cheek in foreground.

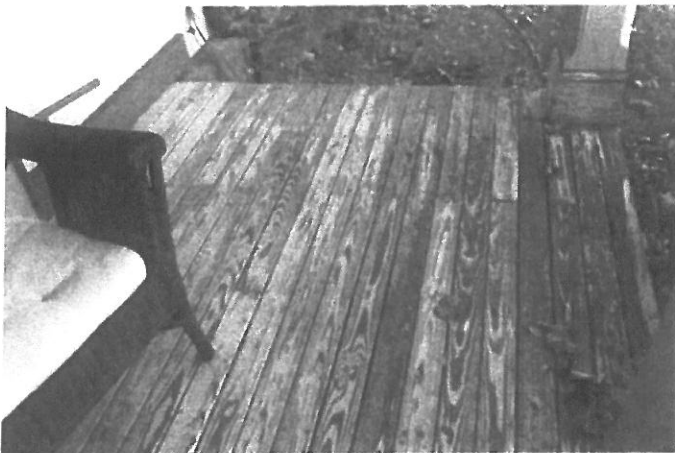
16. Decking at front east piazza is worn.

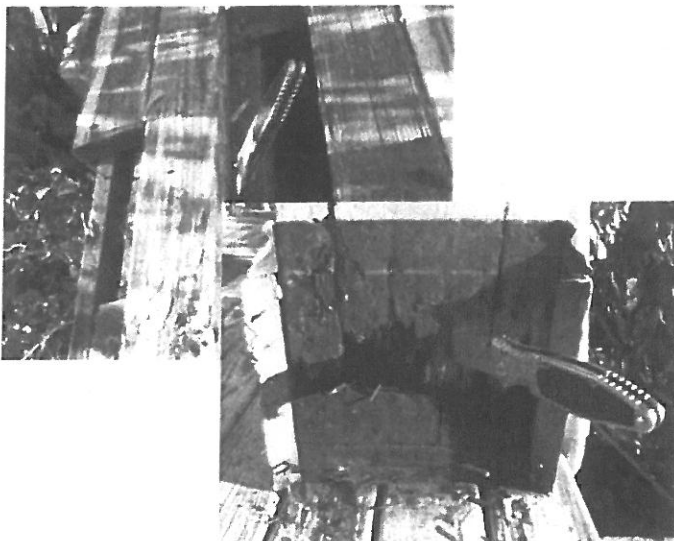
17. Rot in east piazza joist in upper photo. Rot in column base at east piazza lower photo.

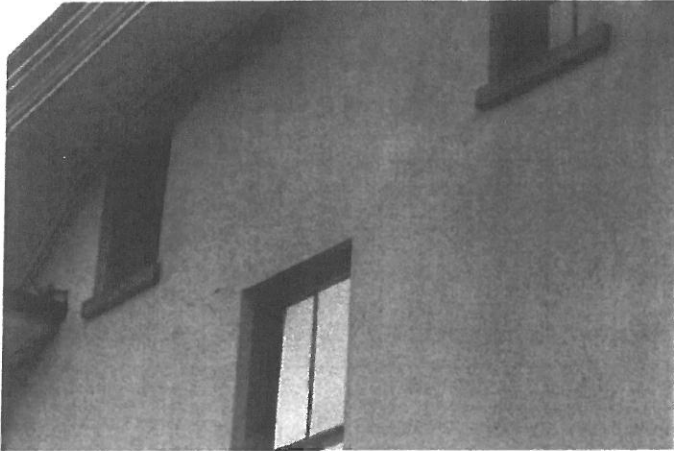
18. Cracks in stucco at second floor. These are new since 1995 painting.

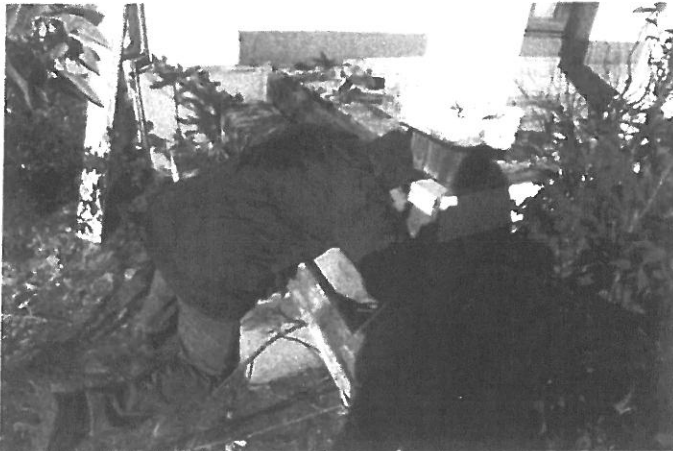
19. Gary Wolf peering into opening to see conditions under piazza deck.

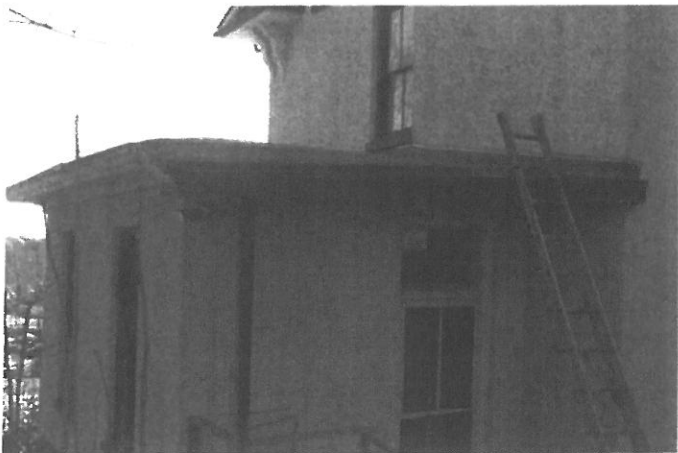
20. Access setup to review opening at edge of roof over ice chest entry.
