William Flagg Homer House  
Belmont Woman's Club  
Building Survey and Investigation

Wolf Architects, Inc.  
MacLeod Consulting, Inc.

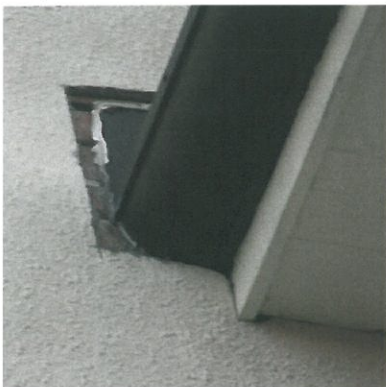
Split brownstone sill and peeling paint

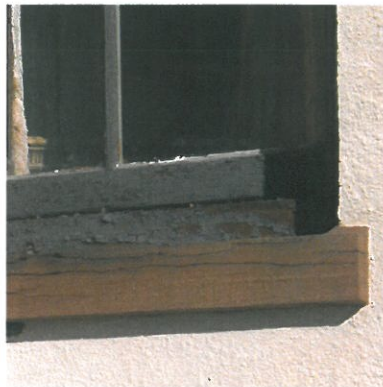
Deteriorated mortar; open joints at foundation

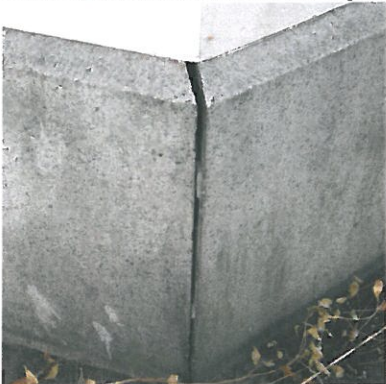
Split brownstone sill

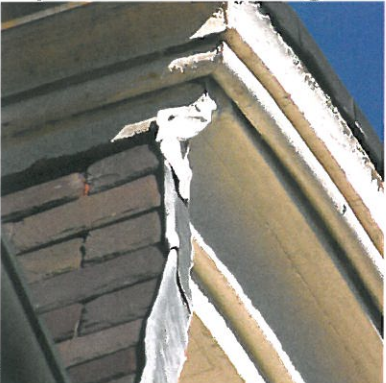
Brick replacement and repair

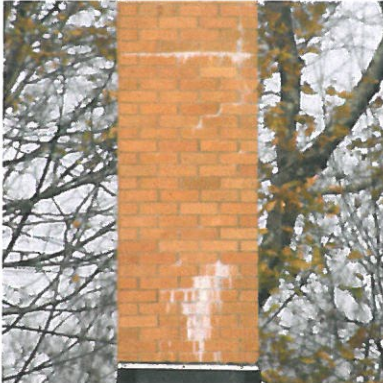
## CONDITIONS OVERVIEW: TYPICAL CONDITIONS

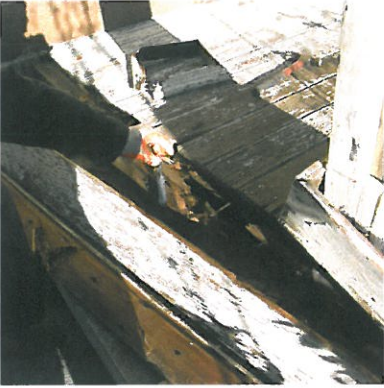
**Broken and damaged scrolls**

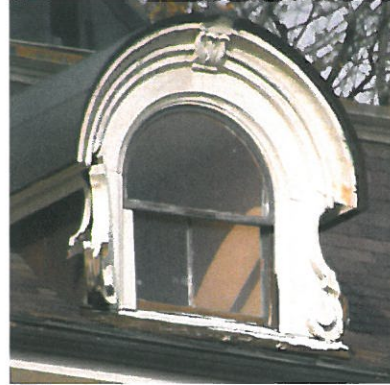
**Original moulding**

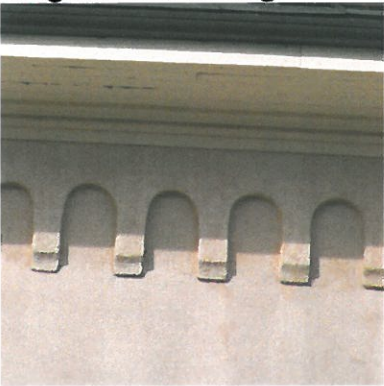
**Damaged cupola roof**

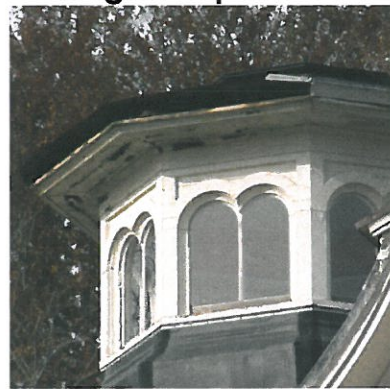
**Drive cracking and patching**

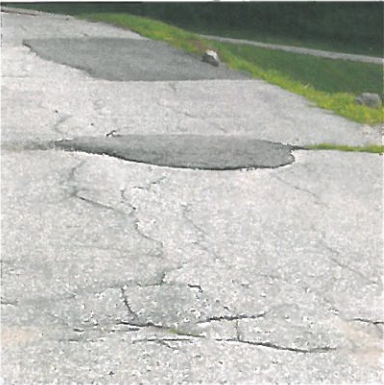
# CONDITIONS OVERVIEW: TYPICAL CONDITIONS

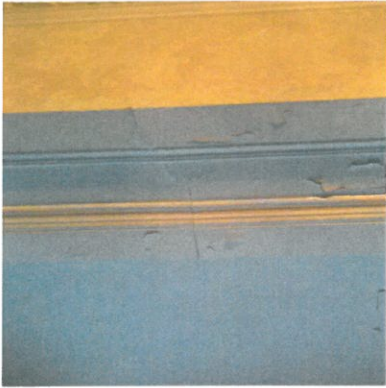
Possible evidence of settling

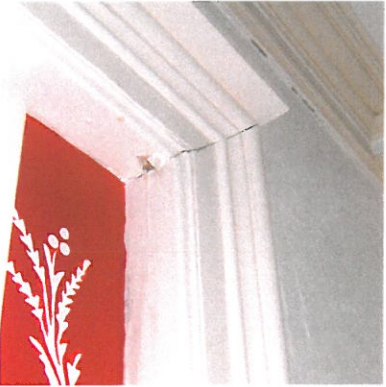
Peeling paint due to moisture

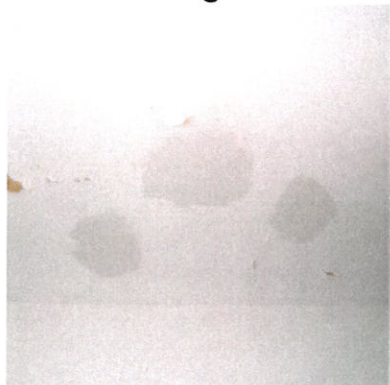
**William Flagg Homer House  
Belmont Woman's Club  
Conditions Assessment**

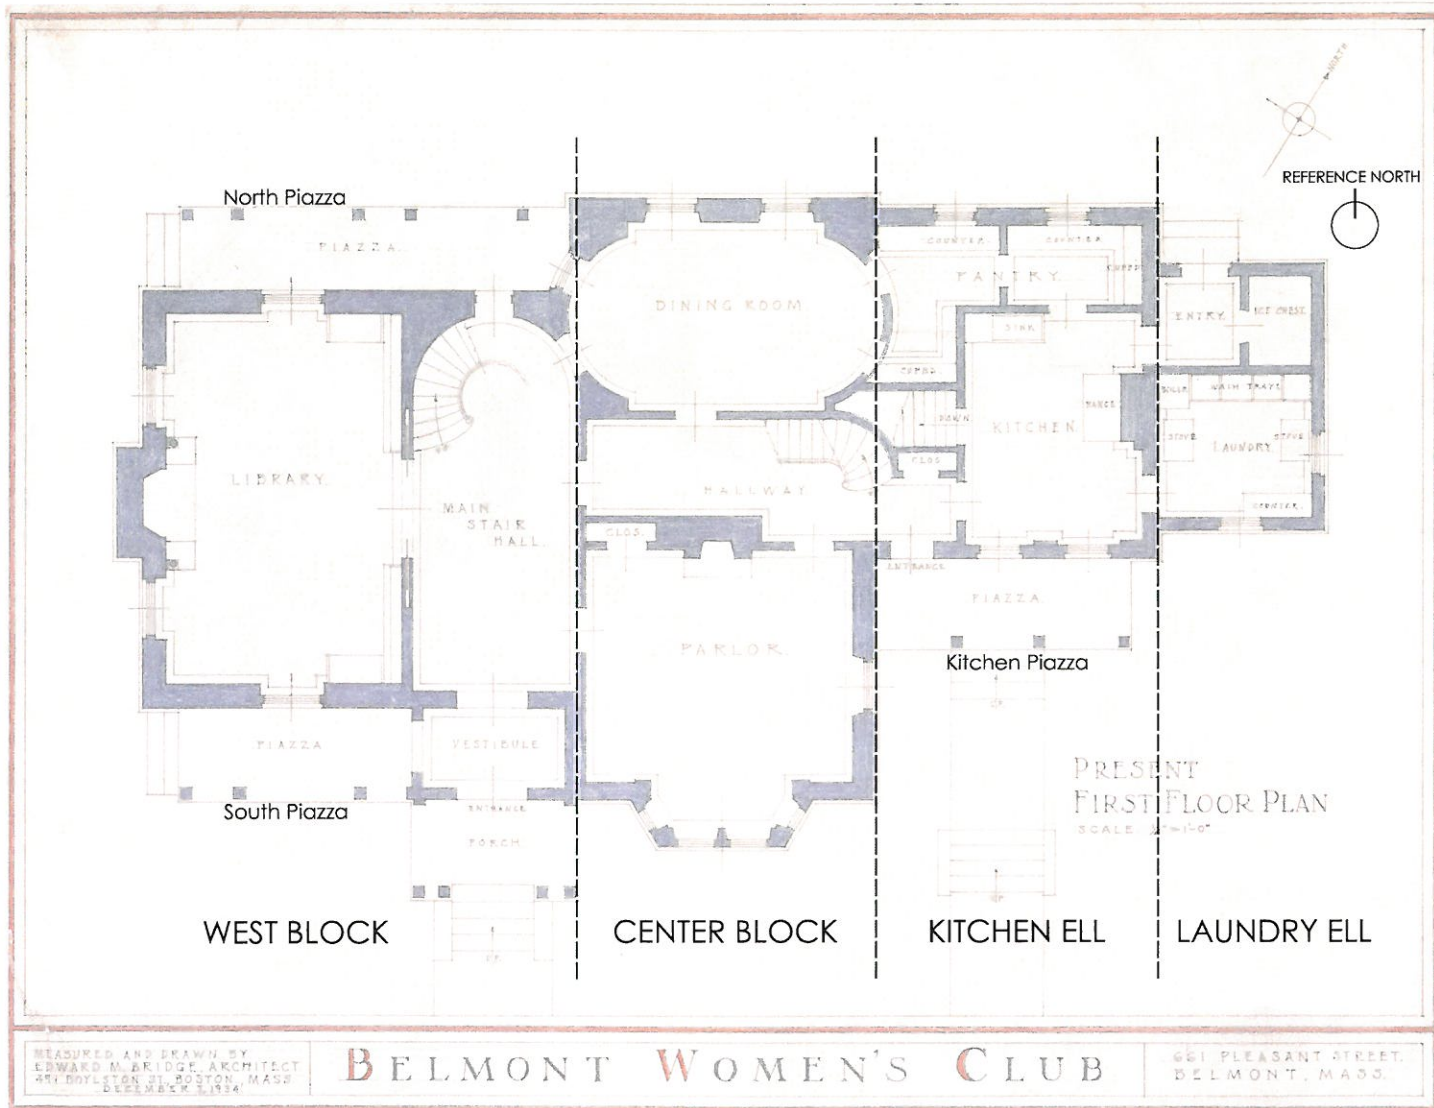
MEASURED AND DRAWN BY  
EDWARD M. BRIDGE, ARCHITECT  
451 DOYLSTON ST., BOSTON, MASS.  
DECEMBER 2, 1934

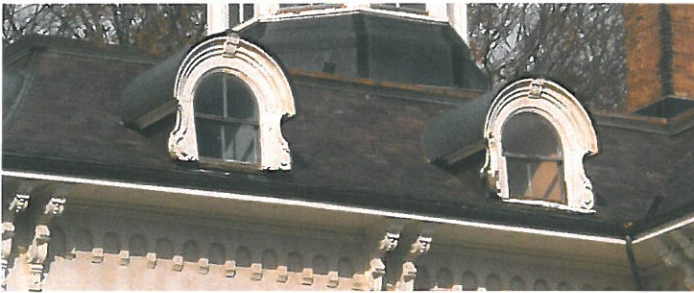
### Front, South-facing Slope

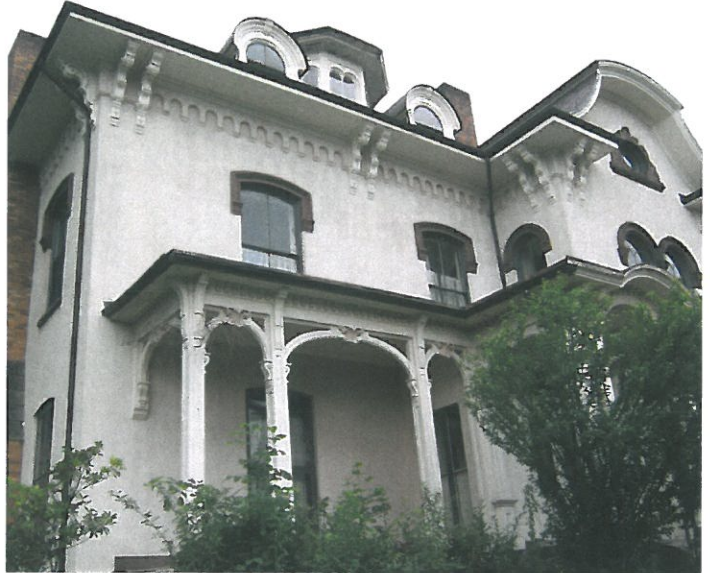
#### **Soffit, brackets and cornice**

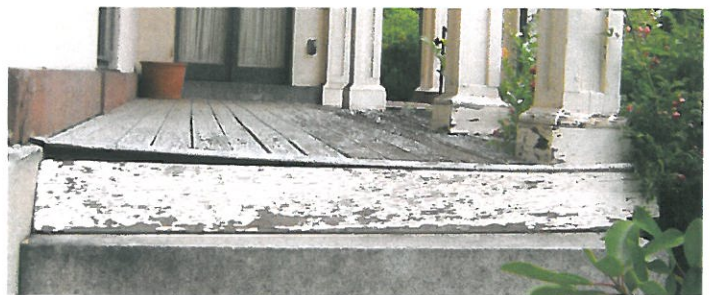
#### **Rubber roof**

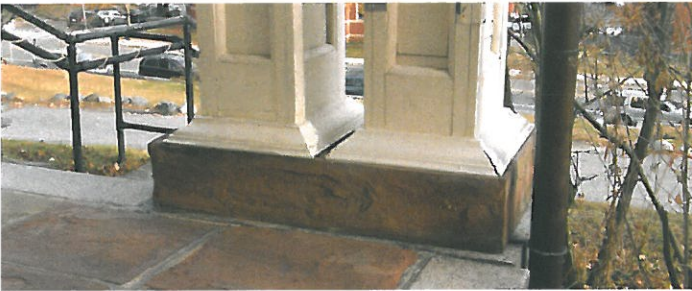
### **Front Vestibule and Entry Porch**

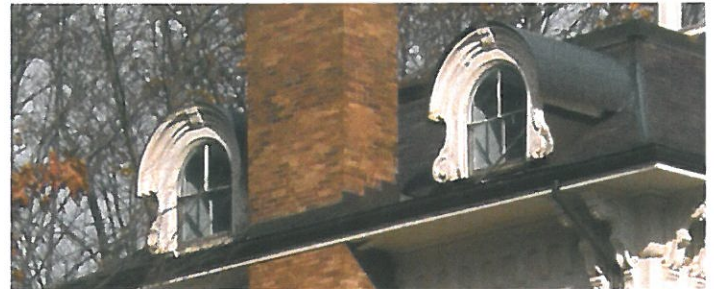
### **West-Facing Slope**

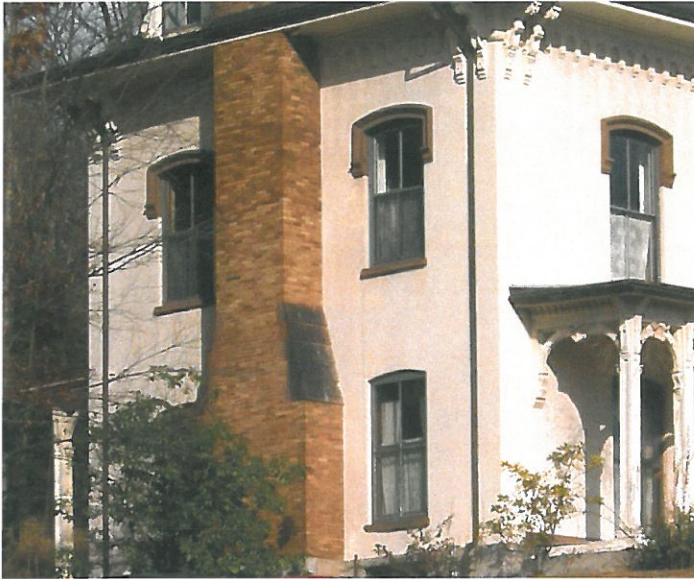
#### **Soffit, brackets and cornice**

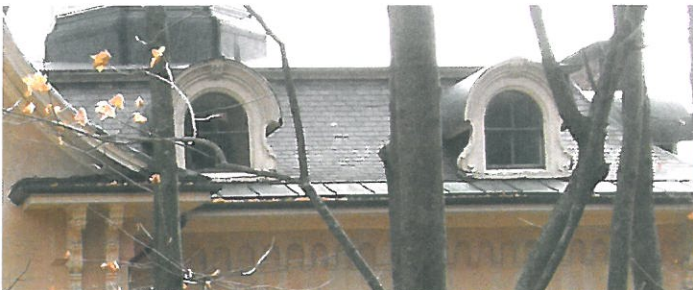
### North-facing Slope

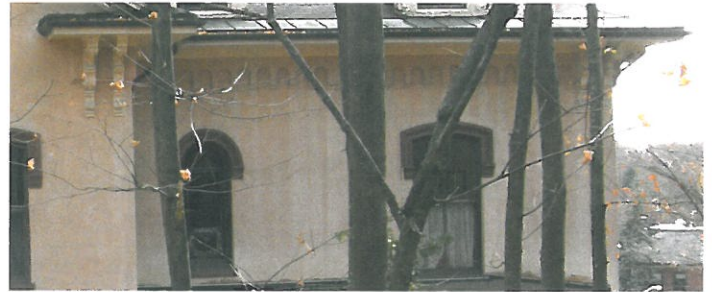
#### **Soffit, brackets and cornice**

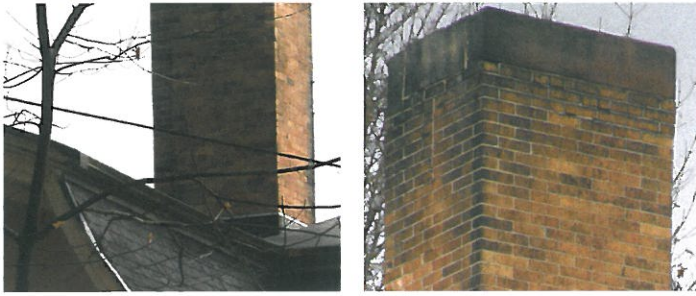
### Top Roof Surface

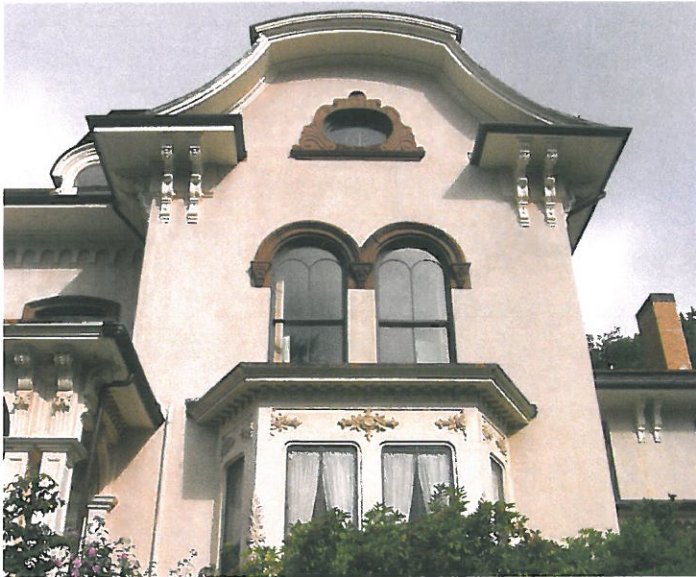
#### Soffit, brackets and cornice

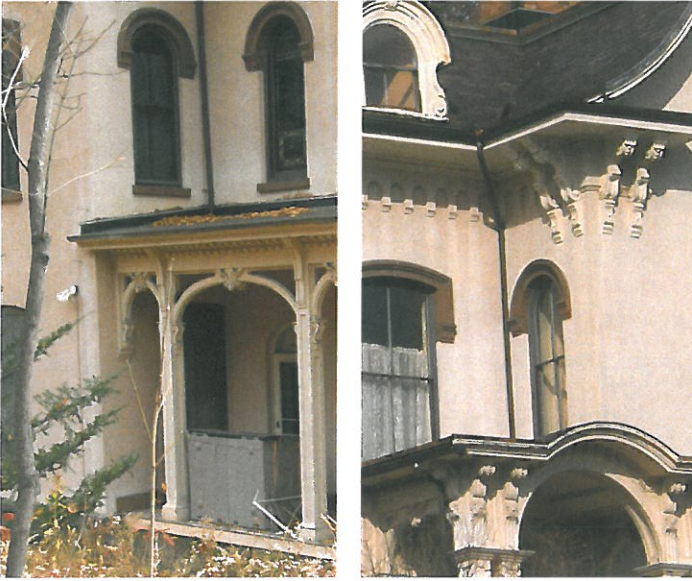
#### **Soffit, brackets and cornice**

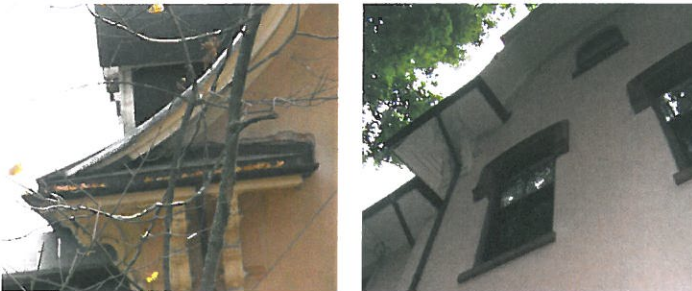
#### **Flashing at wall of house**

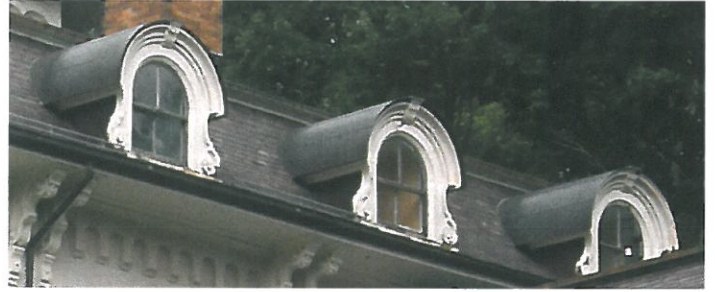
### East-facing Slope

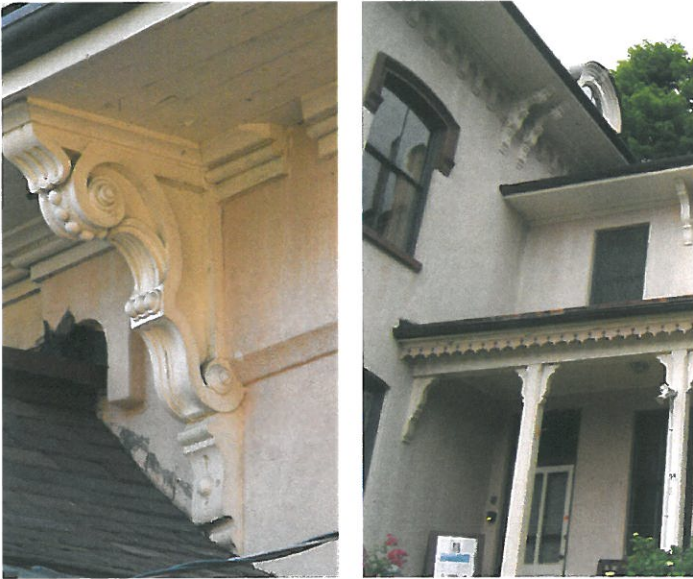
### **Soffit, brackets and cornice**

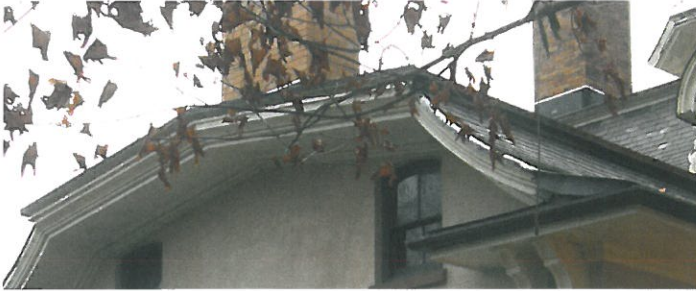
#### **Flashing at perimeter**

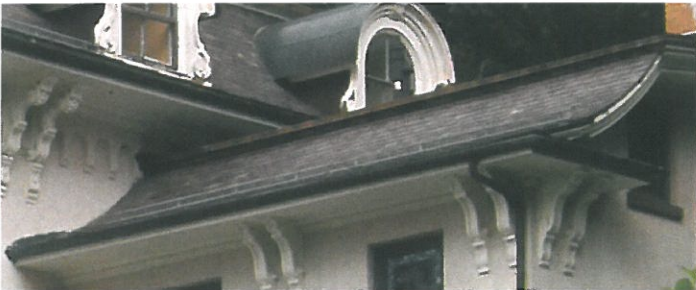
### South-facing Slope

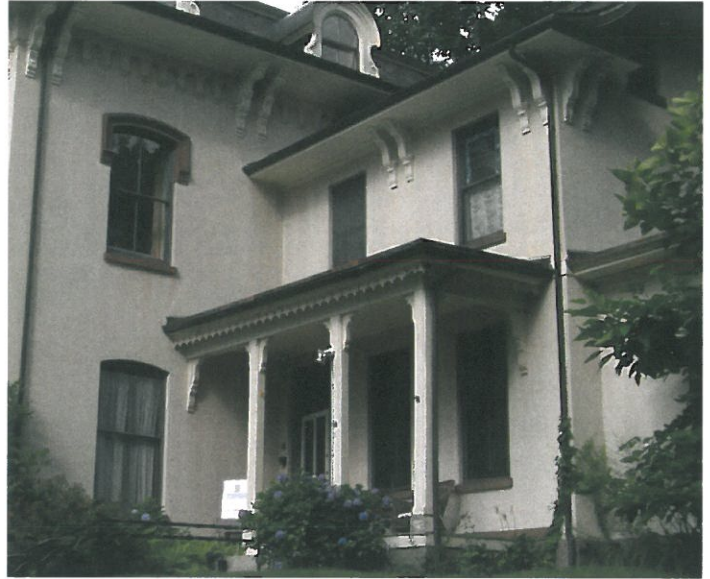
#### **Soffit, brackets and cornice**

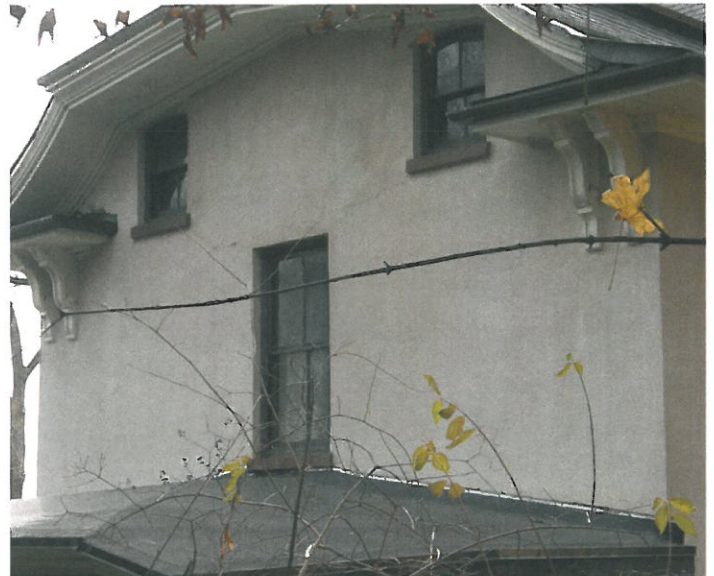
### **Soffit, brackets and cornice**

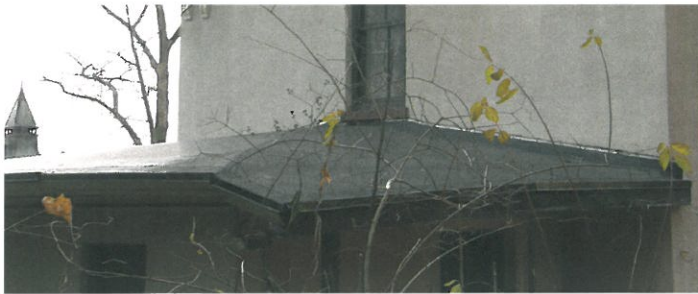
#### **Flashing at wall**

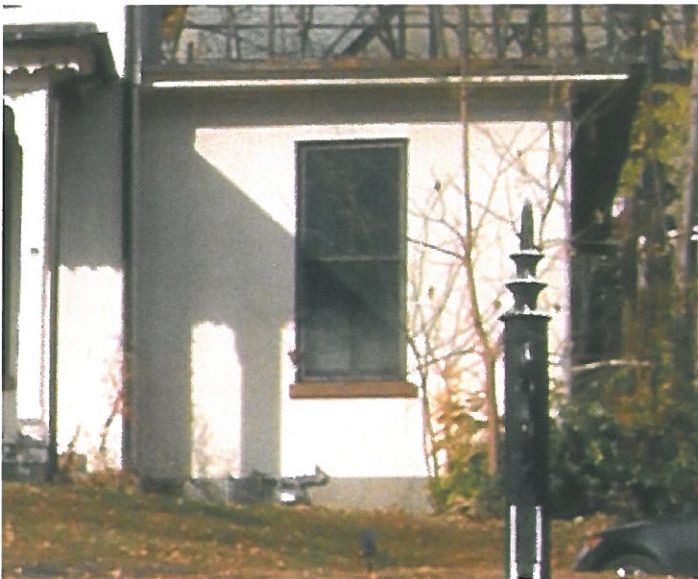
#### **Soffit, brackets and cornice**

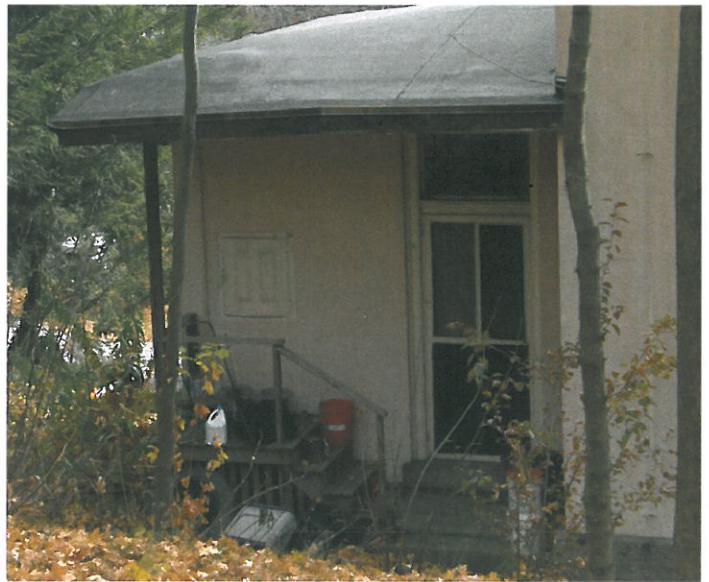
#### **Soffit, brackets and cornice**

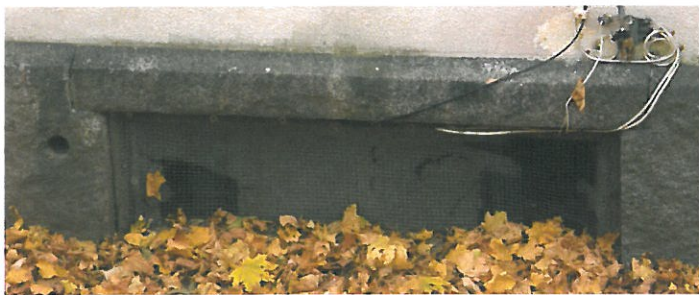
- Miscellaneous windows broken, missing, ajar.
- Miscellaneous brick partition walls have holes crudely broken through them for access, piping, etc.
- General debris, dirt, etc.
- Note: Miscellaneous storm windows, screens, doors, etc. stored here.
- Old insulation—which is likely asbestos-containing—is on some pipes and on mechanical equipment.
- Crawl space at NW corner is inaccessible.

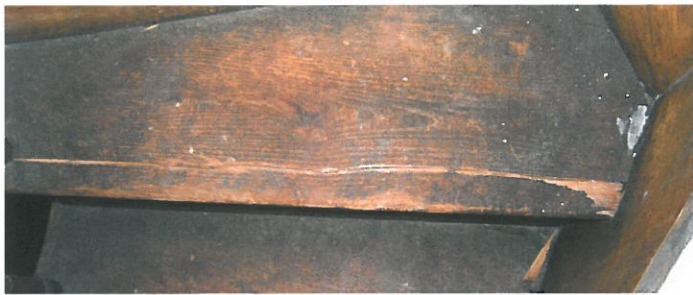
- Broken stair treads.
- Windows not operable; no venting capacity.

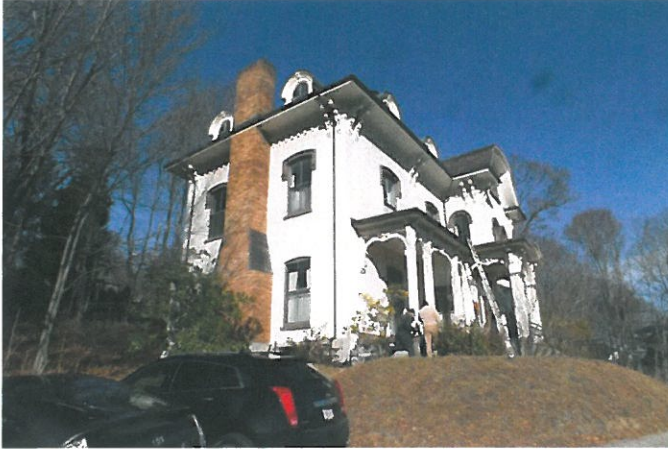
2. Belmont Woman's Club  
viewed from the southeast.

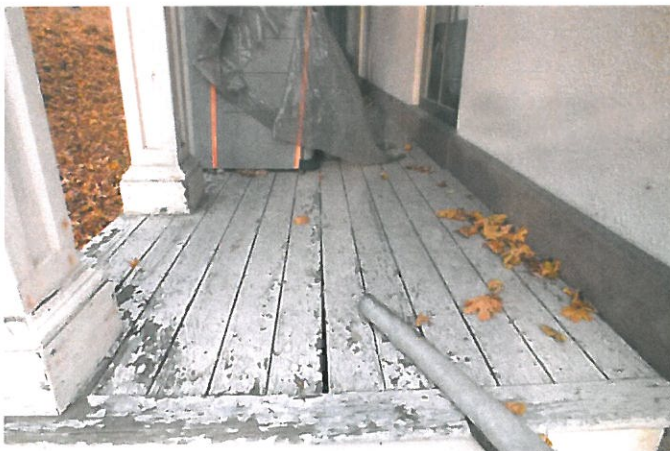
5. Rear piazza deteriorated deck condition.

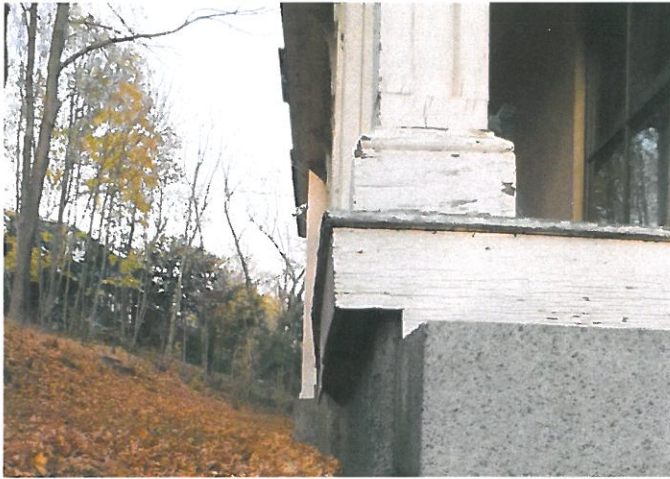
6. Dislocated foundation at rear piazza.

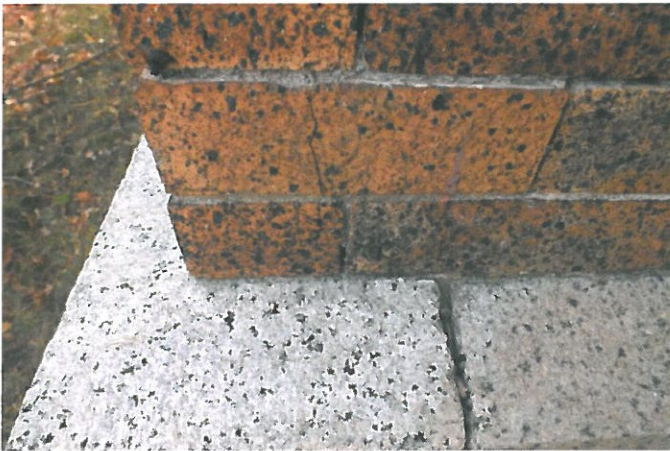
7. Cracks in brick in west chimney where granite foundation facing has opened up at head joint.

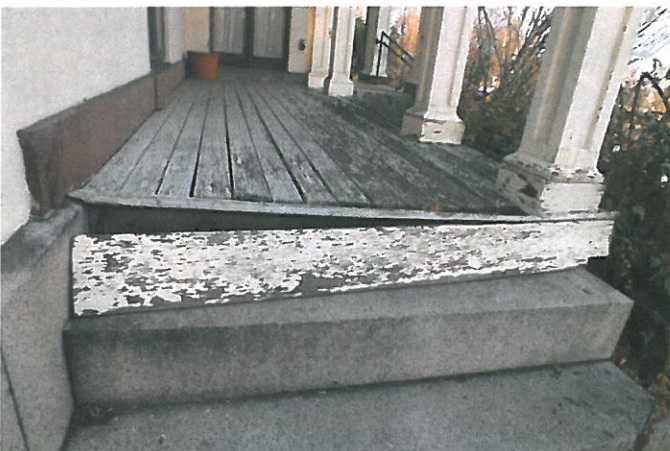
8. Front west piazza deteriorated deck condition.

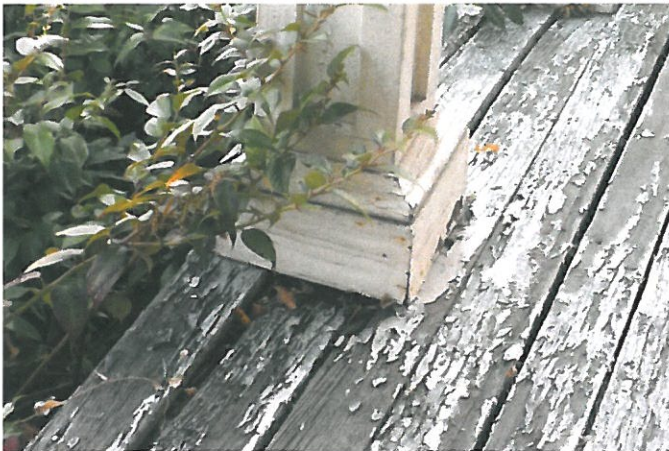
9. Front west piazza column bases.

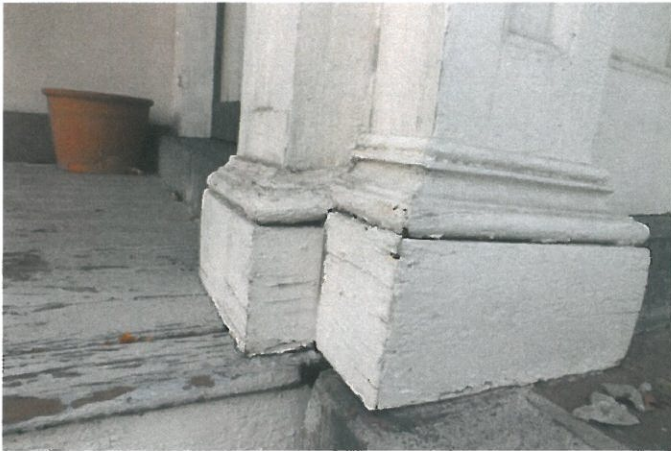
12. Old repairs to column bases disregard alignment at bases.

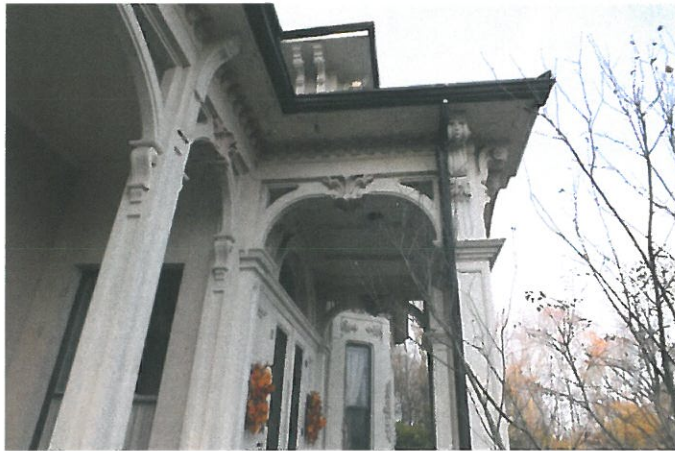
13. Roof over porch has settled along with settlement of porch landing. Columns moved with foundation to out of plumb position.

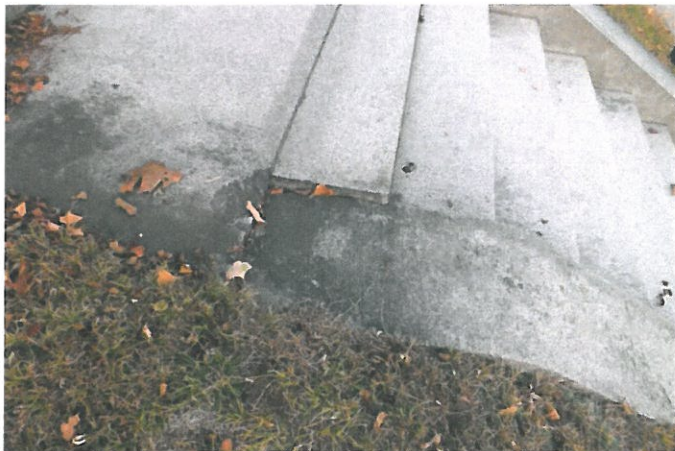
14. Cheek walls to front stairs have settled. West cheek in foreground.

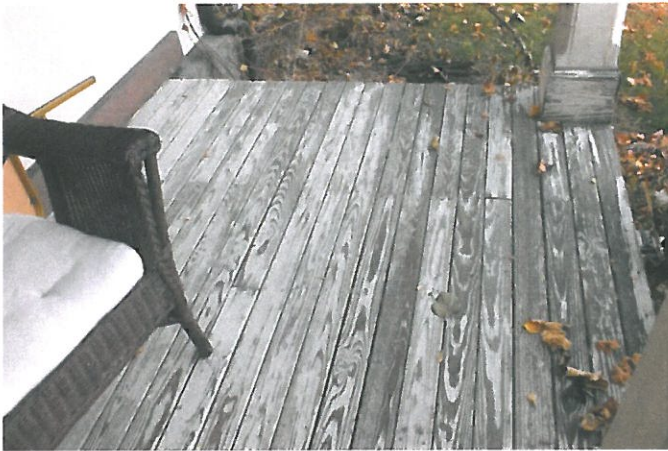
16. Decking at front east piazza is worn.

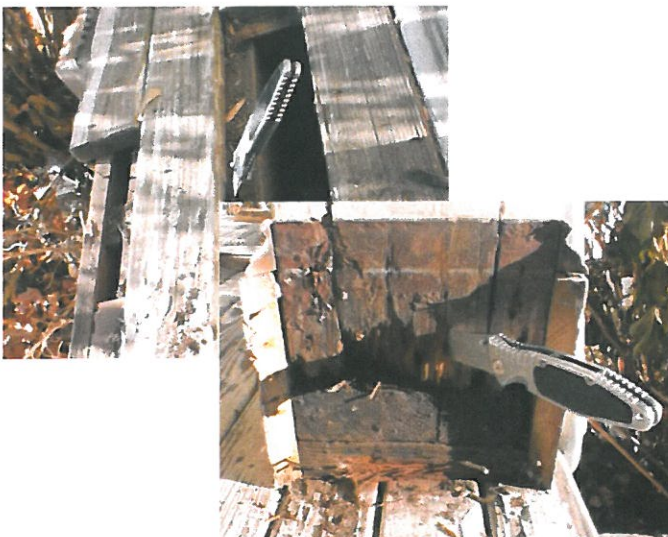
17. Rot in east piazza joist in upper photo. Rot in column base at east piazza lower photo.

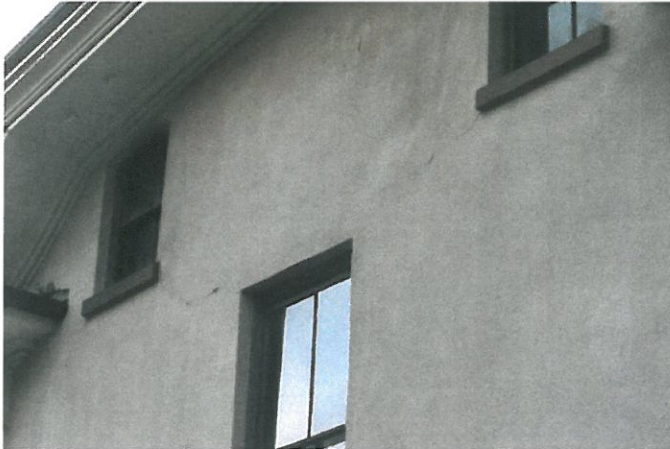
18. Cracks in stucco at second floor. These are new since 1995 painting.

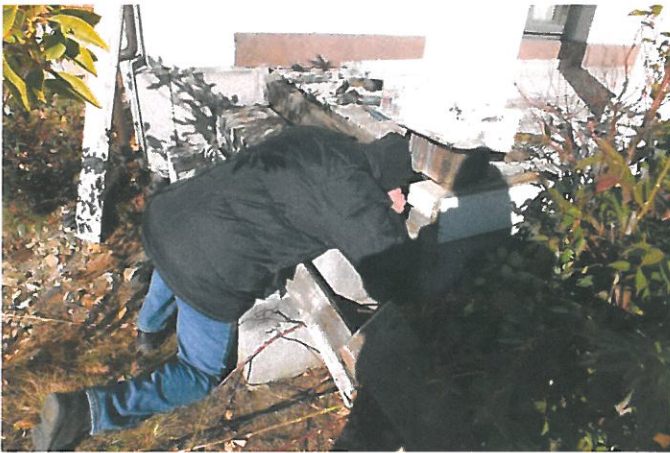
19. Gary Wolf peering into opening to see conditions under piazza deck.

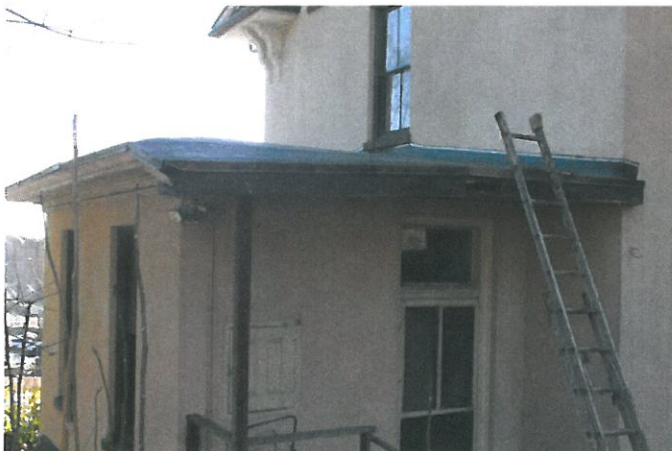
20. Access setup to review opening at edge of roof over ice chest entry.
