STRUCTURES INSPECTION FIELD REPORT

CULVERT INSPECTION

B-07-005

CITY/TOWN BELMONT	8-STRUCTURE NO. B07005-7XR-MUN-BRI	11-Kilo. POINT 000.000	41-STATUS A:OPEN	90-ROUTINE INSP. DATE FEB 3, 2022
07-FACILITY CARRIED HWY BRIGHTON ST	MEMORIAL NAME/LOCAL NAME	27-YR BUILT 1850	106-YR REBUILT 1900	YR REHAB'D (NON 106) 0000
06-FEATURES INTERSECTED WATER WINNS BROOK	26-FUNCTIONAL CLASS Urban Minor Arterial	DIST. BRIDGE INSPECTION ENGINEER J. Dideo		
43-STRUCTURE TYPE 119 : Concrete Culvert	22-OWNER Town Agency	21-MAINTAINER Town Agency	TEAM LEADER O. Moustafa	
107-DECK TYPE N : Not applicable	WEATHER Cloudy	TEMP. (air) 4°C	TEAM MEMBERS P. BURKE <i>Patrick Burke</i>

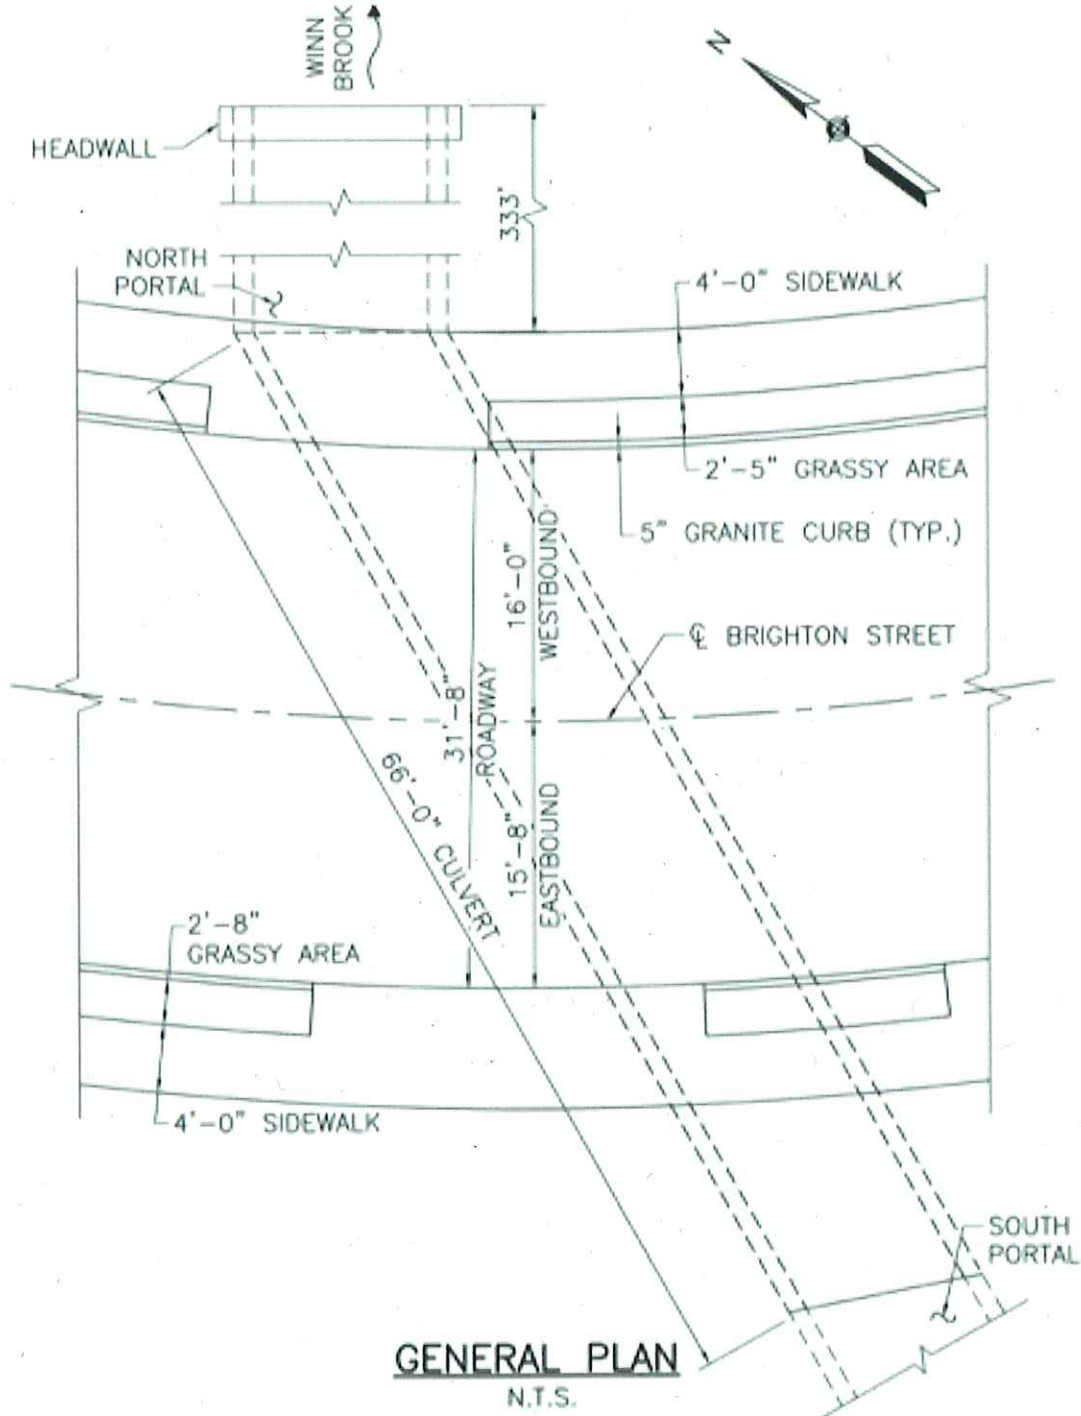
Sketch 1: General Plan

Bridge No. B-07-005 (7XR) carries Brighton Street over Winn Brook in Belmont, Massachusetts. The bridge is orientated east and west. Winn Brook flows from south to north. **See Sketch 1.**

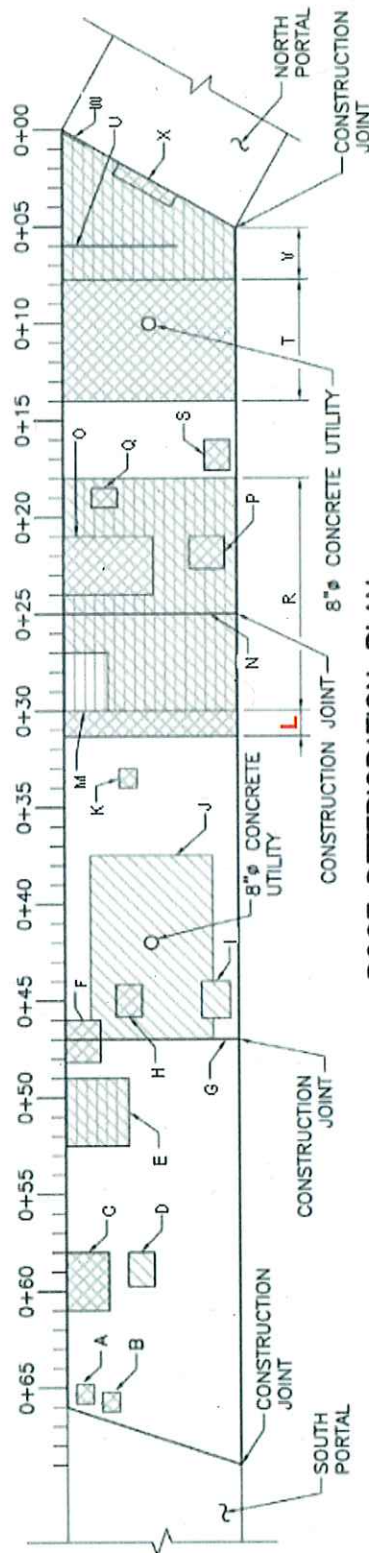
Sketch 2: Roof Deficiencies.

The roof has areas of severe spalling with exposed and corroded reinforcing, areas of heavy scaling and delamination, and construction joints with rust staining, efflorescence, and active leakage. See **Sketch 2** for the roof deficiencies.

- A. 1.5'L x 6'10" W x 1.5" D SPALL WITH EXP. REINF. WITH UP TO 100% SECTION LOSS.
- B. 1.5'L x 1.5'10" W x 1.5" D SPALL WITH EXP. REINF. WITH UP TO 100% SECTION LOSS.

- C. 3'-0" L X 2'-3" W X 1 1/2" D SPALL WITH EXP. REINF.
- D. 21" L X 16" W AREA OF DELAM.
- E. 3'-6" L X 3'-4" W AREA OF DELAM. AND SCALING UP TO 1/2"
- F. 2'-2" L X 22" W X 1 1/2" D SPALL AT UTILITY WITH EXP. REINF.

- G. WITH UP TO 100% SECTION LOSS
- H. CONSTRUCTION JOINT WITH RUST STAINING, AND ACTIVE LEAKAGE
- I. 20" L X 16" W X 1 1/2" D SPALL WITH EXP. REINF.
- J. 23" L X 18" W AREA OF DELAM.

- K. 9'-6" L X 16" W AREA OF DELAM.
- L. 12" L X 11" W X 1" D SPALL WITH EXP. REINF.
- M. 2.5' L X 4" W X 4" D SPALL WITH EXP. REINF. AND ACTIVE WATER LEAKAGE, HEAVY RUST STAINING AROUND THE INCASED STEEL PIPE.

- N. CONSTRUCTION JOINT WITH FW ACTIVE LEAKAGE, LIGHT RUST STAINING, AND HEAVY EFFLORESCENCE.
- O. 3'-0" L X 4'-8" W X 1 1/2" D SPALL WITH EXP. REINF.
- P. 20" L X 22" W X 2" D SPALL WITH EXP. REINF.

- Q. 12" L X 16" W X 2" D SPALL WITH EXP. REINF.
- R. 12' L X FW AREA OF DELAM. AND INTERMITTENT HEAVY SCALING UP TO 1" D.
- S. 19" L X 16" W X 2" D SPALL WITH EXP. REINF.

- T. 6'-3" L X FW X 2.5" D SPALL WITH EXP. REINF. TRANS. BAR AT STATION 0+12 WITH 100% SECTION LOSS. TYPICAL EXPOSED BARS IN SPALL WITH APPROXIMATELY 50% LOSS

- U. 6'-0" L LINE OF RUST STAINING, WATER LEAKAGE, AND EFFLORESCENCE.
- V. 5'-0" AREA OF DELAM. AND SCALING.
- W. ROOF FASCIA WITH 4" H X 16" W X 1 1/2" D AREA OF SCALING.

- X. ROOF FASCIA WITH 4" H X 3'-5" W X 5" D SPALL WITH EXP. REINF.

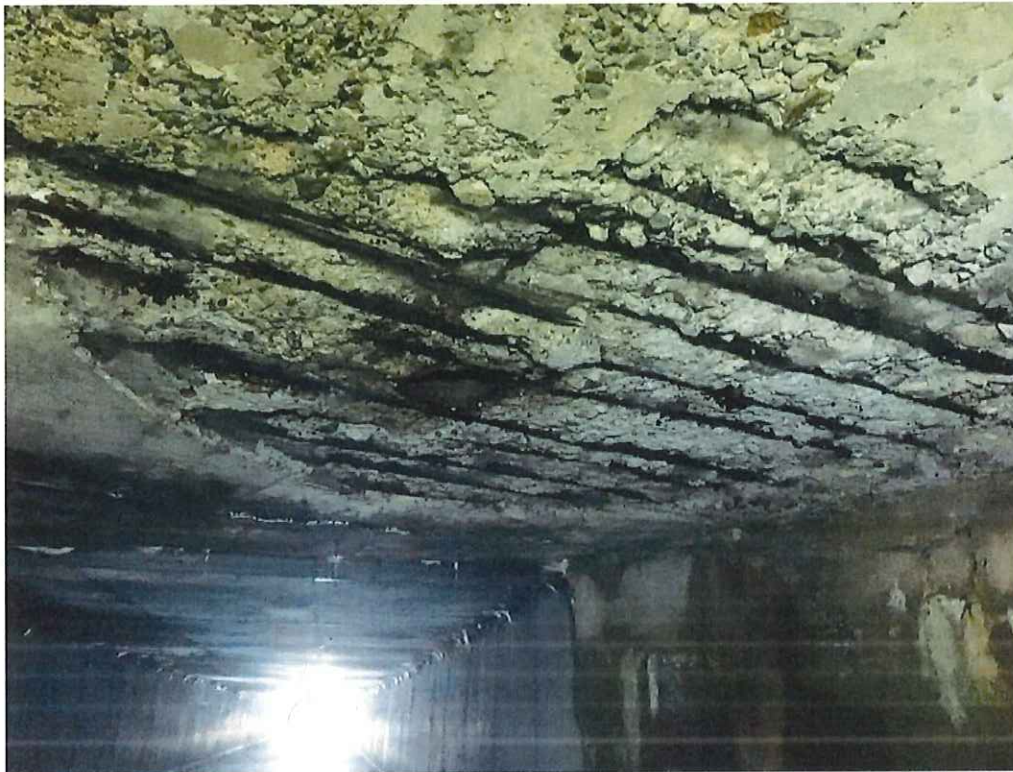
- Between Station (00+08) and Station (00+14), there is 6'-3" long x full width x 2.5" deep area of spalling with exposed and rusted rebars in both directions with typically 50% section loss. At Station (00+12), the exposed rebars have up to 100% section loss. **Photo 1.**

Photo 1: Station (00+08) to Station (00+14), 6'-3" long x full width x 2.5" deep area of spalling with exposed, rusted rebar and up to 100% section loss.

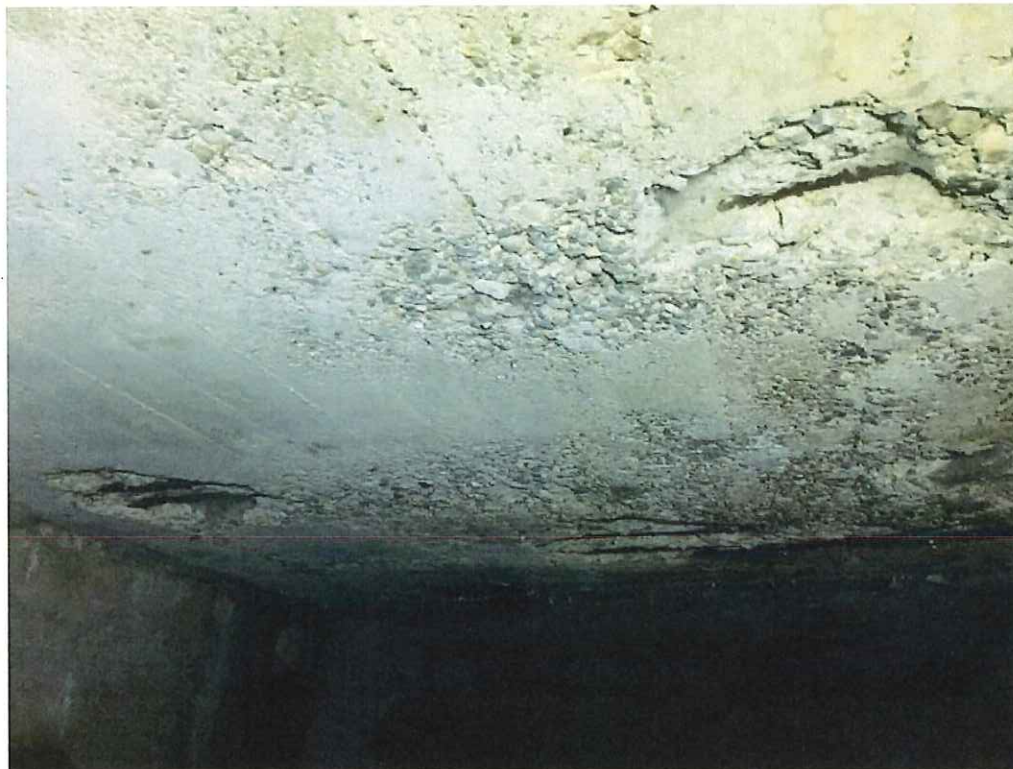
- Between Station (00+18) and Station (00+30), there is a 12' long x full width area of delamination and intermittent heavy scaling up to 1" deep. There are also multiple spalls, up to 3' long x 4'-8" wide x 1.5" deep with exposed and rusted rebars. **Photo 2.**

Photo 2: Station (00+18) to Station (00+30), 12' L x full width area of delamination, heavy scaling and multiple spalls, up to 3' L x 4'-8" W x 1.5" D with exposed and rusted rebar.

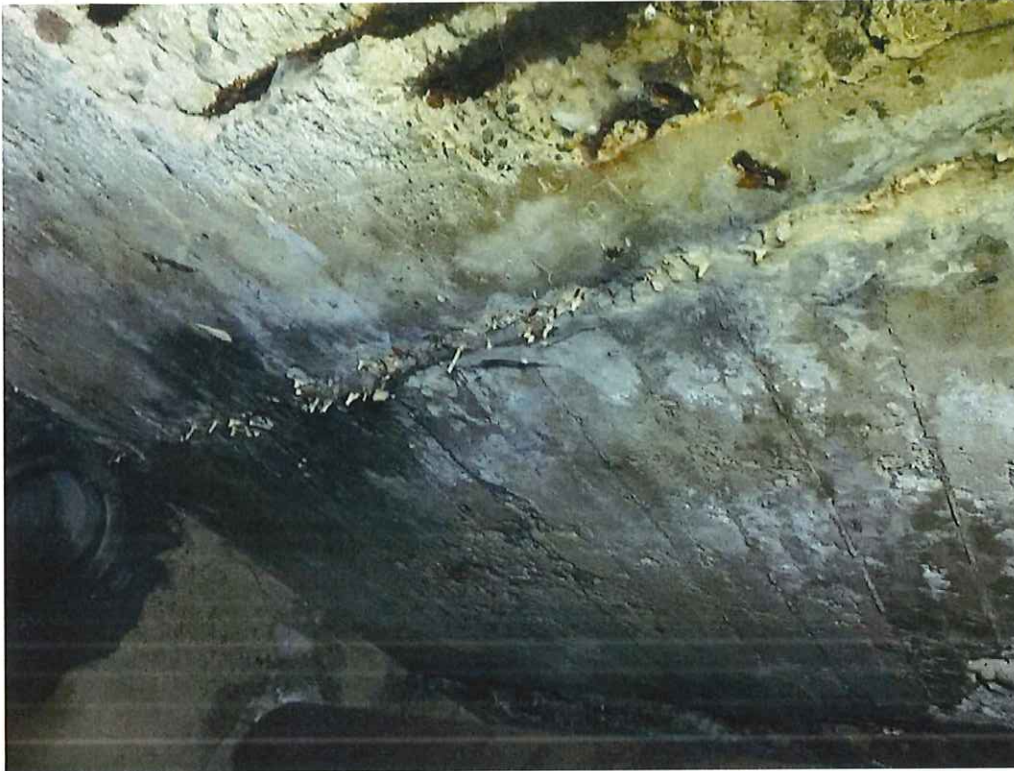
- At Station (00+25), there is active leakage at the construction joint with heavy efflorescence and rust staining. **Photo 3.**
- At Station (00+31), there is 2.5' long x full width x 4" deep spall with exposed and rusted rebars. There is also heavy rust staining and active leakage around the incased steel pipe inside the roof. **Photo 4.**

Photo 3: Station (00+25), active leakage at the construction joint with heavy efflorescence and rust staining.

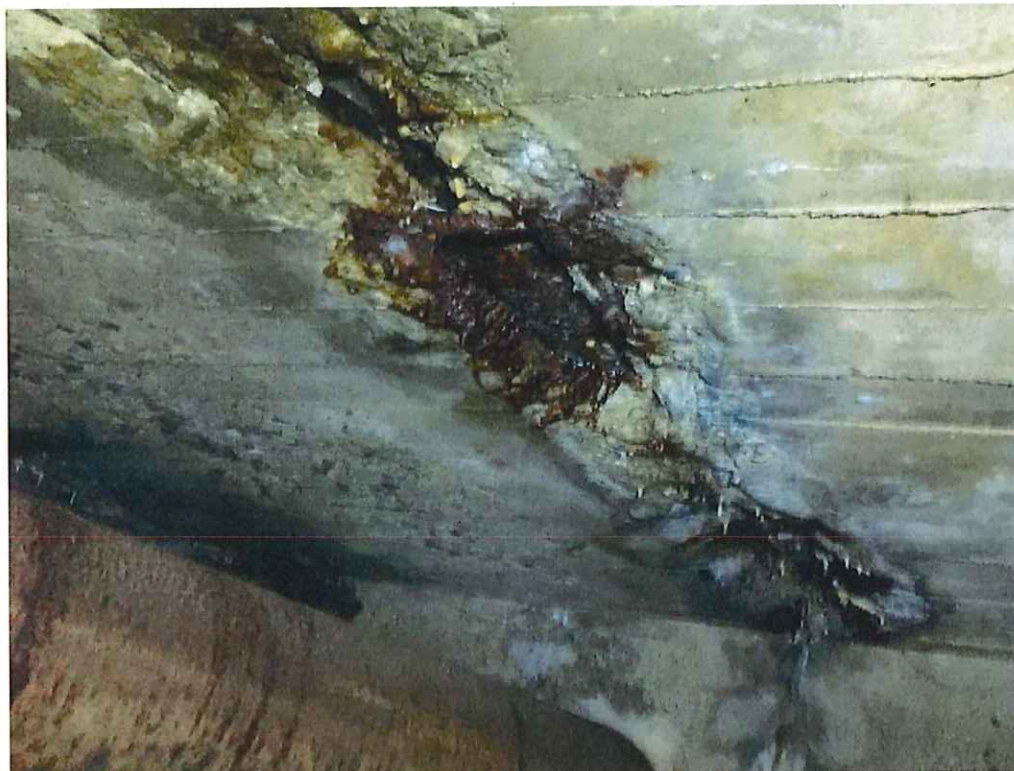
Photo 4: Station (00+31), 2.5' L x full width x 4" D spall with exposed and rusted rebars in both direction. There is heavy rust staining and active leakage around the incased steel pipe inside the roof.

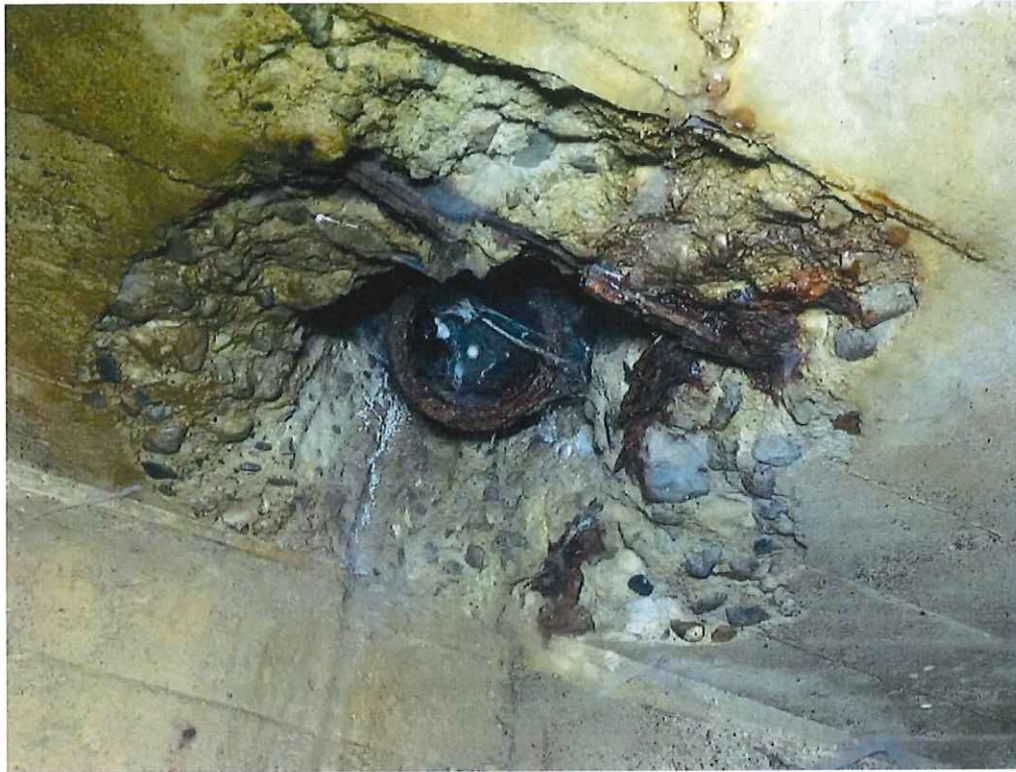
- At Station (00+47), there is 2'-2" long x 22" wide x 11" deep spall with exposed and rusted rebars with 100% section loss around the utility pipe. **Photo 5.**

Photo 5: Station (00+47), 2'-2" L x 22" W x 11" D spall with exposed and rusted rebars with 100% section loss around the utility pipe.

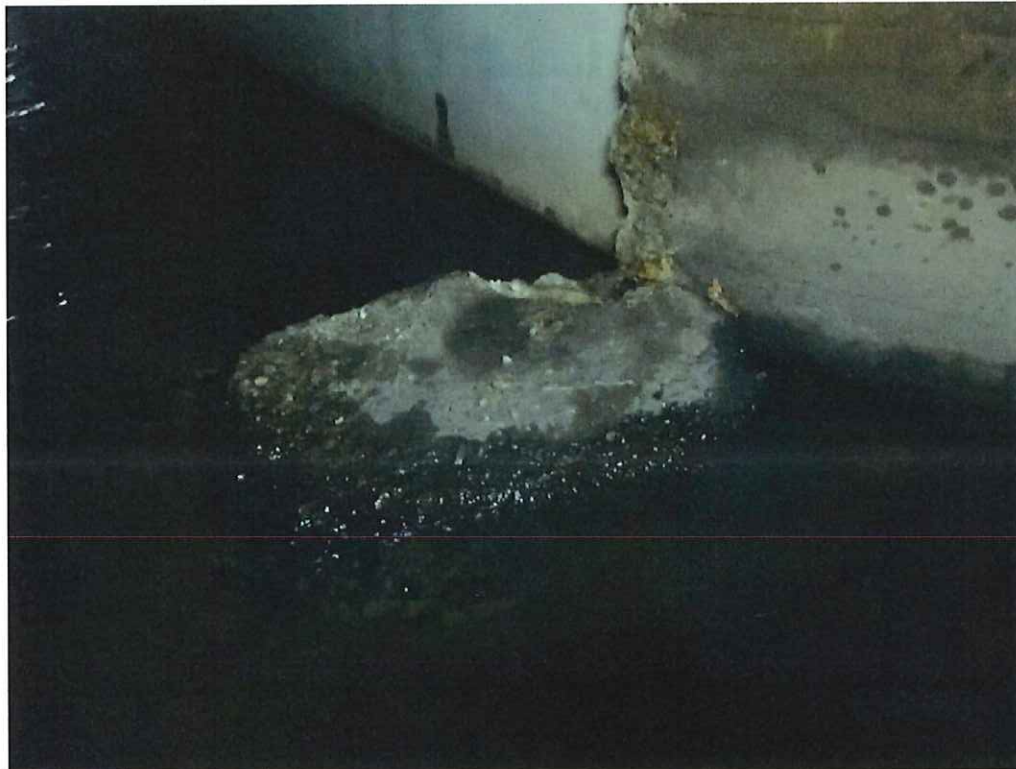
There are isolated areas of scaling up to 1/4" deep. At the northeast corner, there is a 3' wide x 2.5' mass of concrete cast onto the floor. **Photo 6.**

Photo 6: Floor, northeast corner, there is a 3' wide x 2.5' mass of concrete cast onto the floor.

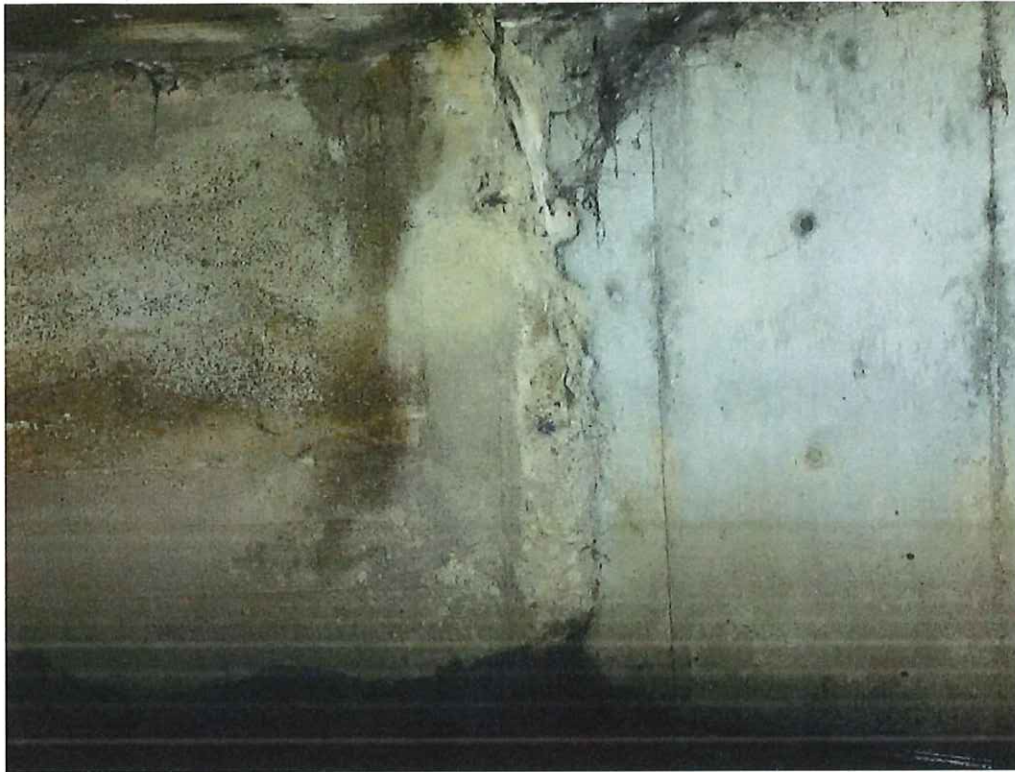
- At the north fascia, there is a full height x full width x up to 11" deep spall with exposed and corroded reinforcing. **Photo 7.**
- From Station (00+00) to Station (00+25) approximately 2' from the top, there are intermittent longitudinal hairline cracks.

Photo 7: West wall, north fascia, full height x full width x up to 11" D spall with exposed and rusted rebar.

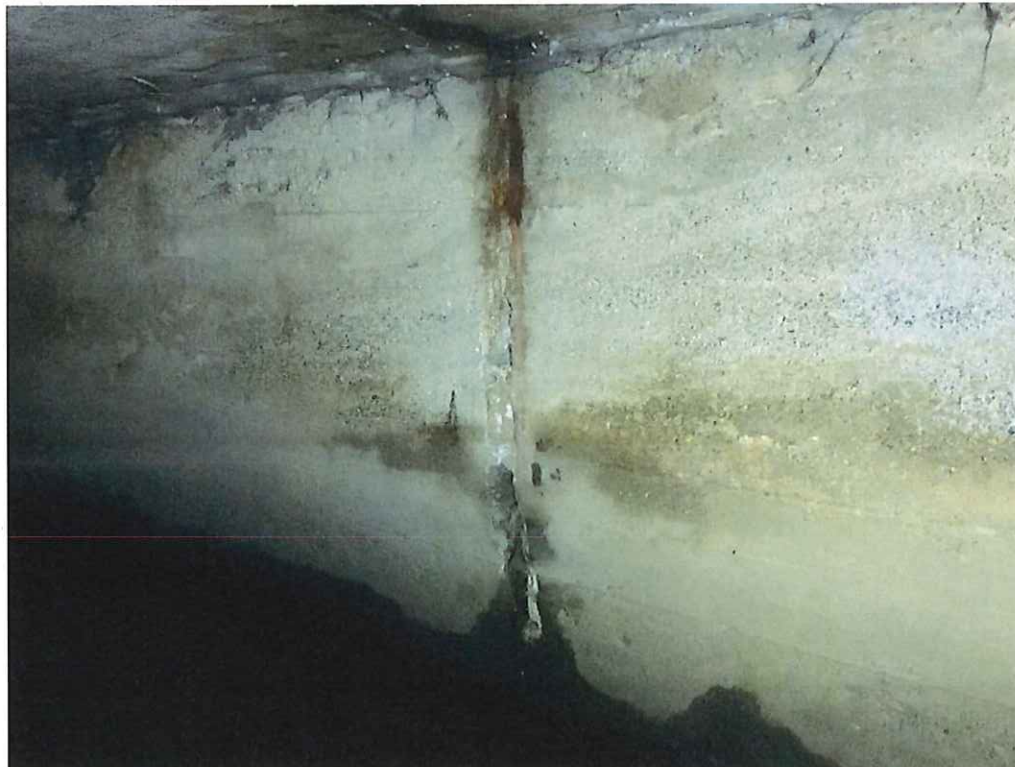
- At station (00+06), there is a full height x 4" wide x 2.5" deep spall, heavy rust staining and a full height x 1/8" wide crack that extends into the roof with light efflorescence. **Photo 8.**

Photo 8: West wall, Station (00+06), full height x 4" W x 2.5" D spall, heavy rust staining and a full height x 1/8" W crack that extends into the roof with light efflorescence.

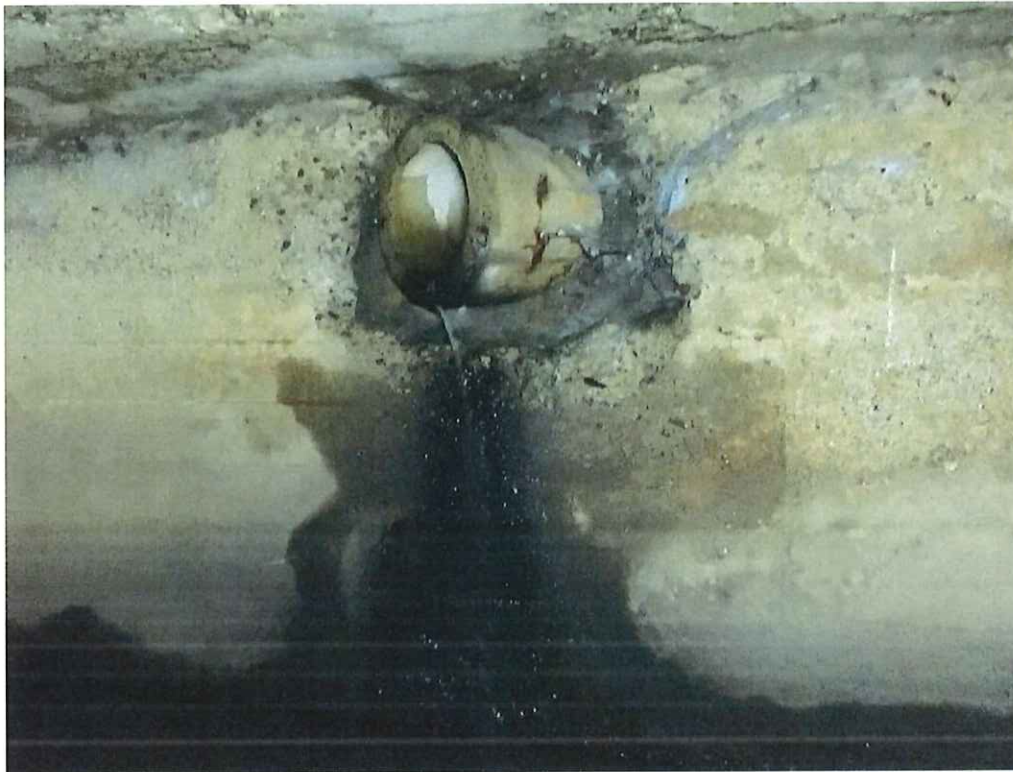
Photo 9: West wall, Station (00+17) around the 12" diameter RCP, 2.5' H x 3.5' L x 2.5" D area of scaling.

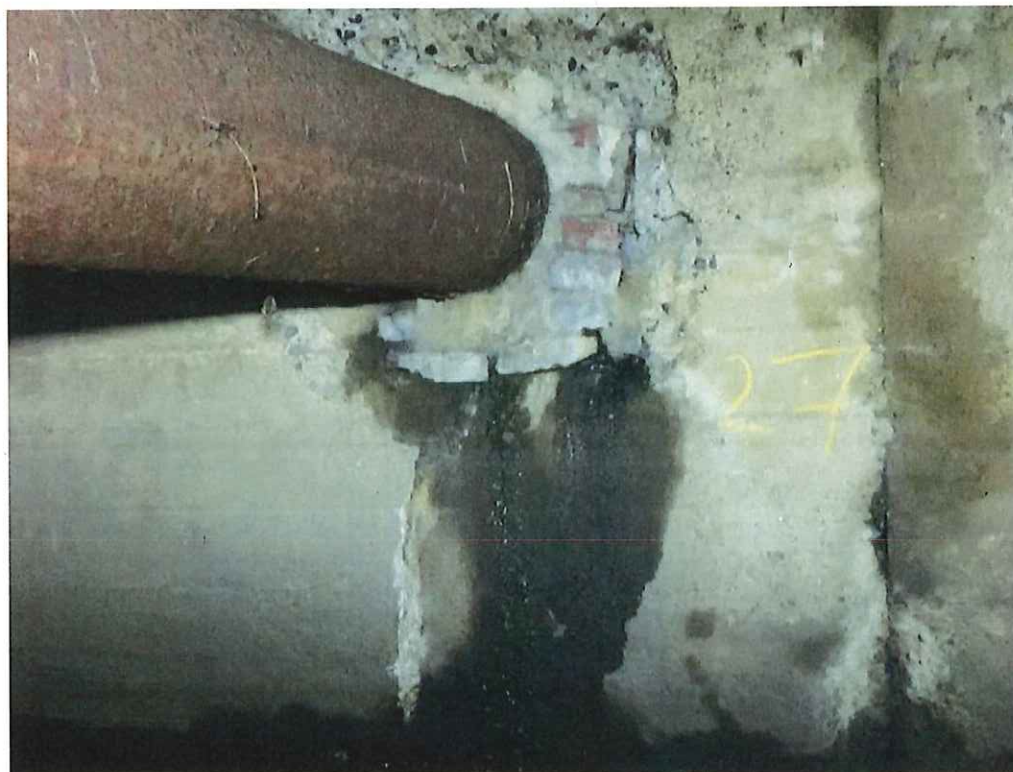
- At Station (00+27) around the steel utility pipe, there is a 2'-4" high x 2'-8" wide x 3" deep area of scaling with active leakage at the bottom. Extending from the bottom of the blockout, there is a 2' long vertical hairline crack with efflorescence. **Photo 10.**

Photo 10: West wall, Station (00+27) around the steel utility pipe, 2'-4" H x 2'-8" W x 3" D scaling with active leakage and 2' long vertical hairline crack with efflorescence.

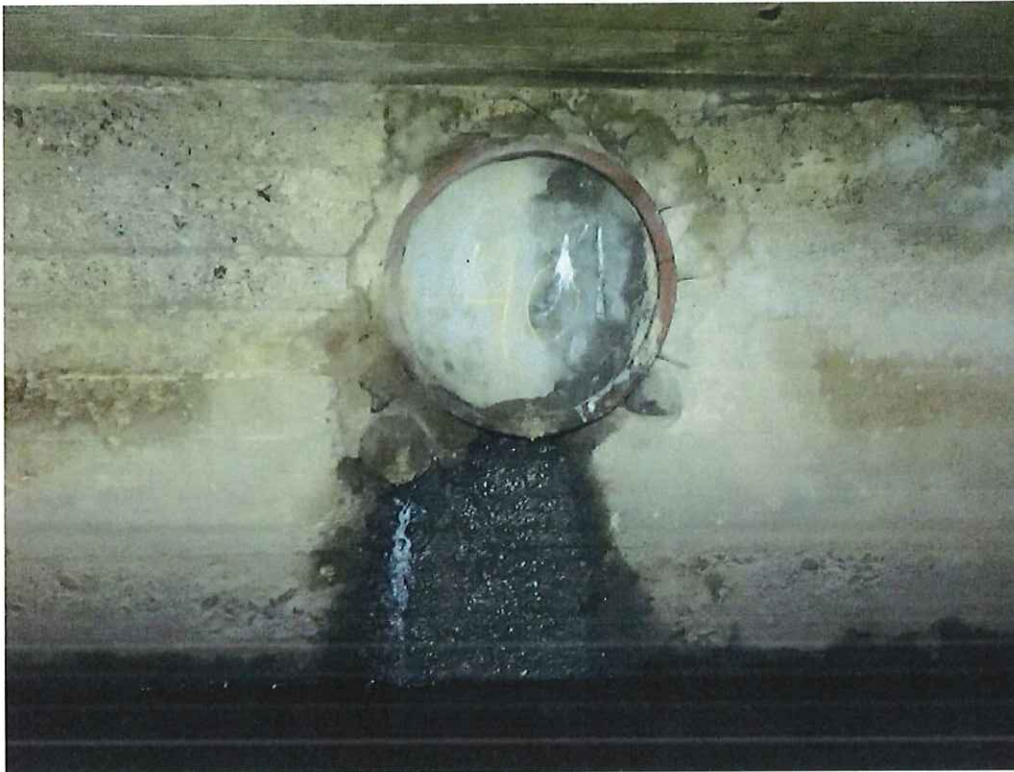
Photo 11: West wall, Station (00+40) below the 24" diameter utility, 2'-3" H x 20" W x 5" D area of scaling and active leakage.

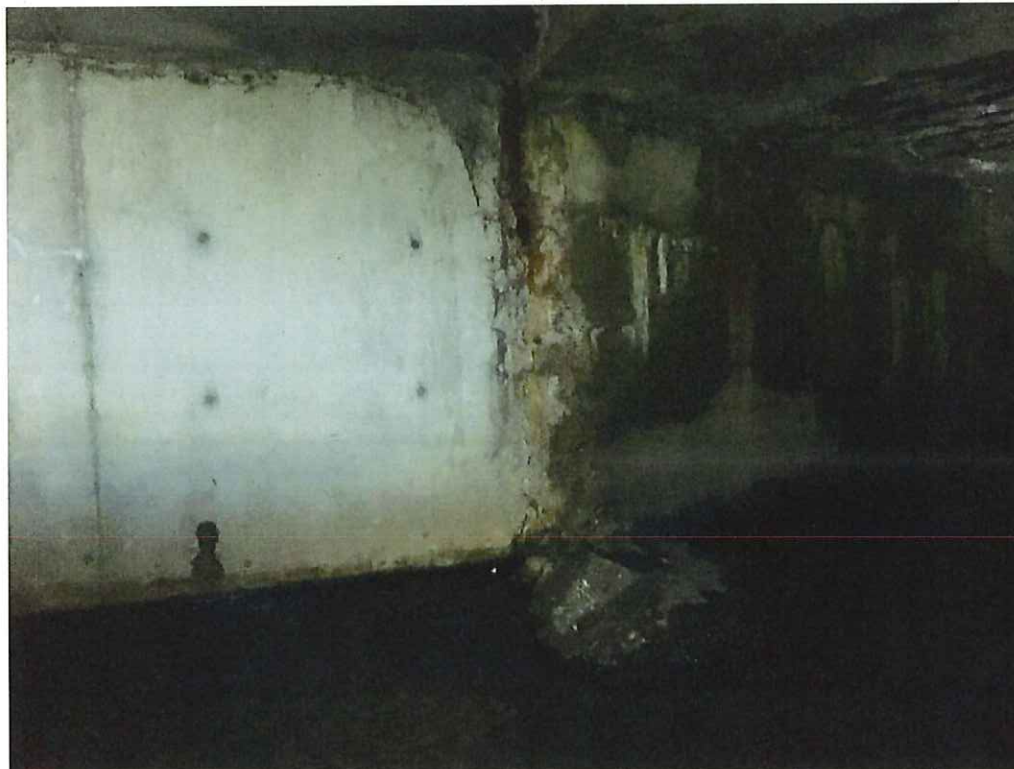
Photo 12: East wall, north end, full H x full width x 7" D spall with exposed and rusted rebar.

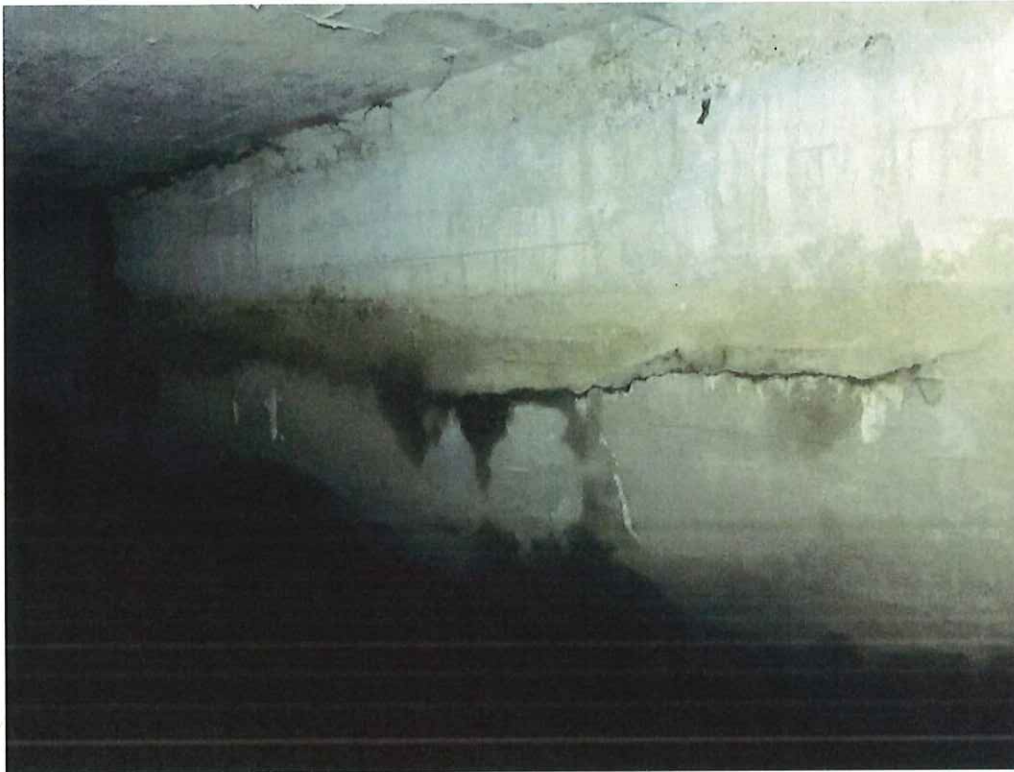
Photo 13: East wall, full length, 1/8" wide horizontal crack with areas of efflorescence and water staining.

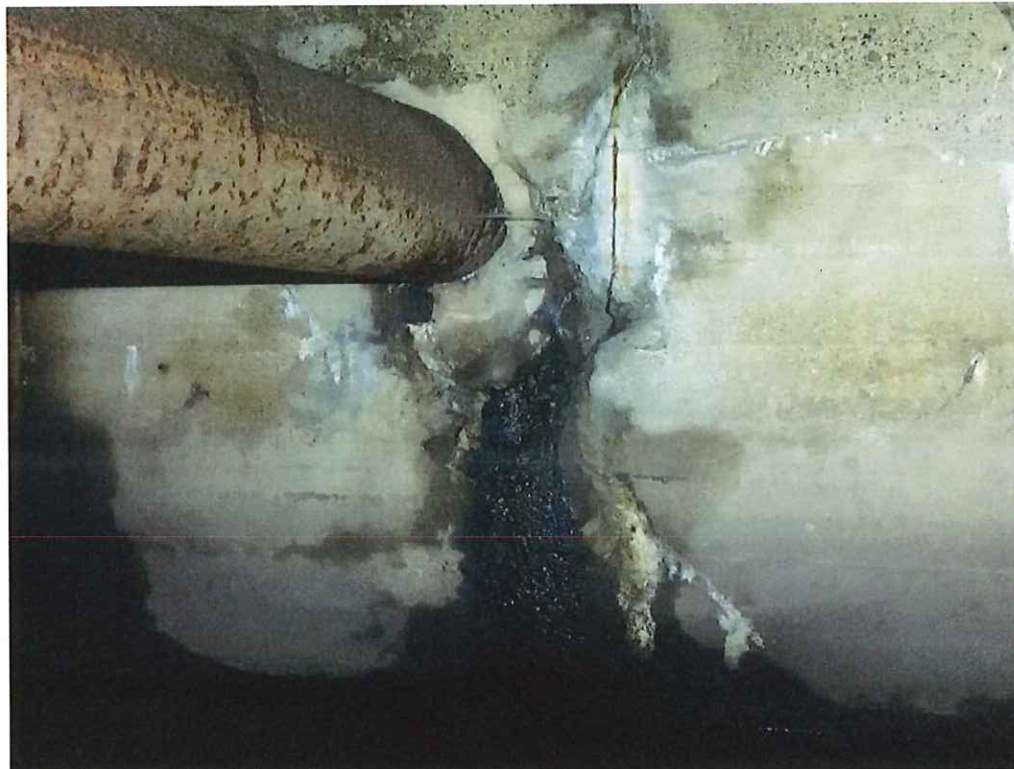
- At Station (00+32) below steel utility pipe, there is a 2.5' high x 2' wide x up to 3" deep area of heavy scaling and water leakage. **Photo 14.**
- At Station (00+33), there is a full height vertical crack with heavy efflorescence. **Photo 14.**

Photo 14: East wall, Station (00+32) below steel utility pipe, 2.5' H x 2' W x up to 3" D area of heavy scaling and water leakage. Also note the full height vertical crack with heavy efflorescence.

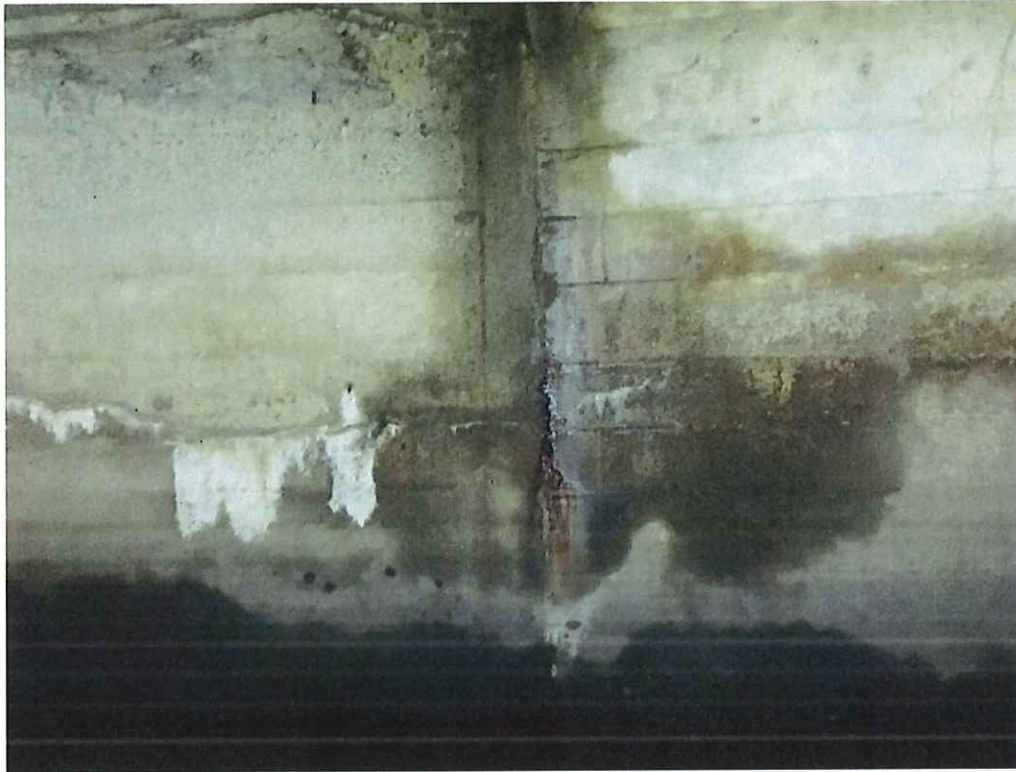
Photo 15: East wall, Station (00+47) at the construction joint, area of rust staining and active water leakage with light efflorescence.

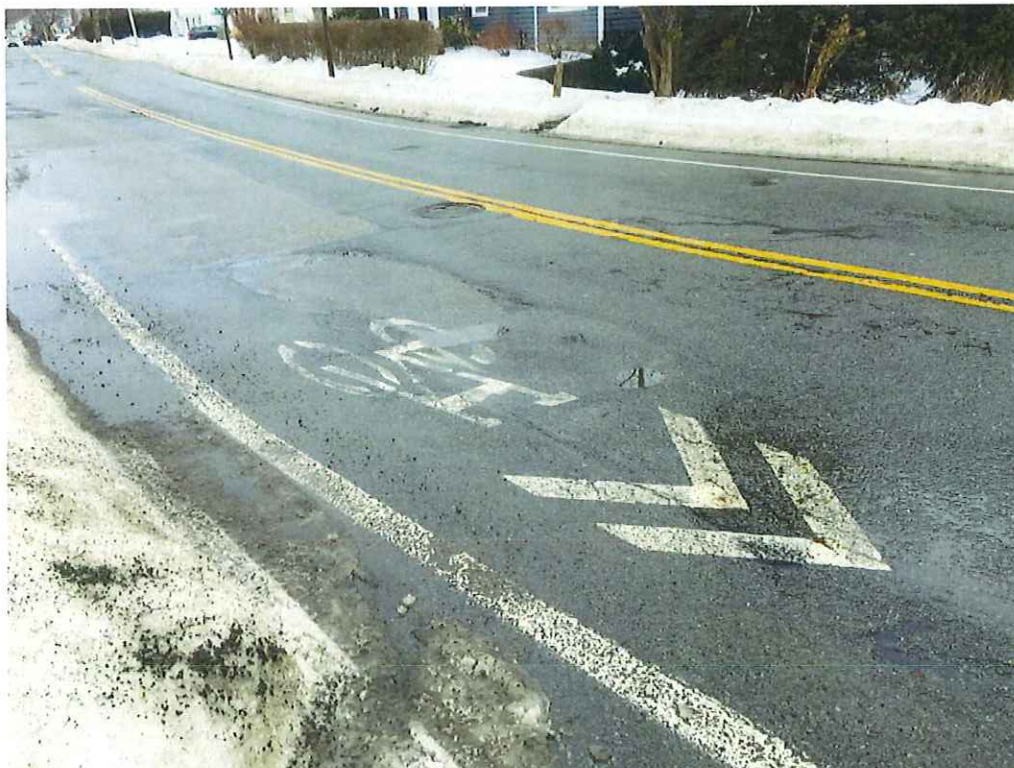
There are multiple sealed cracks and map cracking in both lanes.

There is a minor depression and a 7' long x 2.5' wide patch on the eastbound lane. **Photo 16.**

Photo 16: Eastbound lane, minor depression and a 7' L x 2.5' W patch.

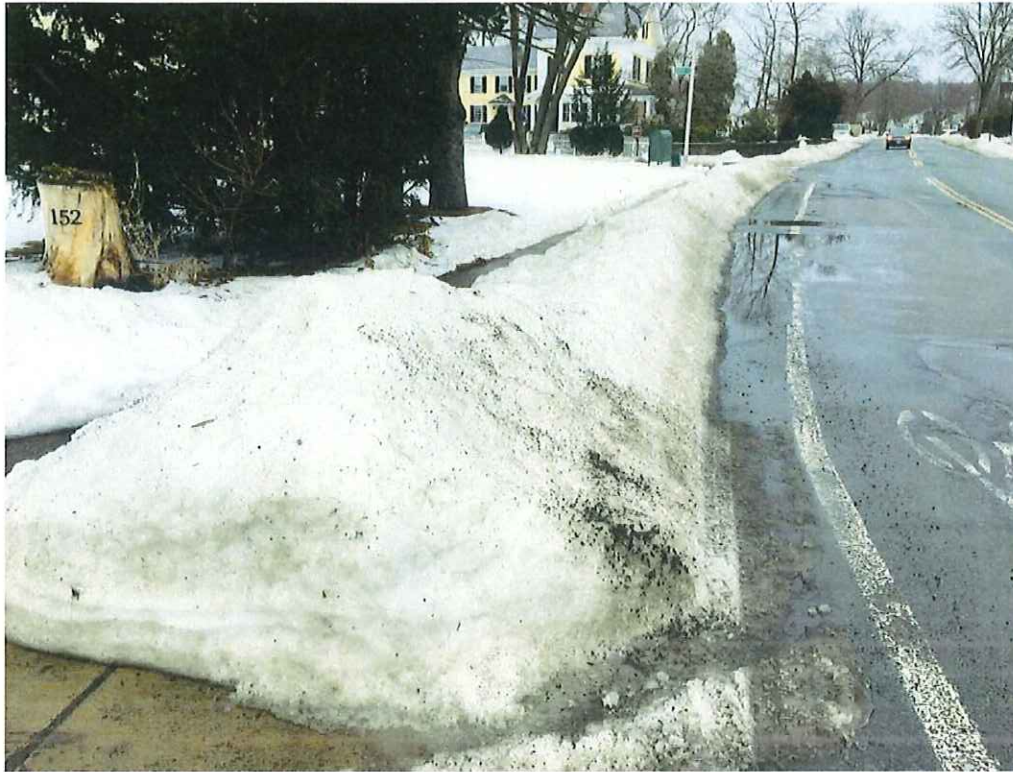
- There are concrete sidewalks at both north and south sides. Both sidewalks were covered by snow at the time of the inspection. **Photo 17.**

Both approaches sidewalks were covered by snow at the time of the inspection. **Photo 17.**

Photo 17: Sidewalks were covered by snow at the time of the inspection.

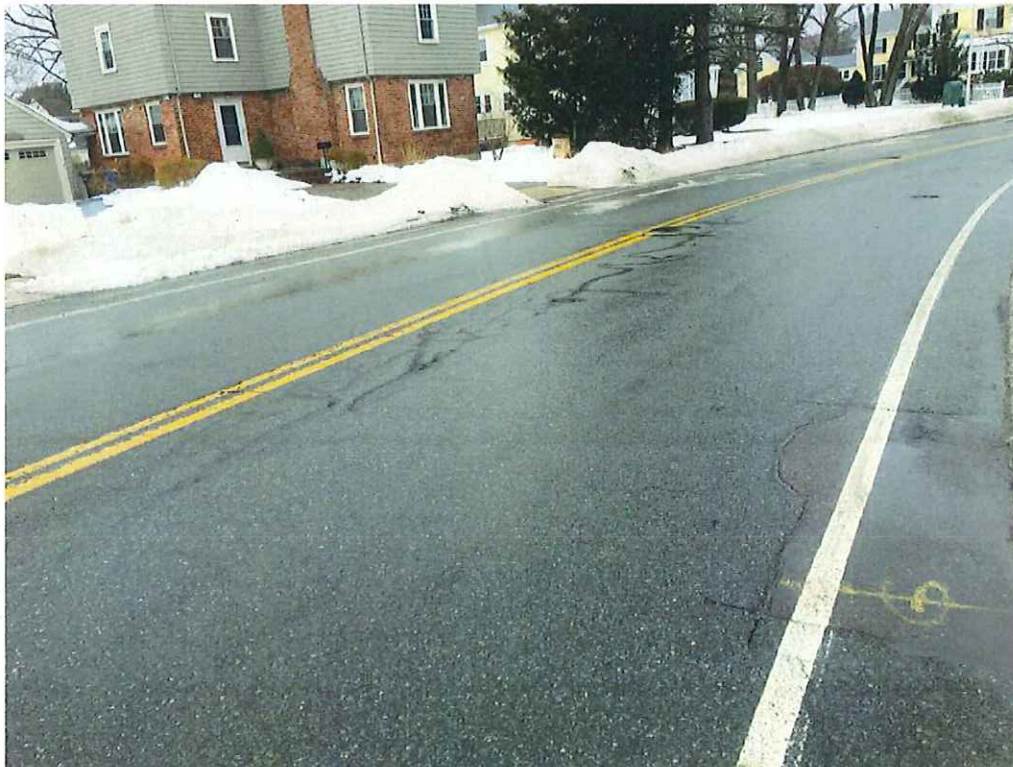
- There are multiple sealed longitudinal and transverse cracks in both lanes of both approaches and there is a 3.5' long 2' wide patch near the north curb. **Photo 18.**

Photo 18: Multiple sealed longitudinal and transverse cracks in both lanes and 3.5' L x 2' W patch near the north curb. (West approach shown).
