STRUCTURES INSPECTION FIELD REPORT

ROUTINE & SPECIAL MEMBER INSPECTION

CITY/TOWN BELMONT=WALTHAM		8.-STRUCTURE NO. B07015-7VB-MUN-CUL		11-Kilo. POINT 000.000	41-STATUS D:OPEN	90-ROUTINE INSP. DATE MAY 2, 2022	
07-FACILITY CARRIED ST 60 TRAPELO RD			MEMORIAL NAME/LOCAL NAME		27-YR BUILT 1850	106-YR REBUILT 1900	YR REHAB'D (NON 106) 0000
06-FEATURES INTERSECTED WATER BEAVER BROOK			26-FUNCTIONAL CLASS Urban Arterial		DIST. BRIDGE INSPECTION ENGINEER J. Dideo		
43-STRUCTURE TYPE 801 : Masonry Slab			22-OWNER Town Agency	21-MAINTAINER Town Agency	TEAM LEADER <i>Joseph J. Dideo</i> T. Leiper		
107-DECK TYPE 1 : Concrete Cast-in-Place			WEATHER Clear	TEMP. (air) 12°C	TEAM MEMBERS P. BURKE <i>P. Burke</i>

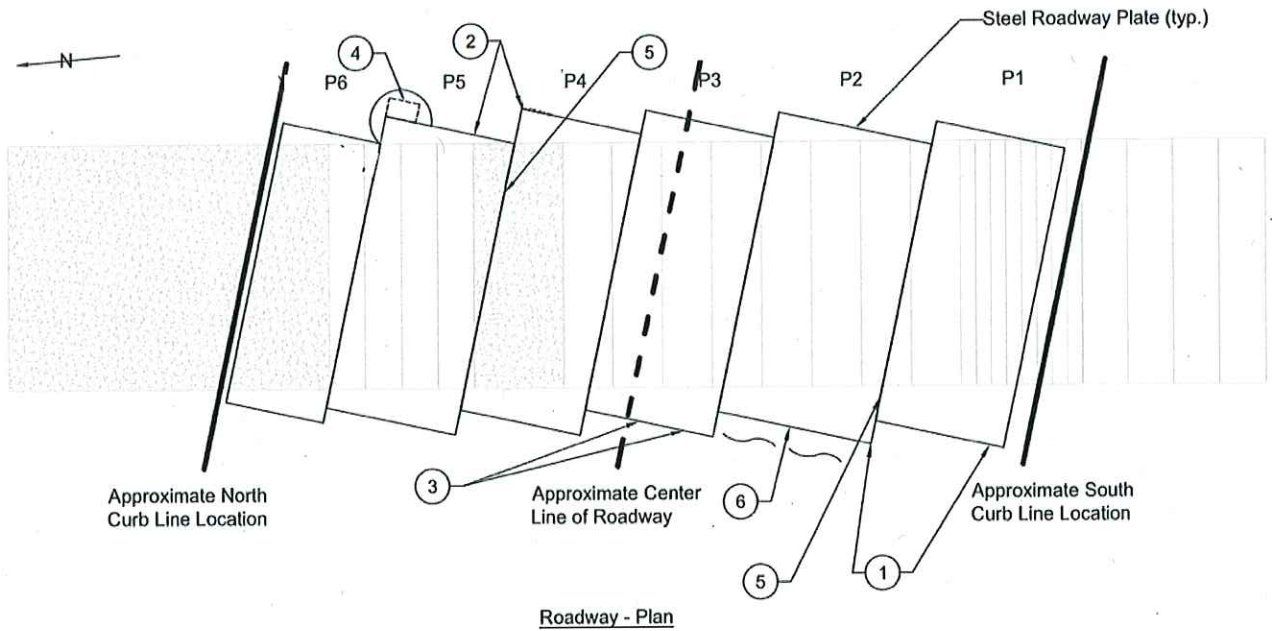
Sketch 1: Roadway Plate Conditions

There are isolated fully broken tack welds between roadway plates. The plates with broken tack welds typically deflect under live load.

1. Southwest corner deflects under live load
2. Northeast corner deflects under live load
3. Minor spalls adjacent to roadway plate
4. 2'-0" W x 7" L depressed bituminous patch with radial cracks $\frac{1}{8}$ " W
5. Full length broken tack weld (typ. 5" L)
6. Minor scrapes and gouges (typ.)

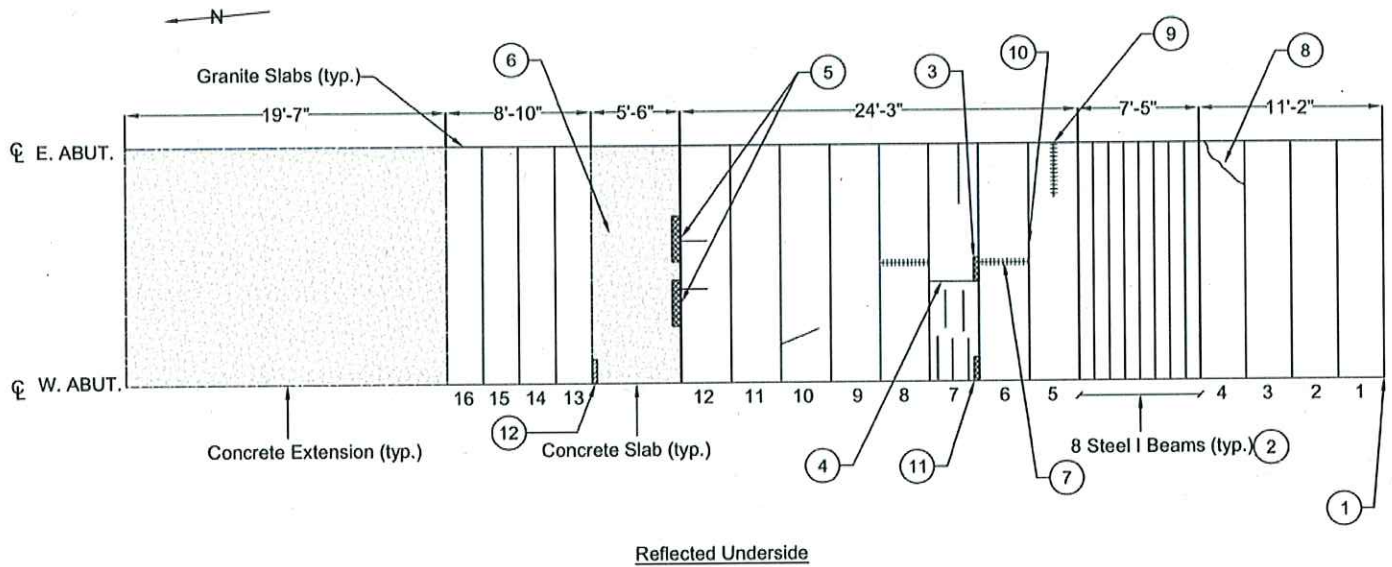
Sketch 2: Superstructure Conditions

There are isolated longitudinal and diagonal hairline cracks, some with efflorescence near the abutments. There are several up to full width transverse hairline cracks, some with efflorescence near mid-span. **See Sketch 2.**

There are two spalls with exposed rebar along the south edge measuring up to 2'-6" long x 9" high x 6" wide. There is a 24" long x 16" wide delamination at the northwest corner. **See Sketch 2.**

1. Granite Slab end unsupported at the SW corner for 6"
2. See Sketch 3: Steel Beam Conditions
3. Granite Slab with a 20" L x 13" W x 2" D spall
4. Granite slab with up to 2" W x full depth crack. Crack gauge reads 0.05mm
5. Two (2) up to 30" L x 6" W x up to 9" D edge spall with exposed rebar
6. 50% of stay in place forms are missing
7. Full width hairline crack with efflorescence. Note: Crack gauge reads 0.00mm
8. 6'-0" L hairline crack
9. 2'-6" L hairline crack with minor efflorescence
10. Loose pointing between the beams
11. 2'-0" L x 5" W x 2" D spall
12. 2'-0" L x 16" W delamination

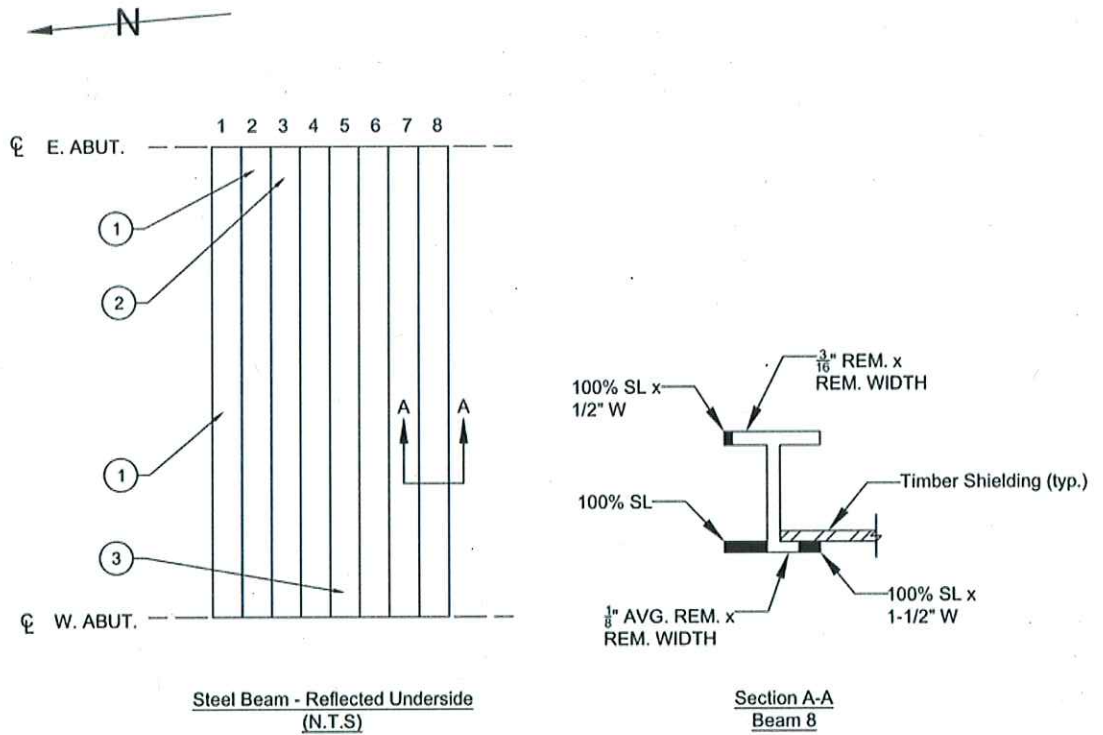
Sketch 3: Steel Beam Conditions

There is typically heavy rust and laminated rust throughout the beams. The top and bottom flanges of isolated beams near the abutments and at mid-span have up to 100% section loss x full width. **See Sketch 3.**

NOTE:
Interior web and top flange inaccessible due to timber shielding.
Beams bottom flanges are typically rotated.

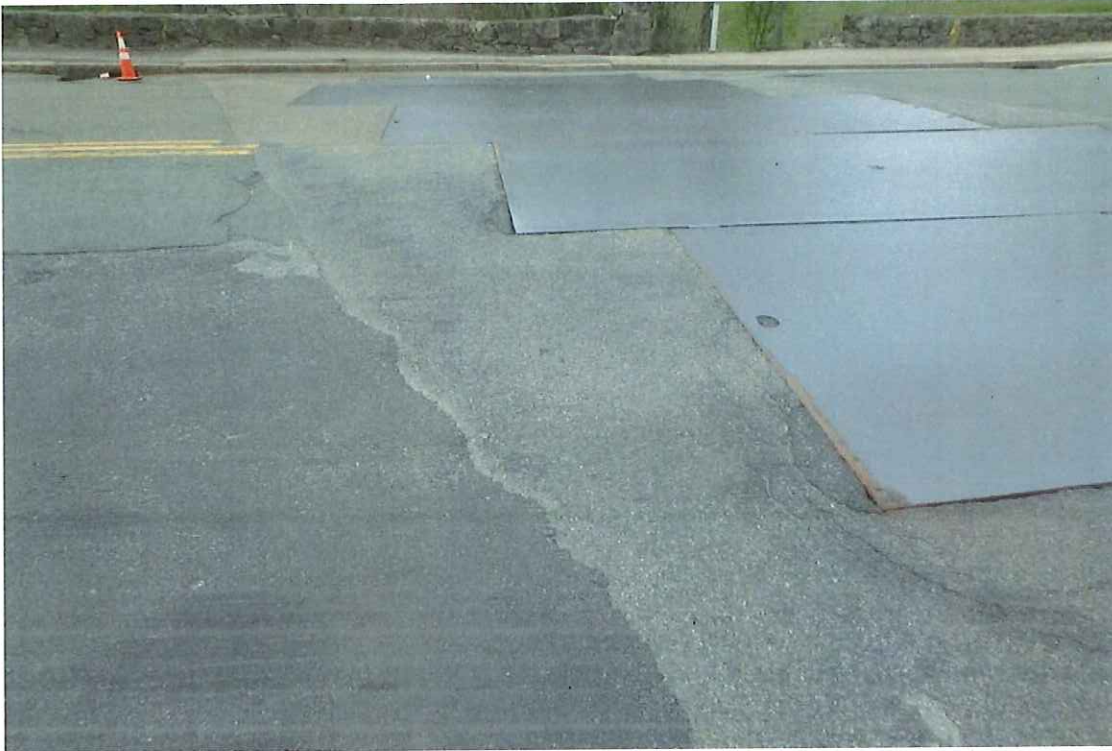
There was a previously noted spall in the pavement at the northeast corner of P4 which has been repaired. **See Photo 3.**

There is a depressed bituminous patch with radial up to 1/8" cracks at the northeast corner of P5. **See Photo 3.**

Photo 3: Steel Plate 4 and 5 at the northeast corner repaired potholes and a 2'-0" W x 7" L patch with radial cracking.

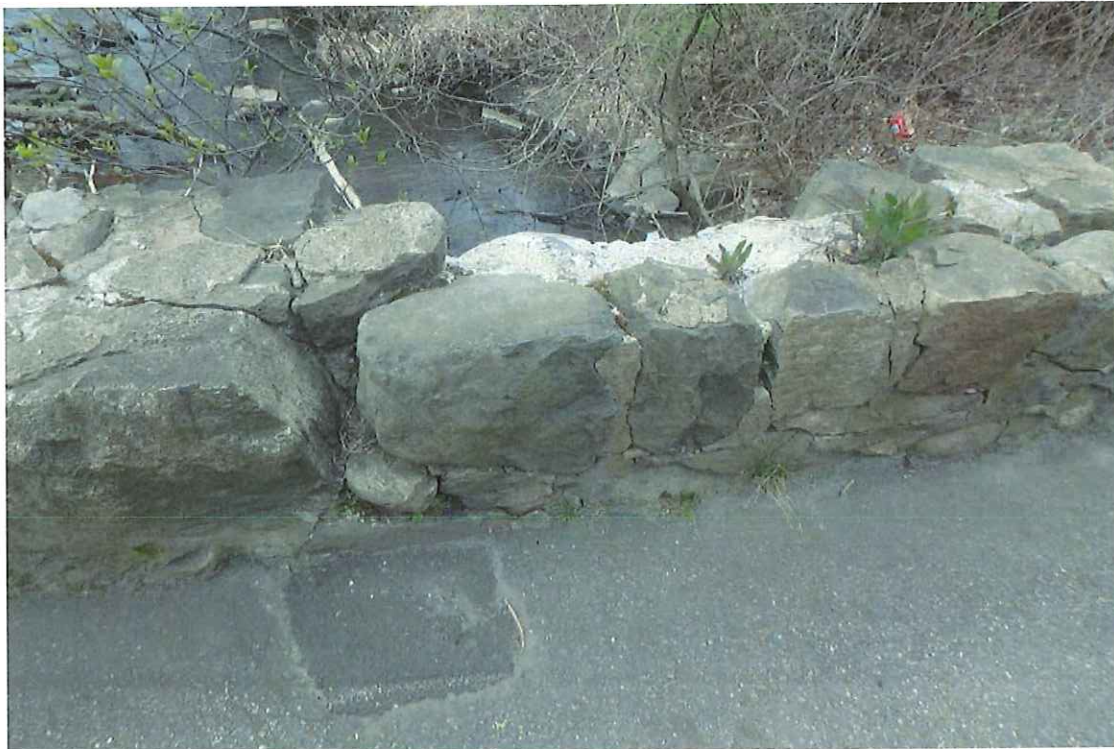
In the south sidewalk near the stone wall there was a 1' diameter hole in the asphalt that has since been repaired. **See Photo 4.**

Photo 4: Repaired hole in south sidewalk. Missing stones and mortar in south railing.

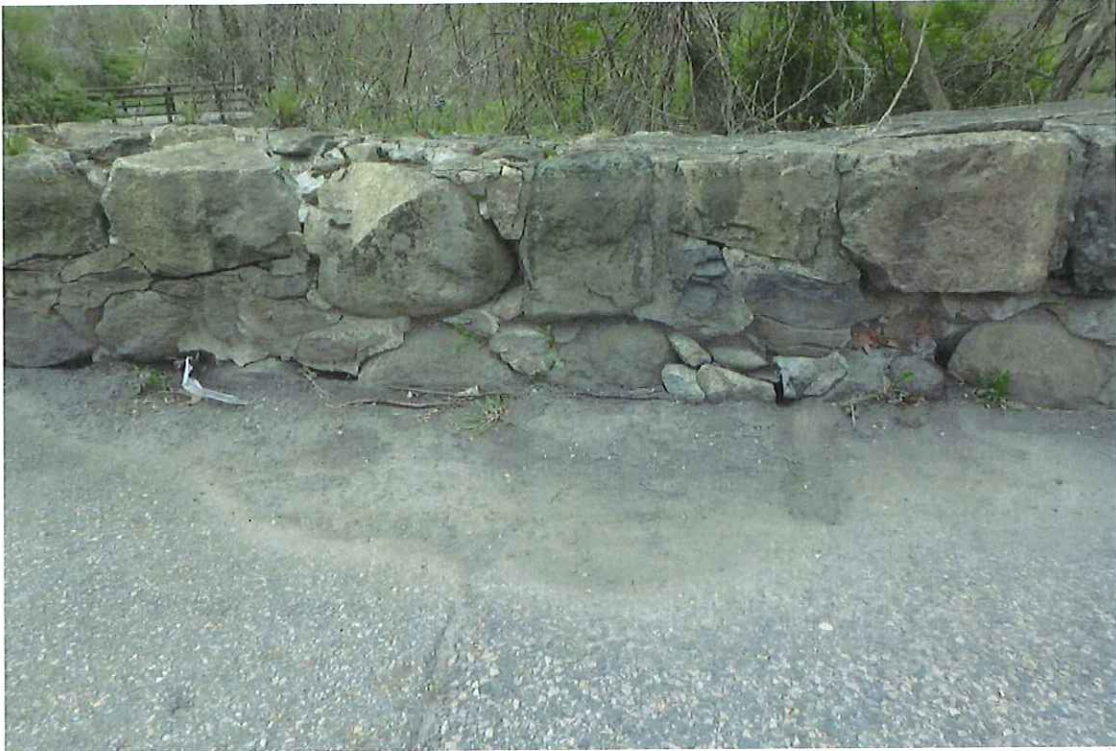
In the masonry stone wall, there is cracked mortar and missing pointing between the stones as well as missing stones. **See Photos 4 & 5.**

Photo 5: South masonry stone wall: Cracked mortar and missing pointing between the stones leading to water intrusion. South Sidewalk: Depression along masonry wall.

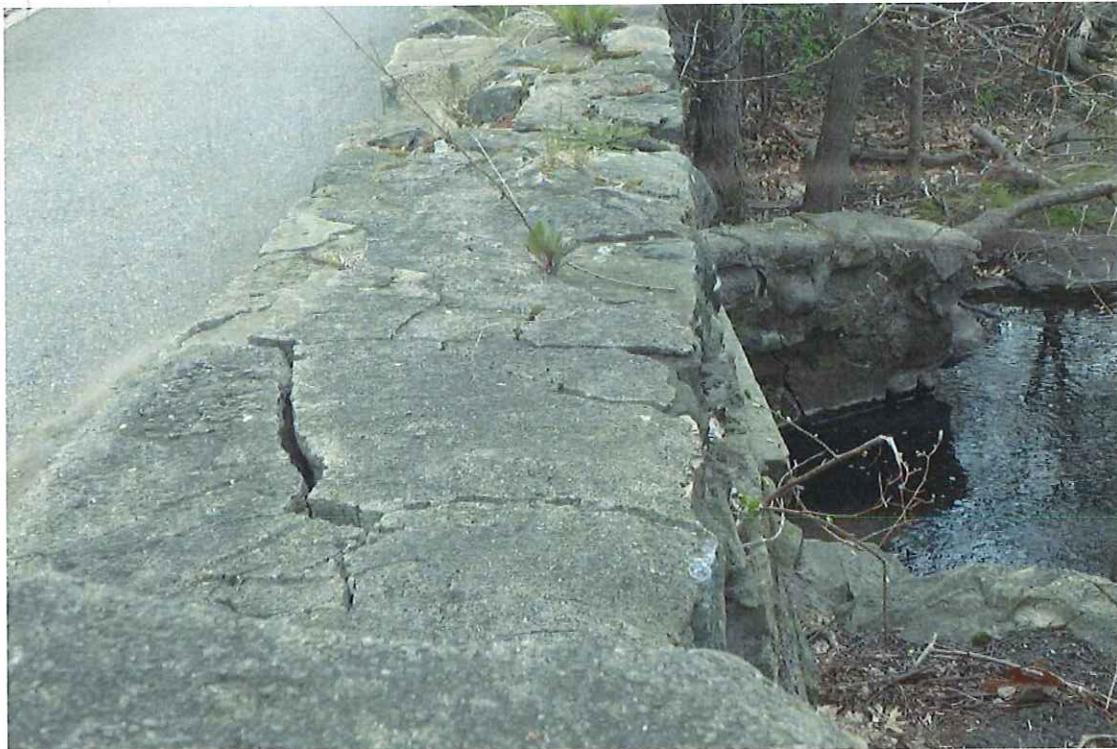
Photo 6: Bulging of western half of masonry wall along area of water intrusion.

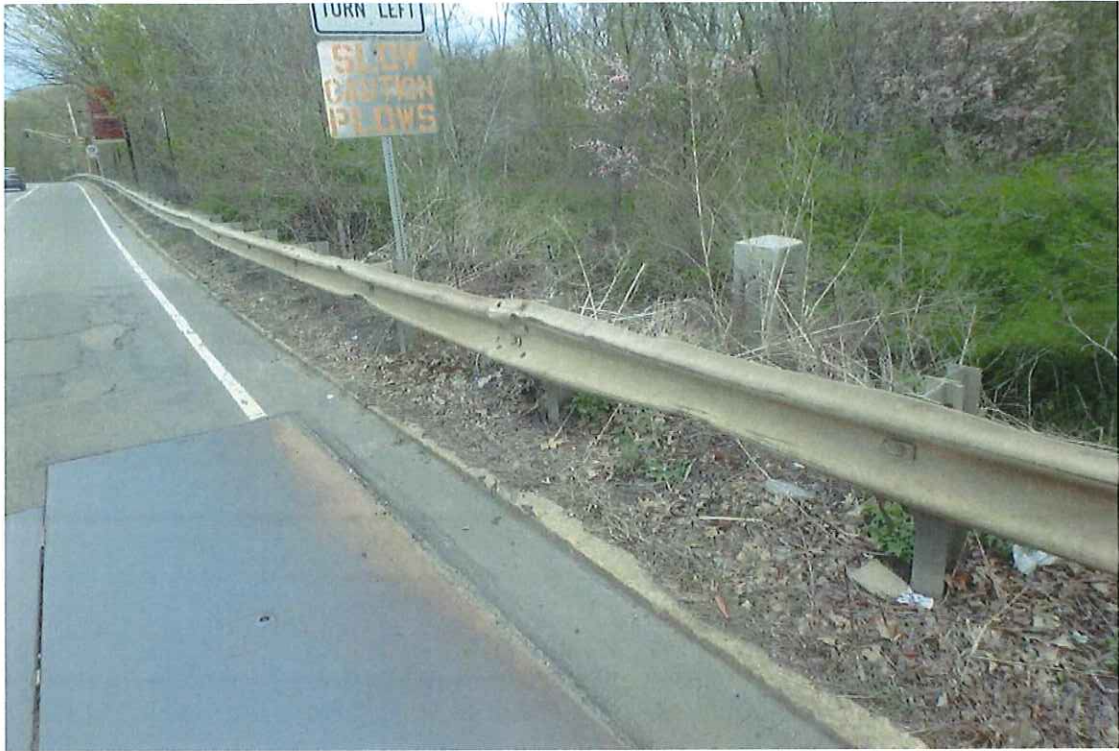
At the north rail, there is impact damage. **See Photo 7.**

Photo 7: North bridge rail: Impact damage.

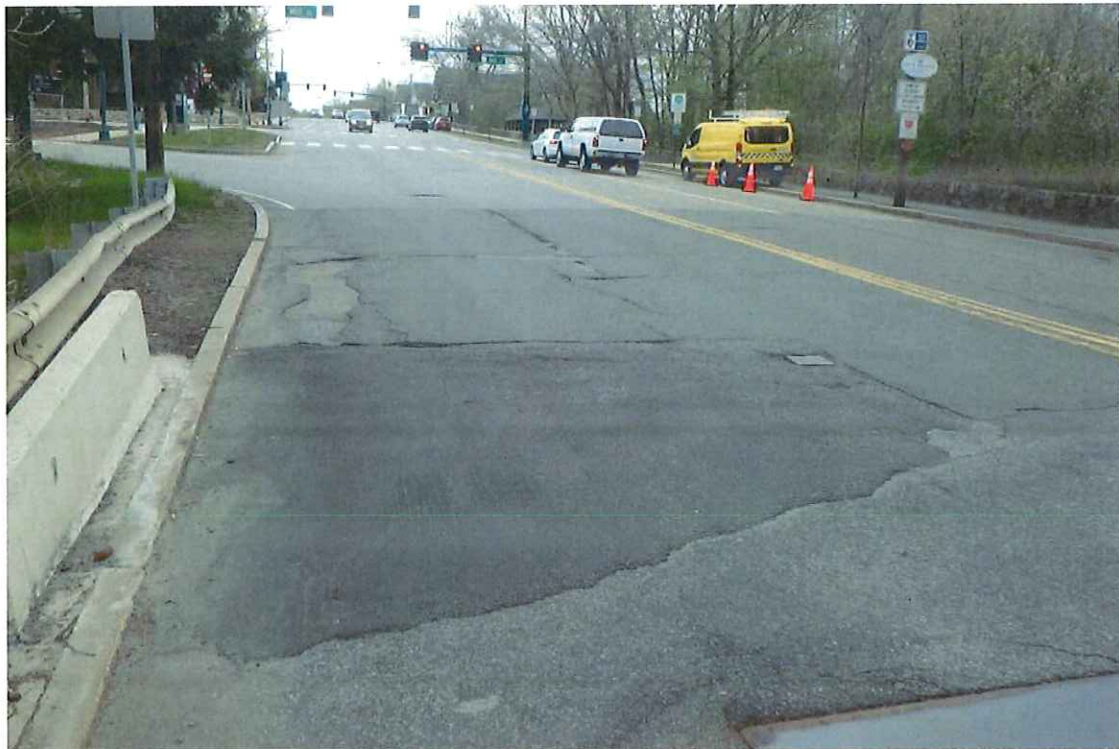
Both approaches have heavy transverse, longitudinal, and map cracks throughout and patching. **See Photo 8.**

Photo 8: East approach: Heavy transverse, longitudinal, and map cracks throughout and patching.

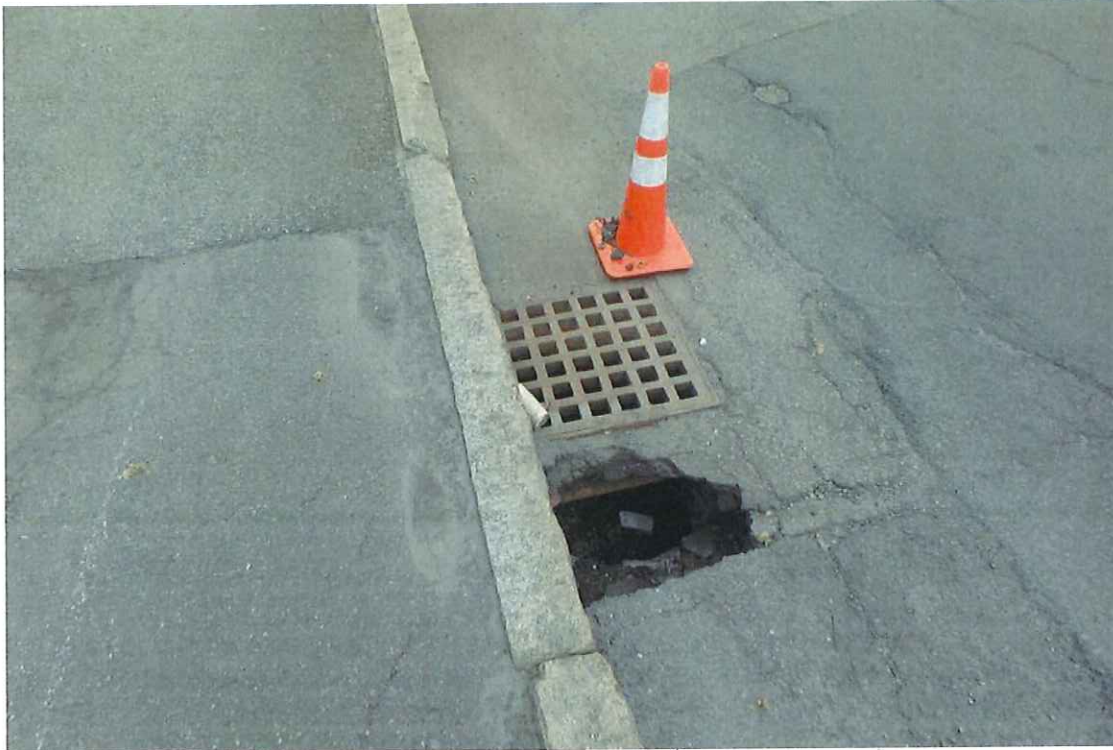
Photo 9: East approach: Sinkhole next to catch basin.

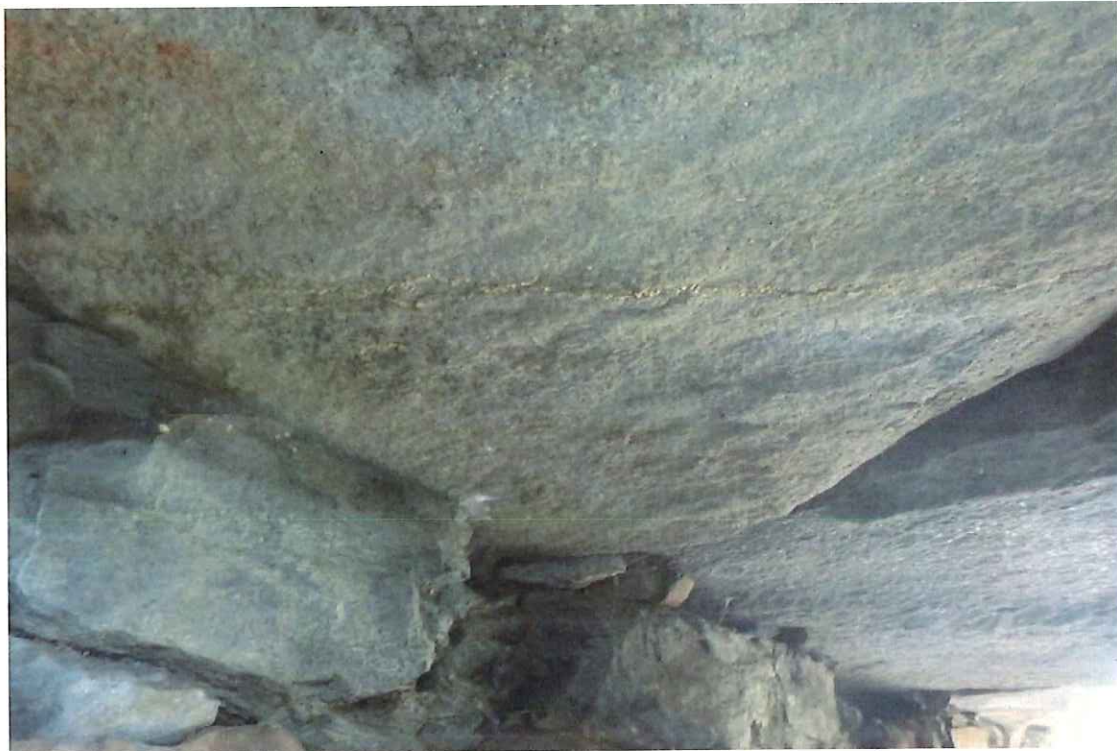
Slab 4 there is a diagonal hairline crack at the east end. **See Photo 10.**

Photo 10: Granite slab 4: Diagonal hairline cracking at the east end.

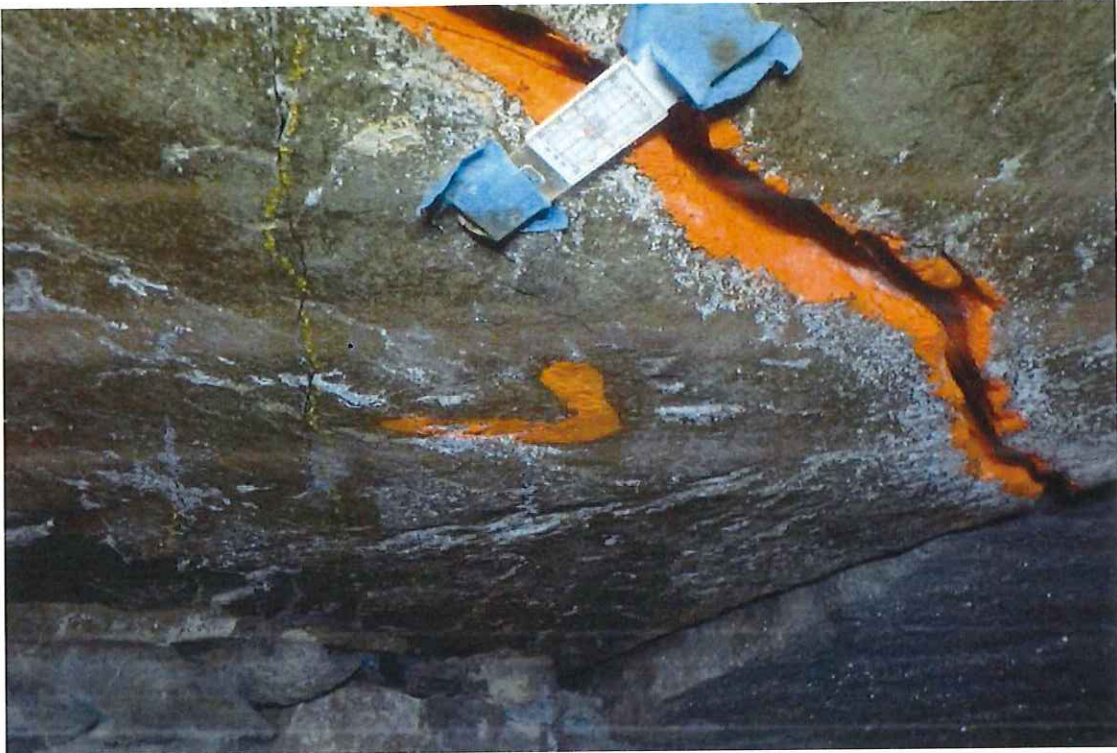
Slab 7 near mid-span has an up to 2" wide x full depth transverse crack, with a 20" long x 13" wide x 2" deep spall at the south edge. **See Photo 11.**

Slab 6 and 7 are monitored with crack gauges. The crack gauges indicated little to no movement since installation. The crack gauge at Slab 7 read 0.05 mm from zero. **See Photos 11 - 13.**

Photo 11: Granite slab 7: Transverse split up to 2" wide near midspan.

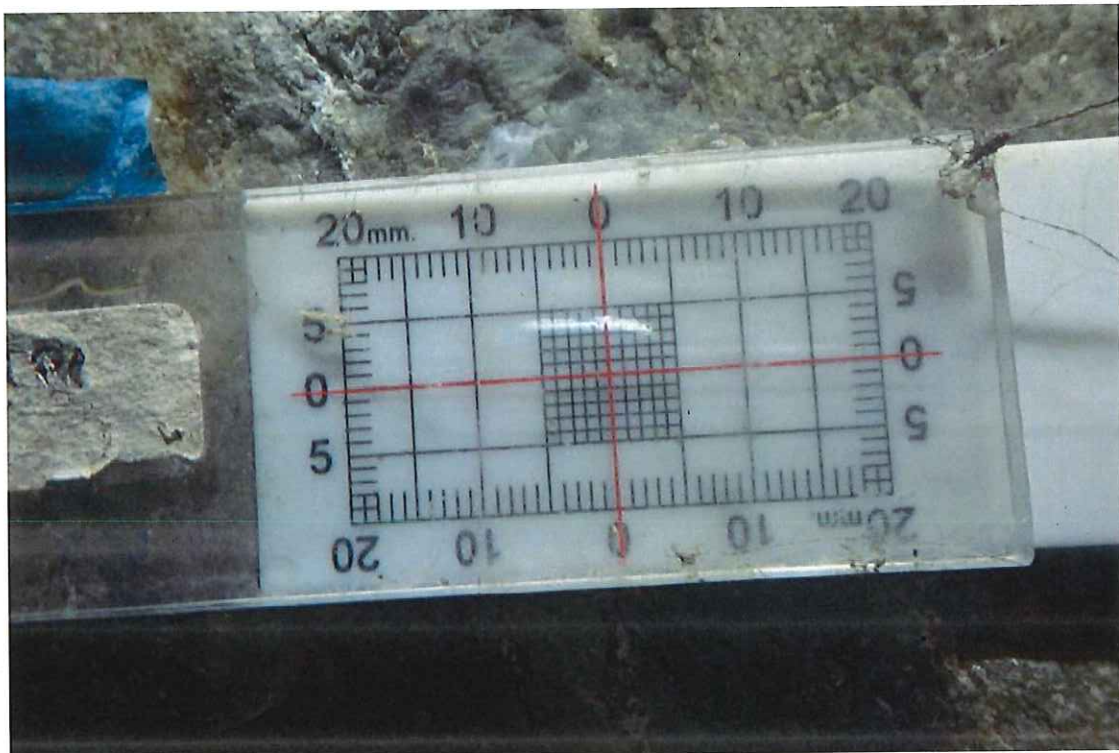
Granite slab 6: Transverse split with previous water leakage noted near midspan.

Photo 12: Granite slab 6: The crack gauge shows minor movement (< 1 mm in both directions).

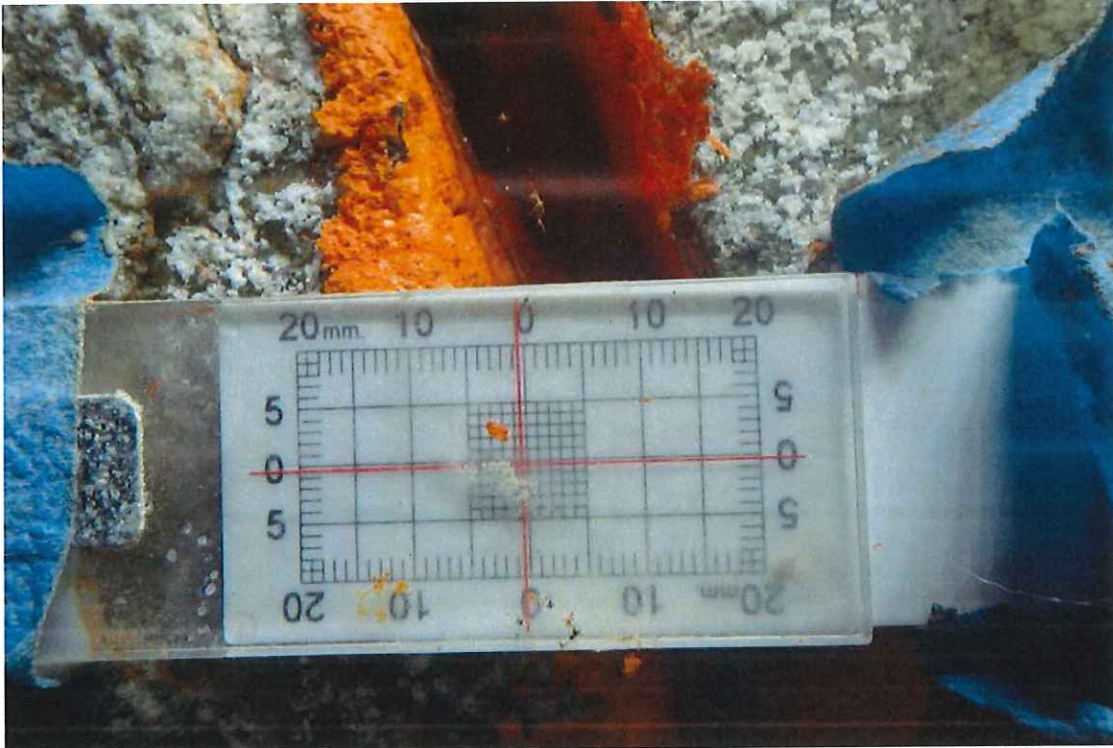
Photo 13: Granite slab 7: The crack gauge shows minor movement (< 1 mm).

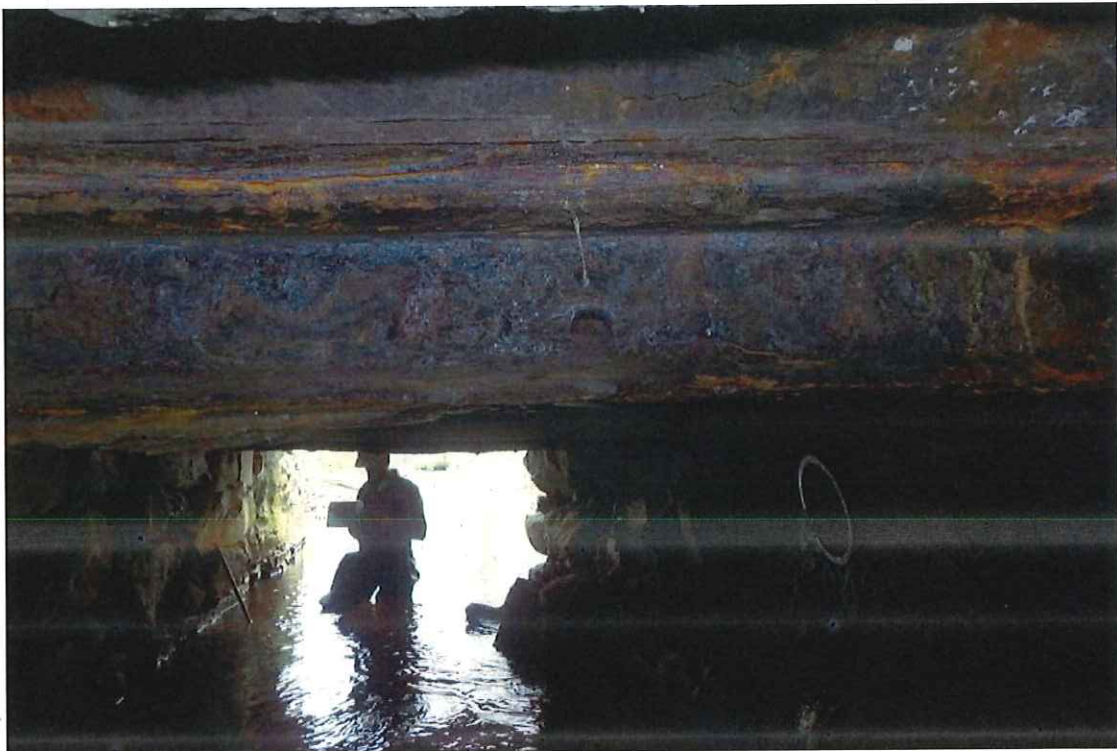
Photo 14: Steel beam 8: Severe section loss at the bottom flange up to 2.5' long x up to 2" wide.

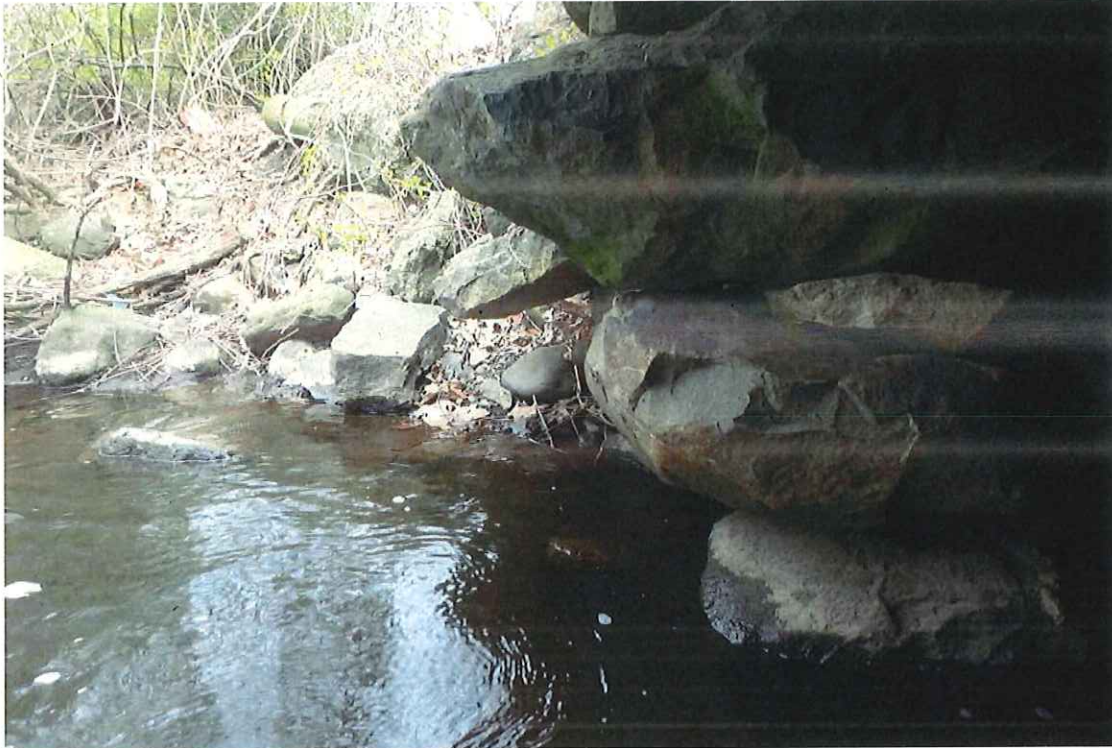
There are typically voids up to 2'-0" deep throughout the abutments. There are missing and cracked stones throughout both breastwalls and below the drainage pipes. Isolated areas have been repaired and filled with concrete and sandbags. Conditions and locations are as follows:

Photo 15: West breastwall: Large voids and missing stones at the south end.

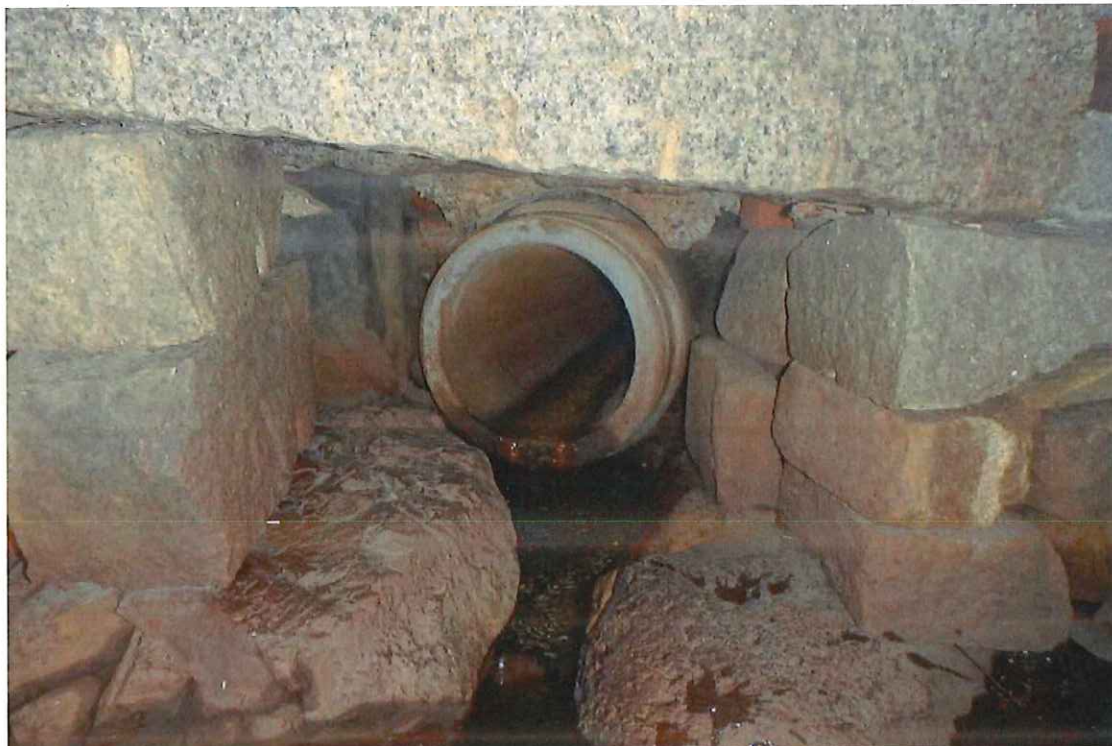
Below the concrete roof section between Slabs 12 & 13 and adjacent to the masonry wall repair (newer concrete wall section), there is a drainage opening, 2' deep, with a RCP discharging water behind the rest of the breastwall due to an open channel floor. **See Photo 16.**

Photo 16: West breastwall: Drainage opening adjacent to wall repair.

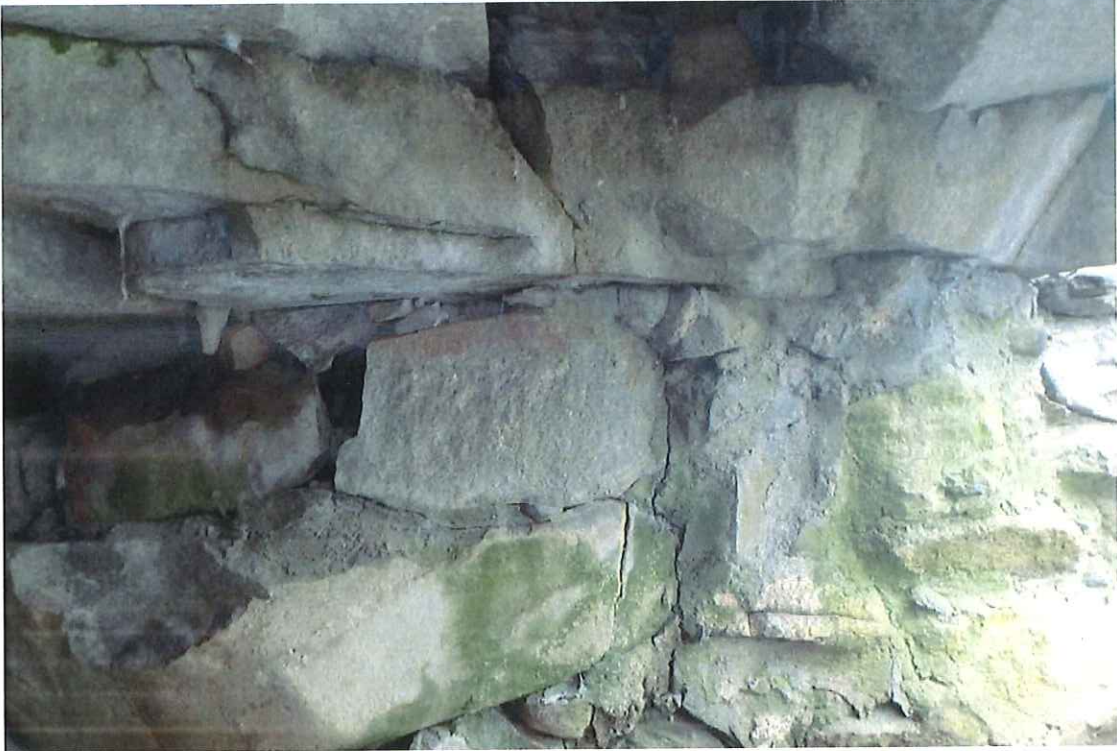
Below Slab 1, there are full height cracks in multiple stones up to 10" long x up to 1/4" wide and a 1-1/2" long x 5" high x 3" deep spall. **See Photo 17.**

Photo 17: East breastwall: There are multiple stones with vertical cracks at the south end below beam 1.

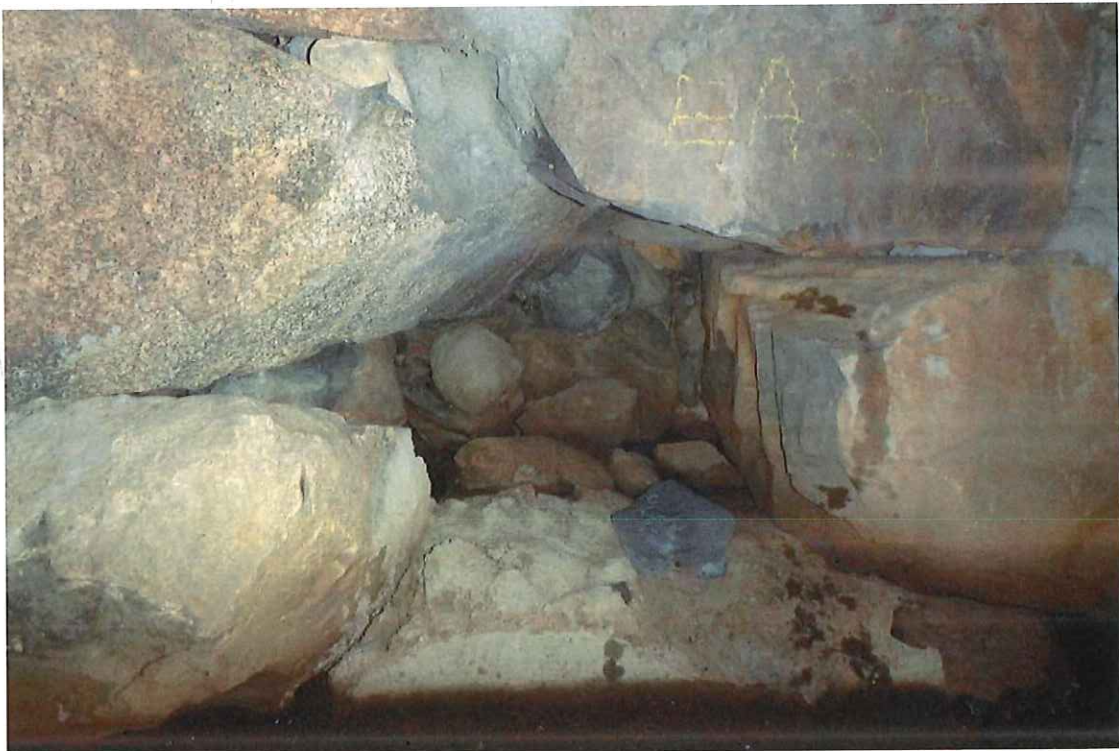
Photo 18: East breastwall: Void in first course of stone above waterline under slab 5.

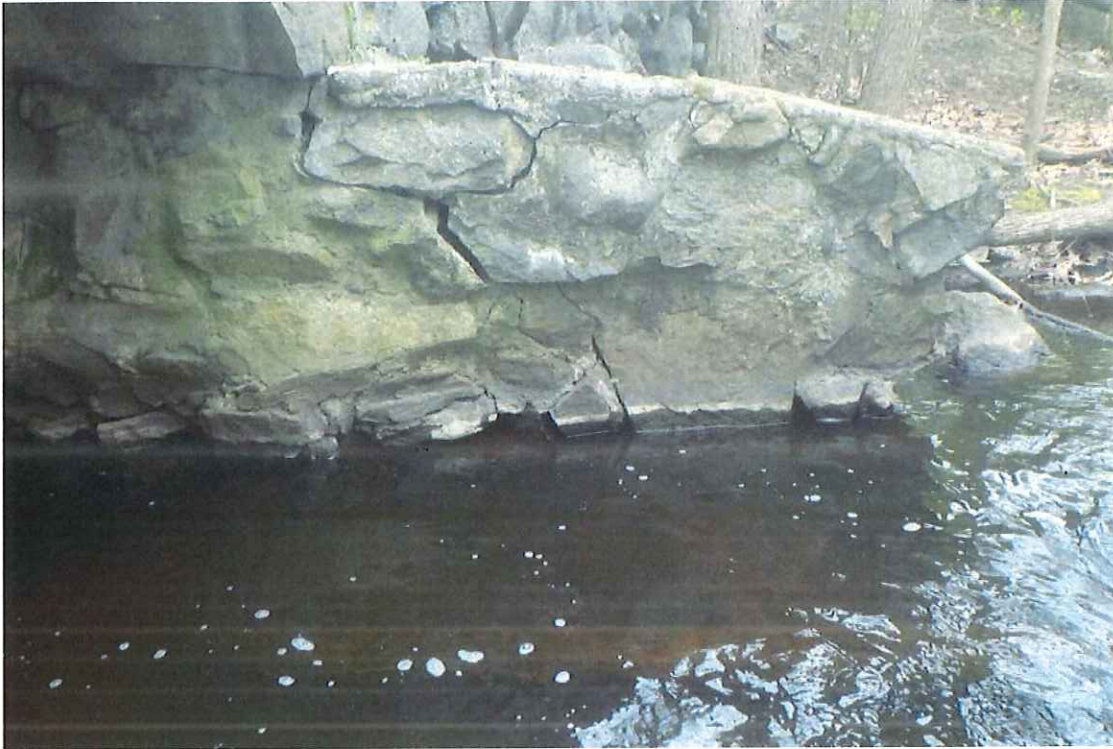
The southeast retaining wall has a full height crack measuring up to 6" wide x up to 2' deep. **See Photo 19.**

Photo 19: Southeast wingwall: Full height crack measuring up to 6" wide x up to 2' deep.

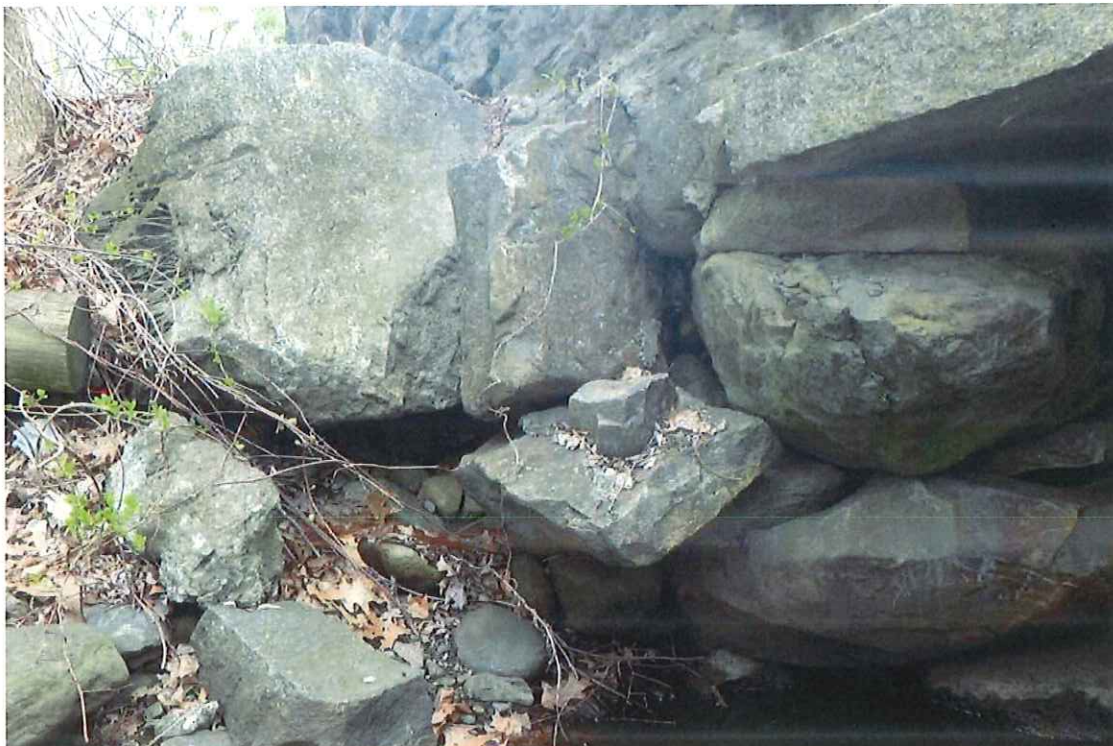
Photo 20: Southwest wingwall: Collapsed.

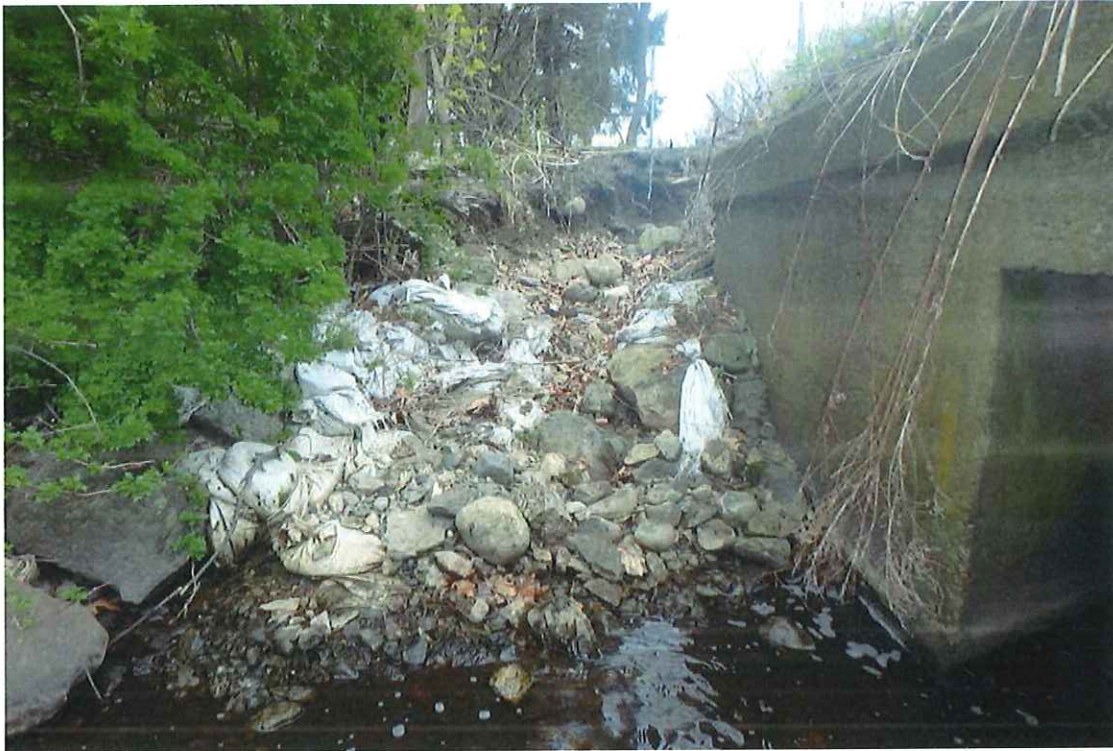
At the northeast slope, there is a failed sandbag slope protection repair. **See Photo 21.**

Photo 21: Northeast slope: Failed slope protection repair.

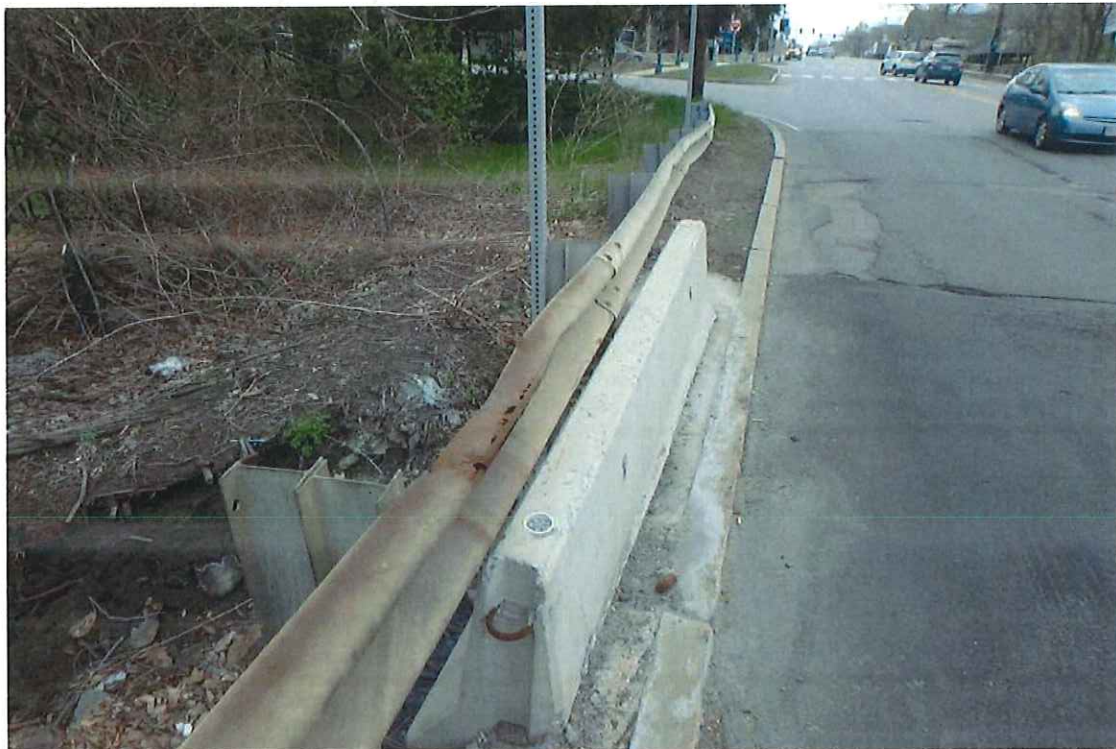
Photo 22: Northeast approach guardrail: 100% section loss and new barrier due to washout behind rail.
