2-DIST  
04

B.I.N.  
7VB

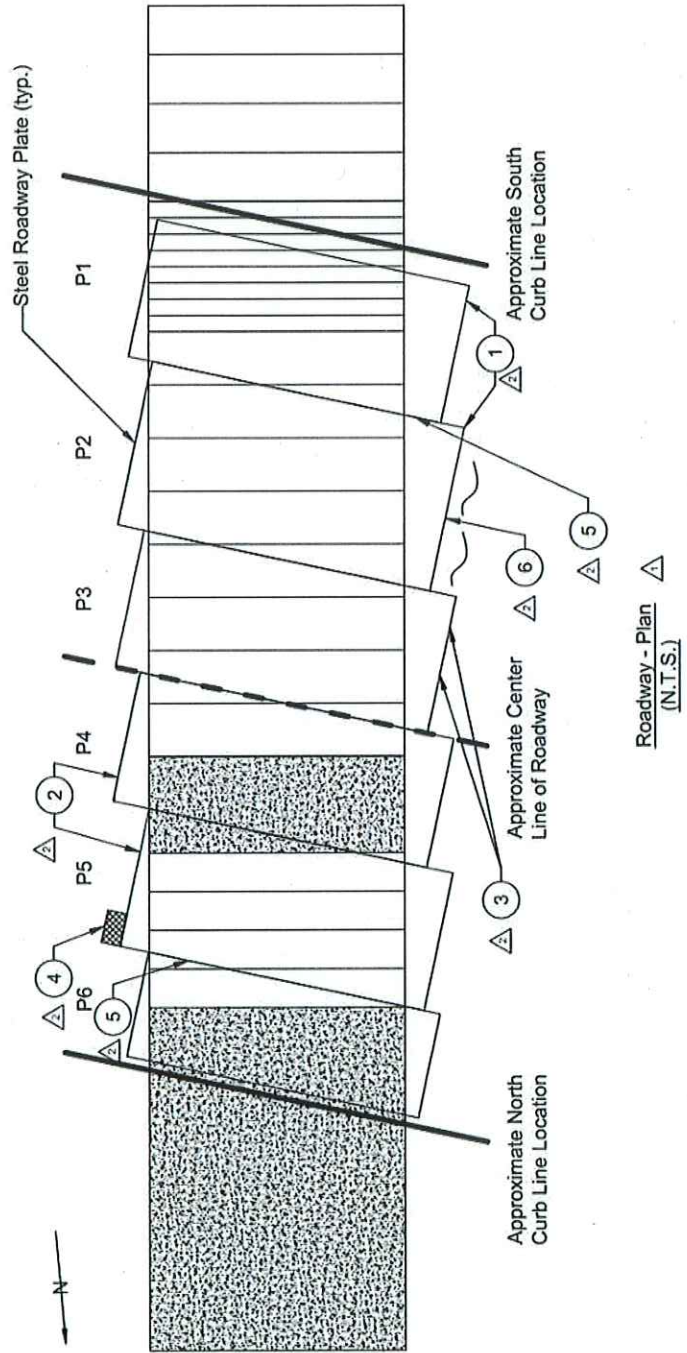
- Legend:**
- Spall (typ.)
  - Delamination (typ.)
  - Hairline Crack (U.O.N)
  - Hairline Crack with Efflorescence (U.O.N)
  - Indicates a newly documented condition
  - Indicates a change in a previously noted condition
- Condition:**
1. Southwest corner deflects under live load
  2. Northeast corner deflects under live load
  3. Minor spalls adjacent to roadway plate
  4. 2'-0" W x 7" L x 2" D spall/pothole
  5. Full length broken tack weld
  6. Minor scrapes and gouges (typ.)

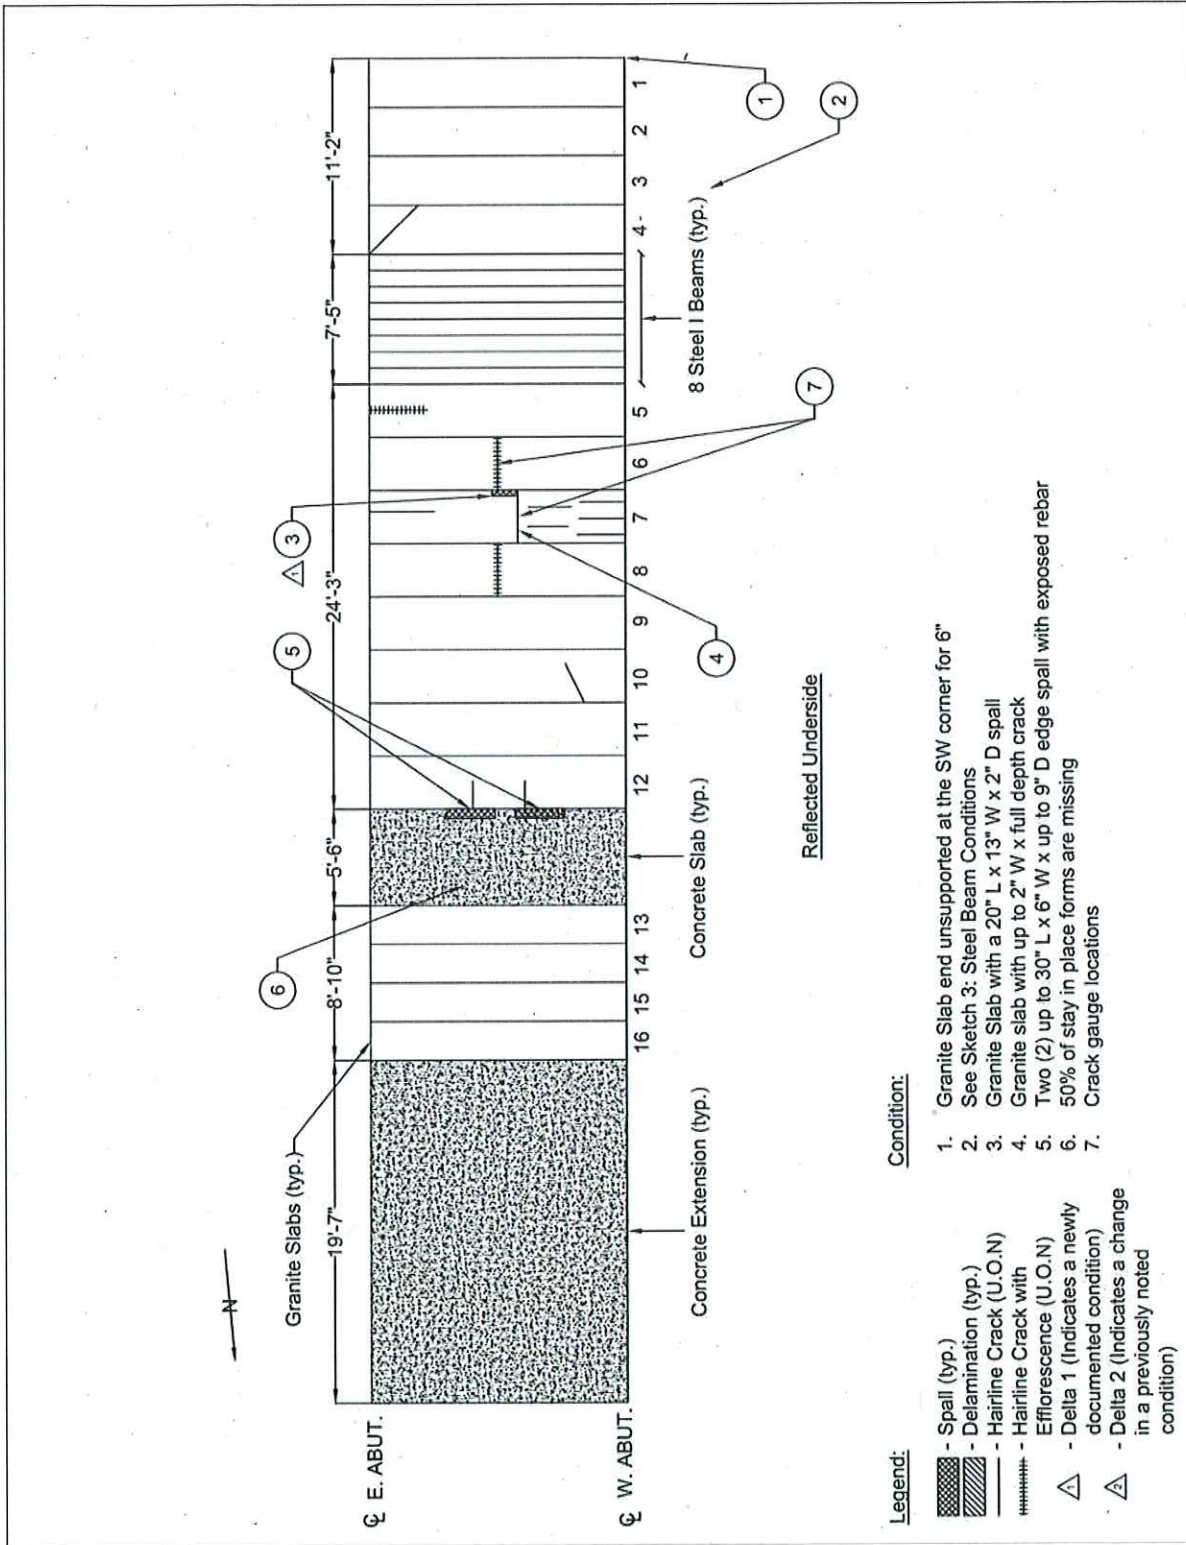
- Legend:**
- Spall (typ.)
  - Delamination (typ.)
  - Hairline Crack (U.O.N)
  - Hairline Crack with Efflorescence (U.O.N)
  - Delta 1 (Indicates a newly documented condition)
  - Delta 2 (Indicates a change in a previously noted condition)
- Condition:**
1. Granite Slab end unsupported at the SW corner for 6"
  2. See Sketch 3: Steel Beam Conditions
  3. Granite Slab with a 20" L x 13" W x 2" D spall
  4. Granite slab with up to 2" W x full depth crack
  5. Two (2) up to 30" L x 6" W x up to 9" D edge spall with exposed rebar
  6. 50% of stay in place forms are missing
  7. Crack gauge locations

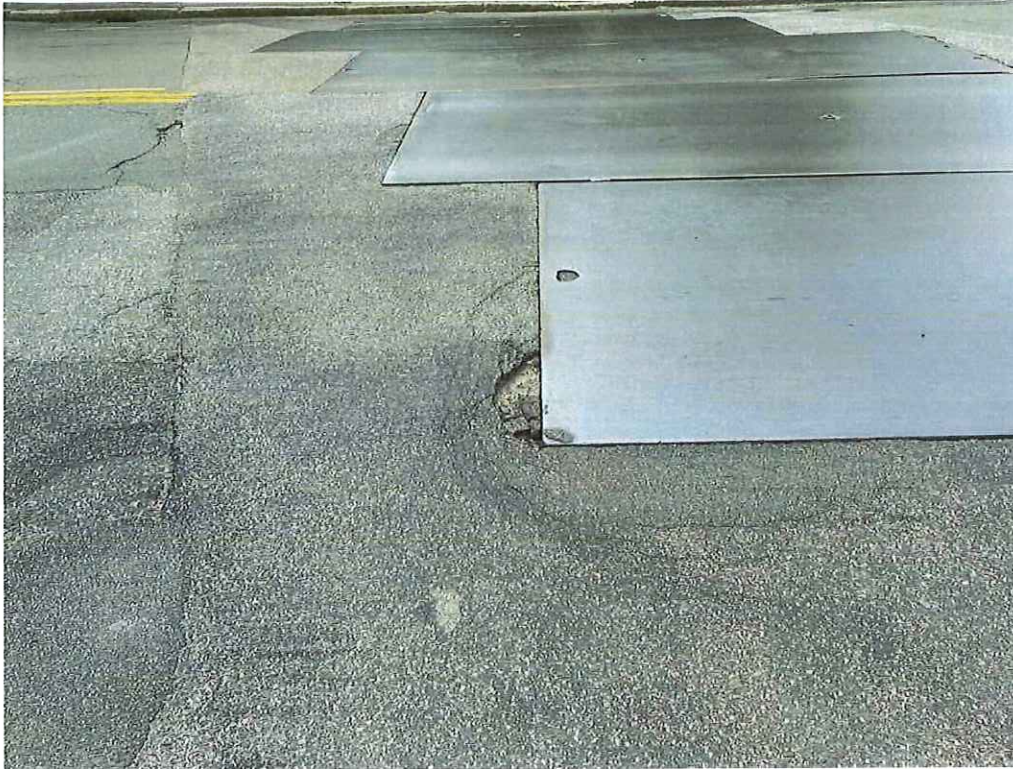
**Photo 11: Steel Plate 5, northeast corner: 2'-0" wide x 7" long x up to 2" deep spall.**

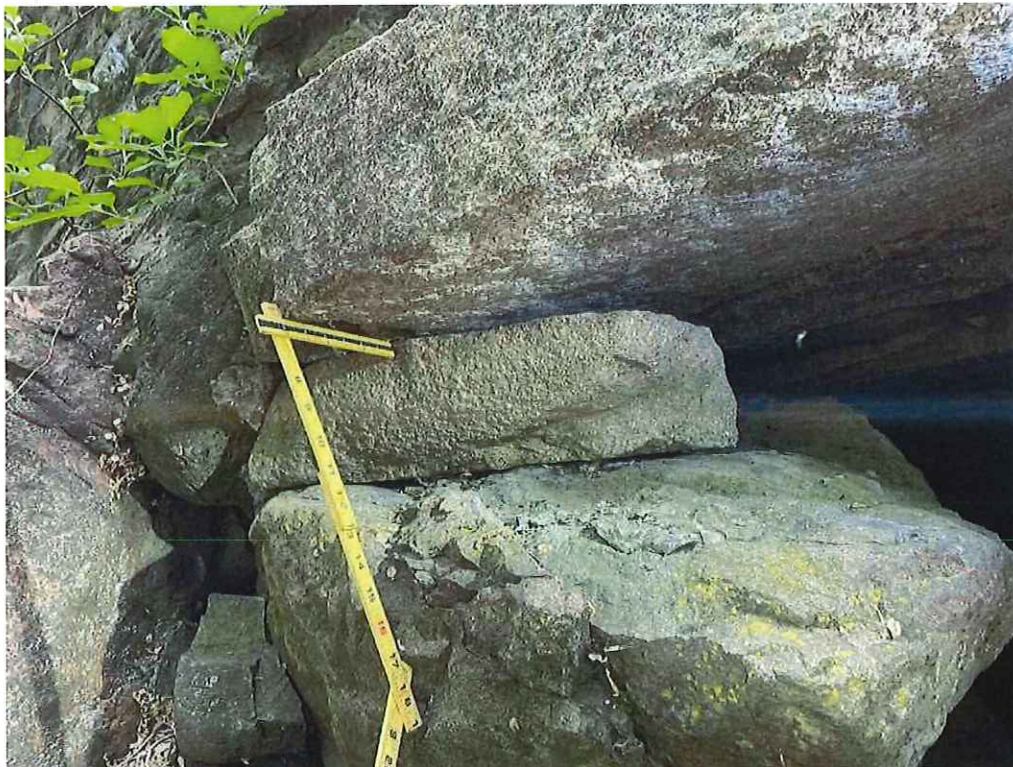
**Photo 12: Slab 1 southwest corner at West Abutment: Slab is unsupported for 6".**

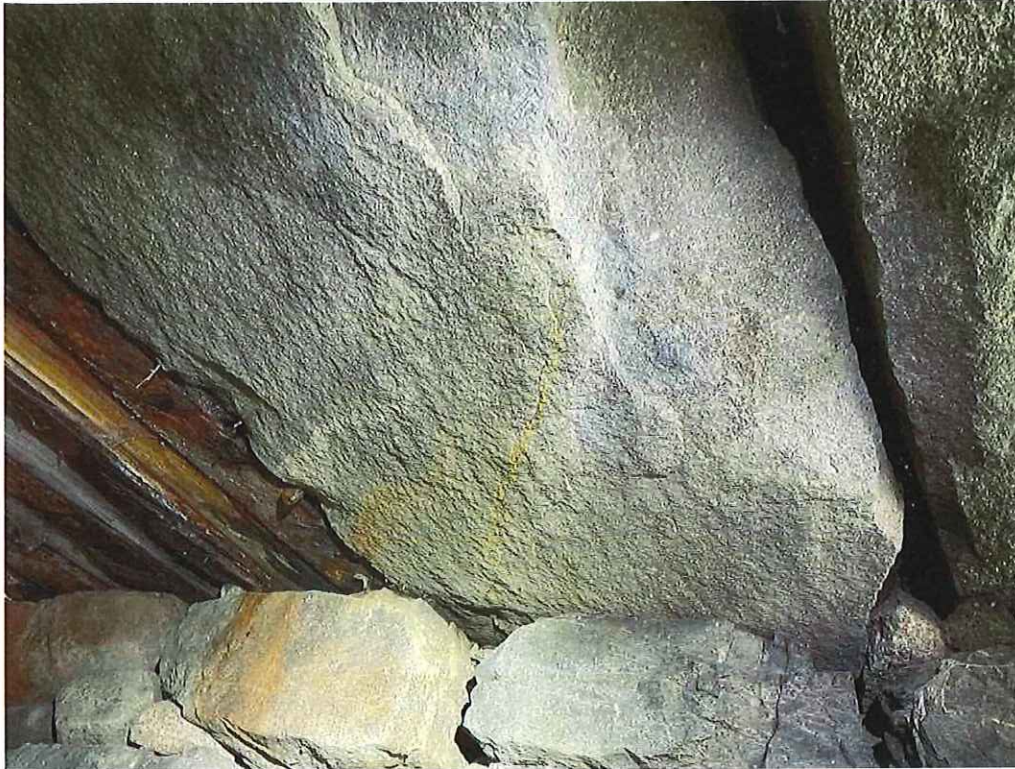
**Photo 13: Slab 4 underside at East Abutment: diagonal hairline crack.**

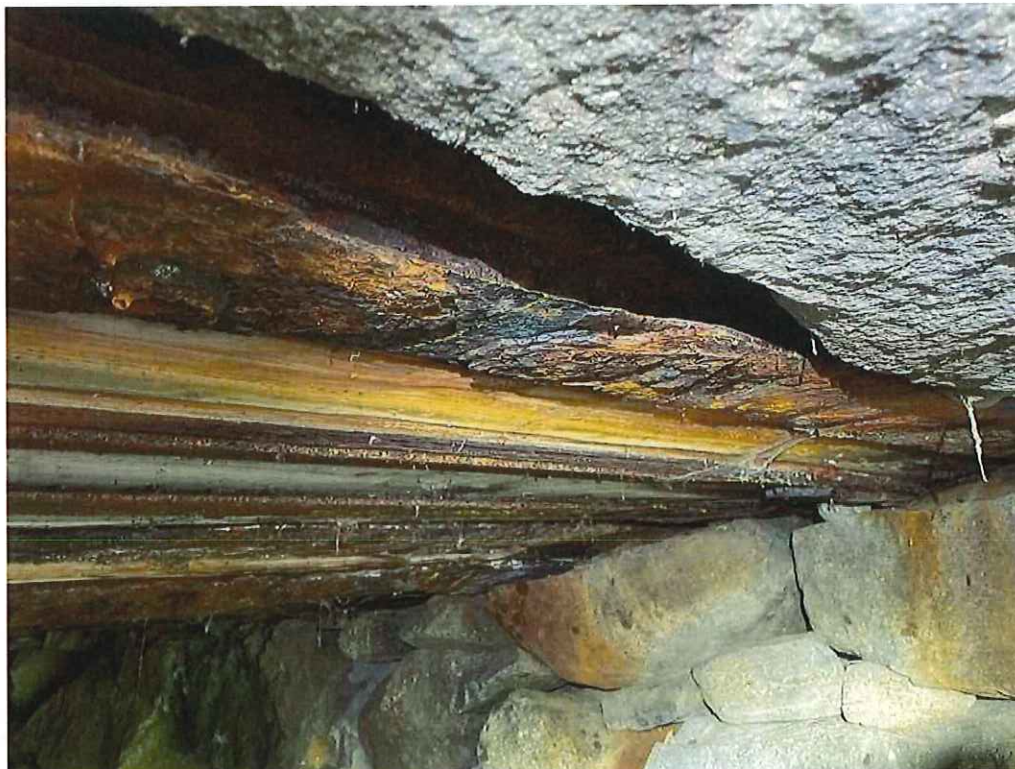
**Photo 14: Steel Beam 1 bottom flange near Mid-span: 100% section loss x 1" wide at the south toe with 3/16" thickness remaining.**

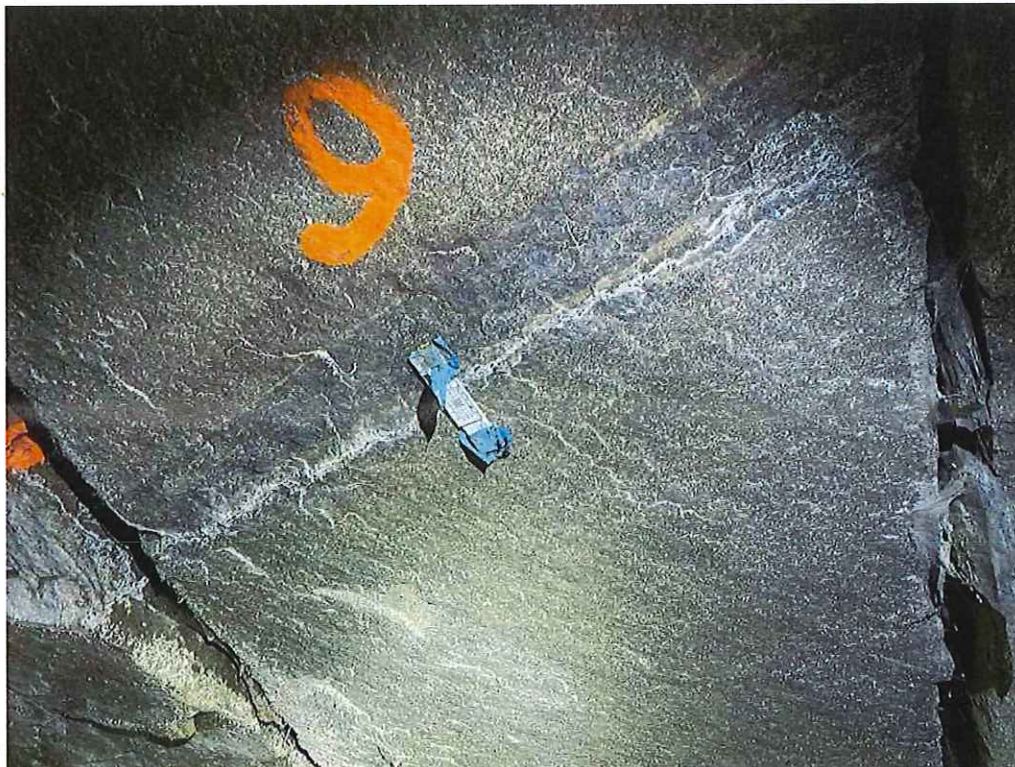
**Photo 18: Slab 6 underside near Mid-span: Transverse hairline crack with efflorescence. Note: Crack Gauge.**

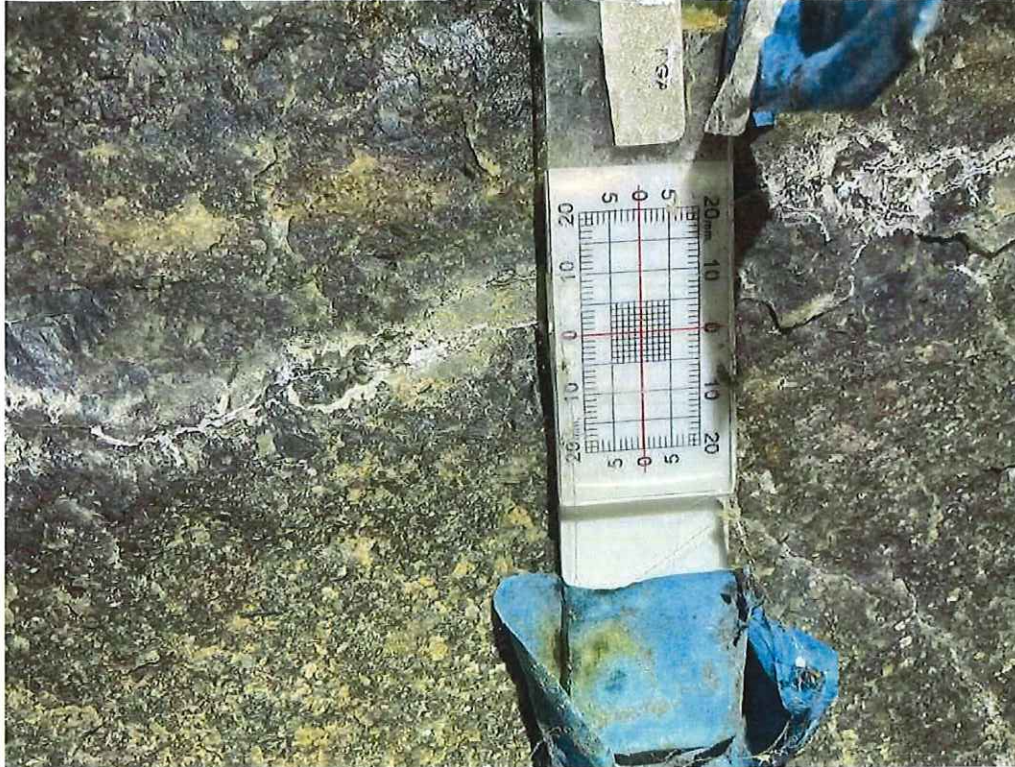
**Photo 19:** Slab 6 underside near Mid-span: Crack gauge shows minor movement ( $< 1$  mm in both directions). No change since previous inspection.

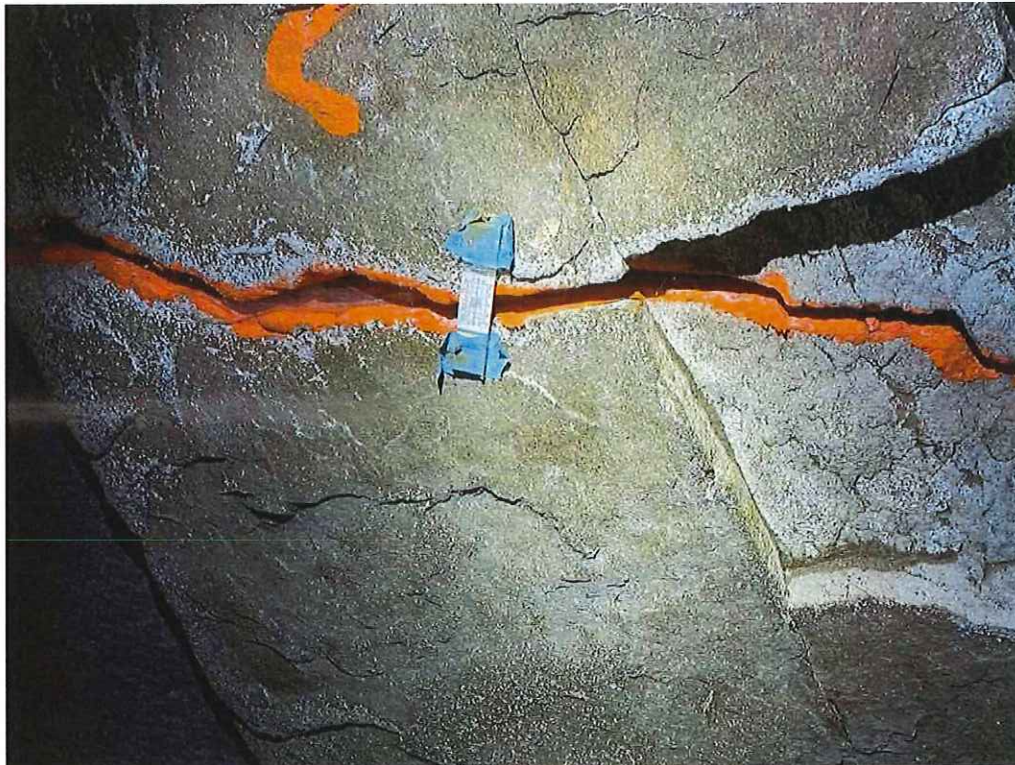
**Photo 20:** Slab 7 near Mid-span: Up to 2" W x FW x FD crack with a 20" L x 13" W x 2" D spall.

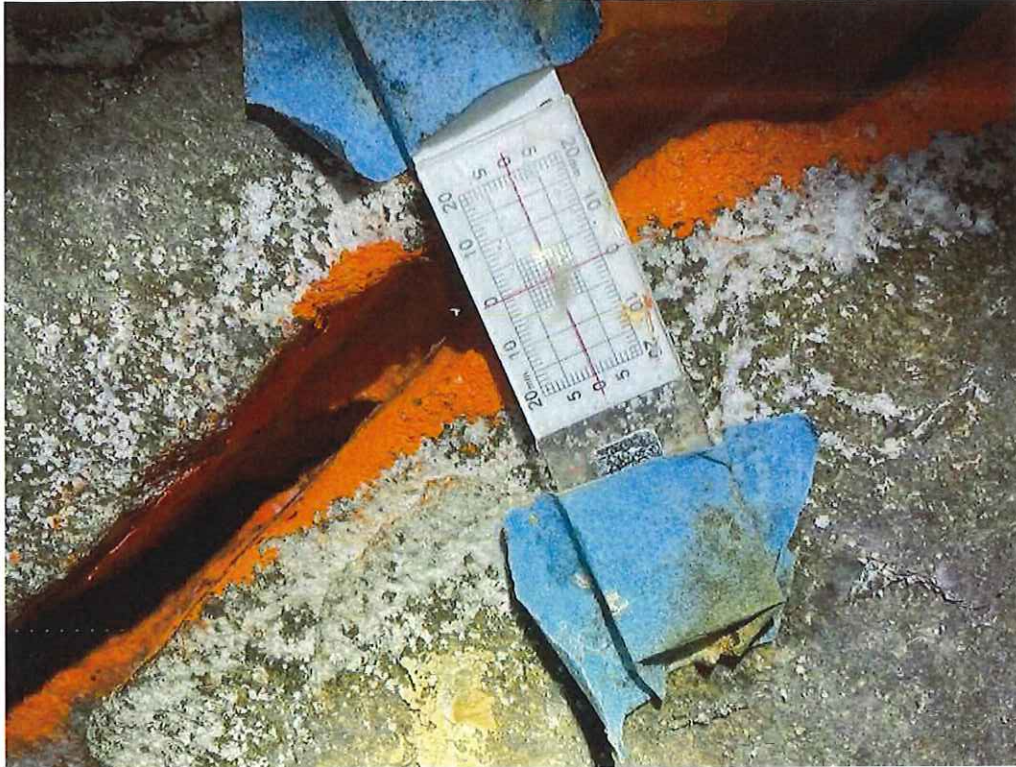
**Photo 21:** Slab 7 near Mid-span: Crack gauge shows minor movement ( $< 1$  mm in longitudinal direction only). No change since previous inspection.

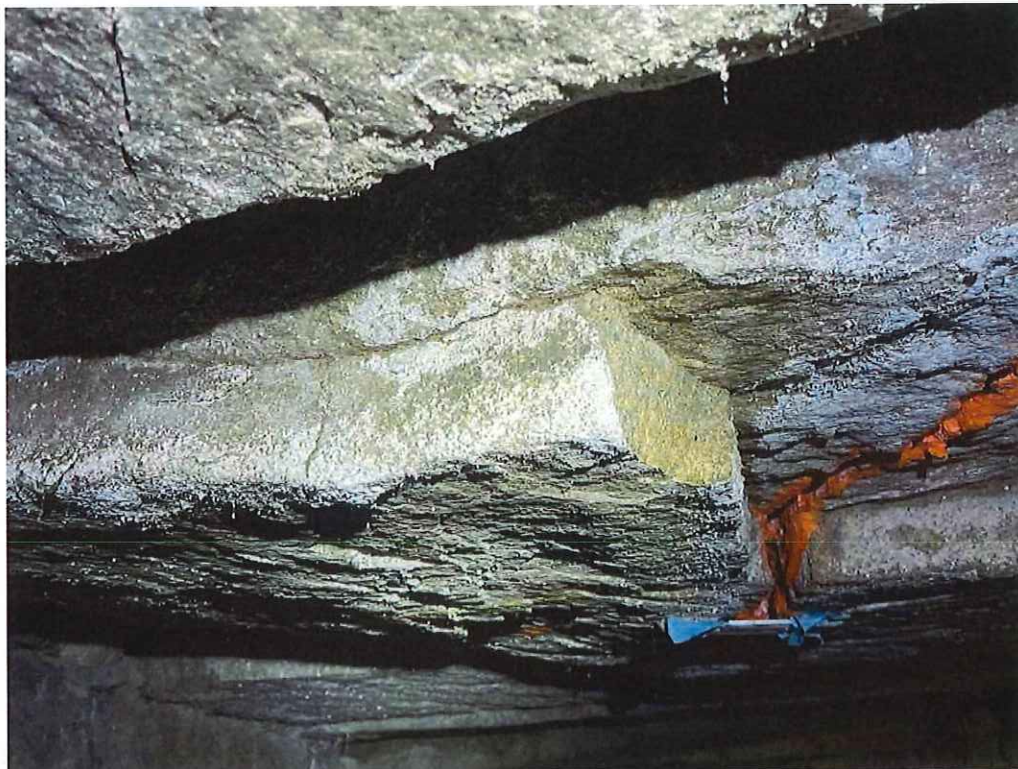
**Photo 22:** Slab 7 near Mid-span at the south edge: 20" long x 13" wide x 2" deep.

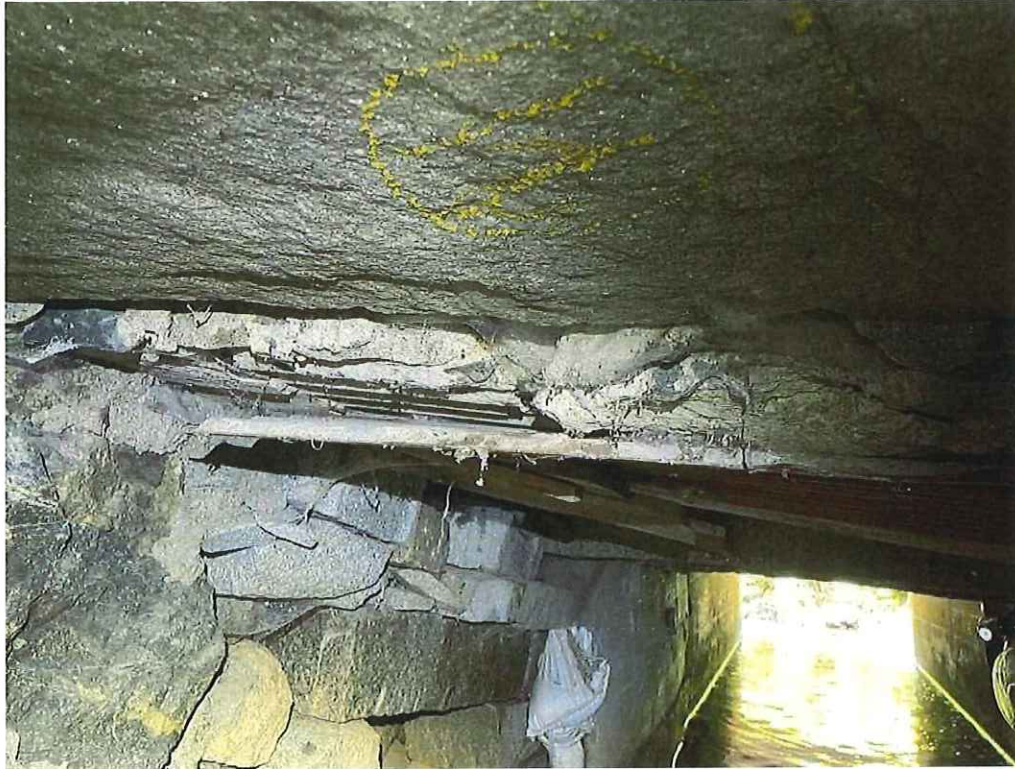
**Photo 23:** Concrete slab at the south edge: Two (2) up to 2'-6" L x 6" W x up to 9" D spalls with exposed rebar.

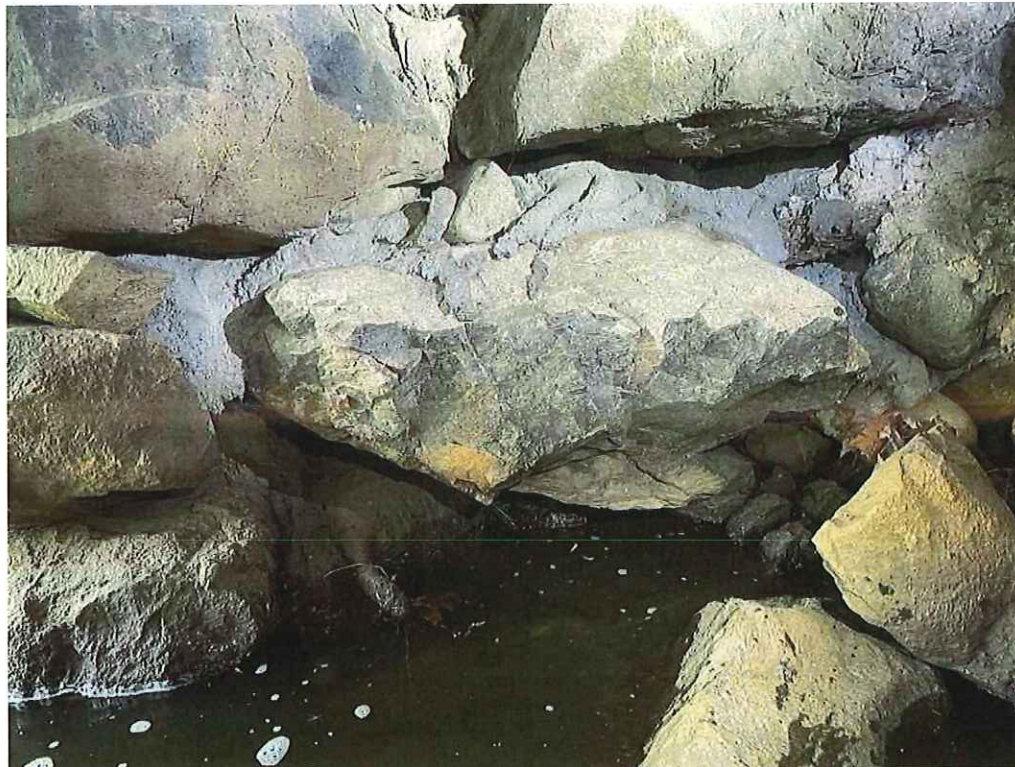
**Photo 24:** West Abutment below Slab 2: 3'-4" long x 20" high x 2'-0" deep void with shifted stones.

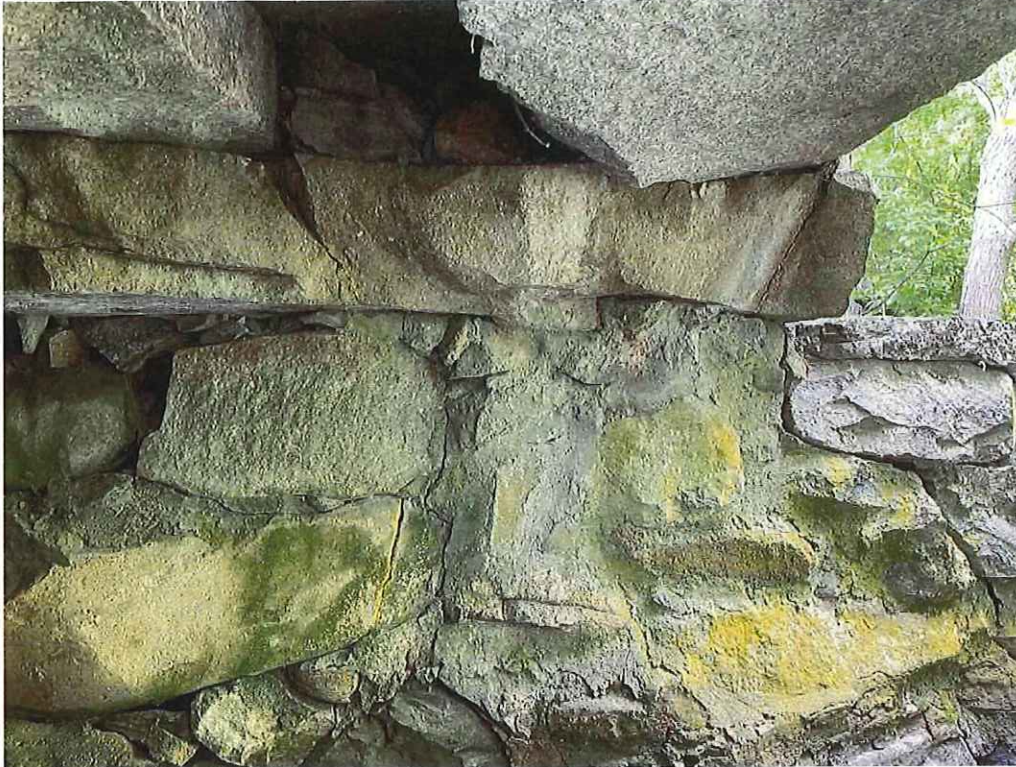
**Photo 25: East Abutment below the south edge of Slab 1: Multiple stones with vertical cracks.**
