## STRUCTURES INSPECTION FIELD REPORT

## SPECIAL MEMBER INSPECTION

B-07-015=W-04-039

Structure B-07-015=W-04-039 (7VB) carries ST 60 Trapelo Road over Beaver Brook along the border line between the Town of Belmont and the City of Waltham. The approaches are west and east and the elevations are south and north. Beaver Brook flows from north to south.

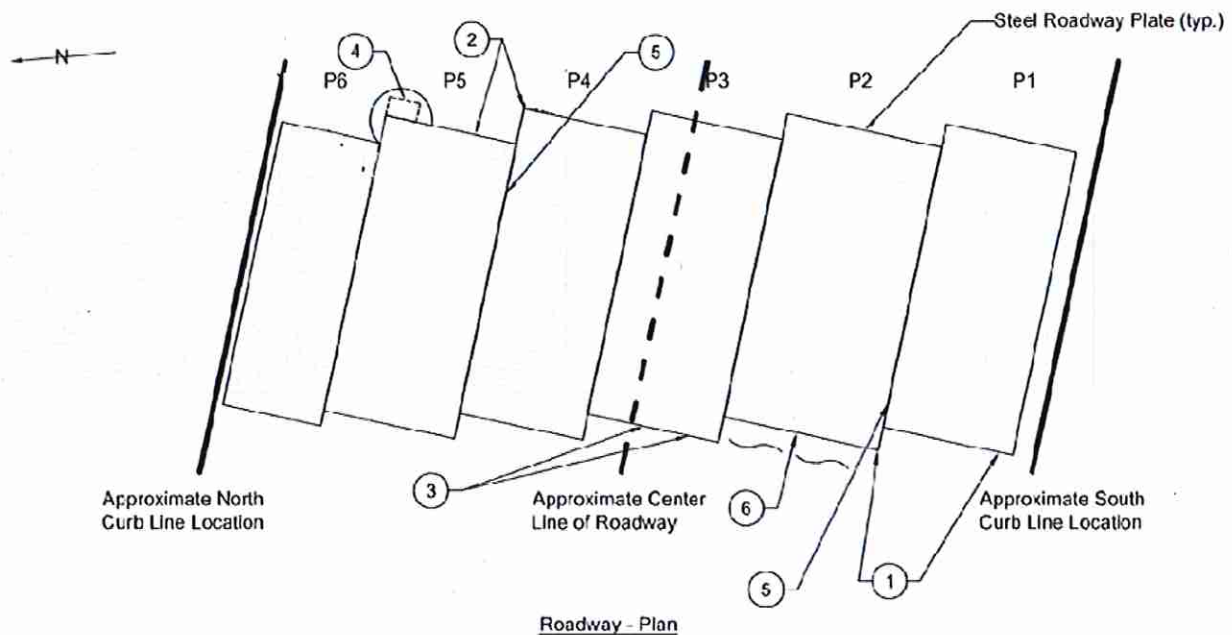
**Sketch 1: Roadway Plate Conditions**

The roadway plates are designated as P1 through P6 from south to north. **See Sketch 1.**

There are isolated fully broken tack welds between roadway plates. The plates with broken tack welds typically deflect under live load.

There is typically minor scrapes and gouges on the leading edge of the roadway plates.

There are isolated transverse hairline cracks in the approaches adjacent to the plates.

1. Southwest corner deflects under live load
2. Northeast corner deflects under live load
3. Minor spalls adjacent to roadway plate
4. 2'-0" W x 7" L depressed bituminous patch with radial cracks  $\frac{1}{8}$ " W
5. Full length broken tack weld (typ. 5' L)
6. Minor scrapes and gouges (typ.)

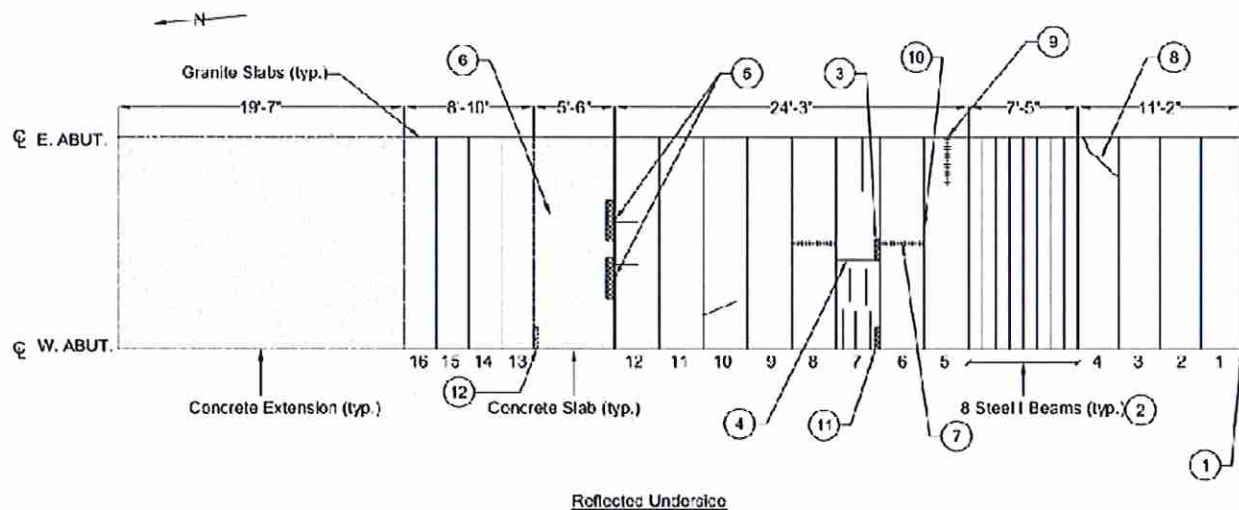
**Sketch 2: Superstructure Conditions**

There are isolated longitudinal and diagonal hairline cracks, some with efflorescence near the abutments. There are several up to full width transverse hairline cracks, some with efflorescence near mid-span. **See Sketch 2.**

The southwest corner of Slab 1 is unsupported for 6".

Slab 7 near mid-span has an up to 2" wide x full depth transverse crack, with a 20" long x 13" wide x 2" deep spall at the south edge.

1. Granite Slab end unsupported at the SW corner for 6"
2. See Sketch 3: Steel Beam Conditions
3. Granite Slab with a 20" L x 13" W x 2" D spall
4. Granite slab with up to 2" W x full depth crack. Crack gauge reads 0.05mm
5. Two (2) up to 30" L x 6" W x up to 9" D edge spall with exposed rebar
6. 50% of stay in place forms are missing
7. Full width hairline crack with efflorescence. Note: Crack gauge reads 0.00mm
8. 6'-0" L hairline crack
9. 2'-6" L hairline crack with minor efflorescence
10. Loose pointing between the beams
11. 2'-0" L x 5" W x 2" D spall
12. 2'-0" L x 15" W delamination

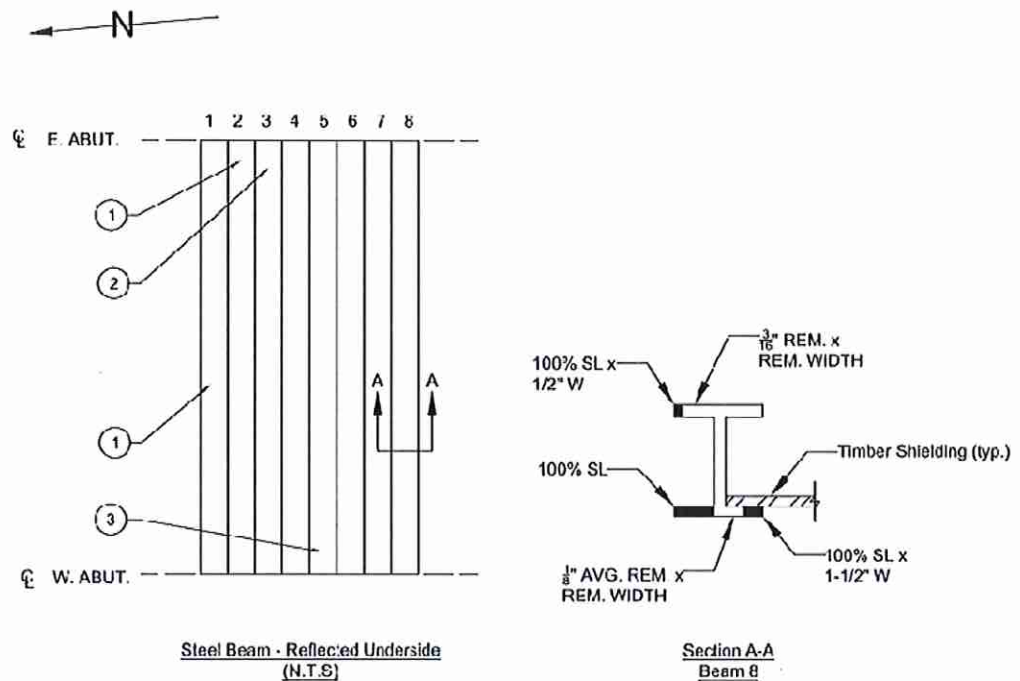
**Sketch 3: Steel Beam Conditions**

There is typically heavy rust and laminated rust throughout the beams. The top and bottom flanges of isolated beams near the abutments and at mid-span have up to 100% section loss x full width. **See Sketch 3 and Photos 6 & 7.**

Interior web and top flange inaccessible due to timber shielding.  
Beams bottom flanges are typically rotated.

1. Bottom Flange: 100% section loss x 1" W at the south leg,  $\frac{3}{16}$ " average remaining x remaining width
2. Bottom Flange: 100% section loss x  $\frac{1}{2}$ " W at legs,  $\frac{1}{8}$ " average remaining x remaining width
3. Bottom Flange: North Flange 2" W cut out at the west end above the drainage pipe. South Flange 100% section loss x  $\frac{1}{2}$ " W

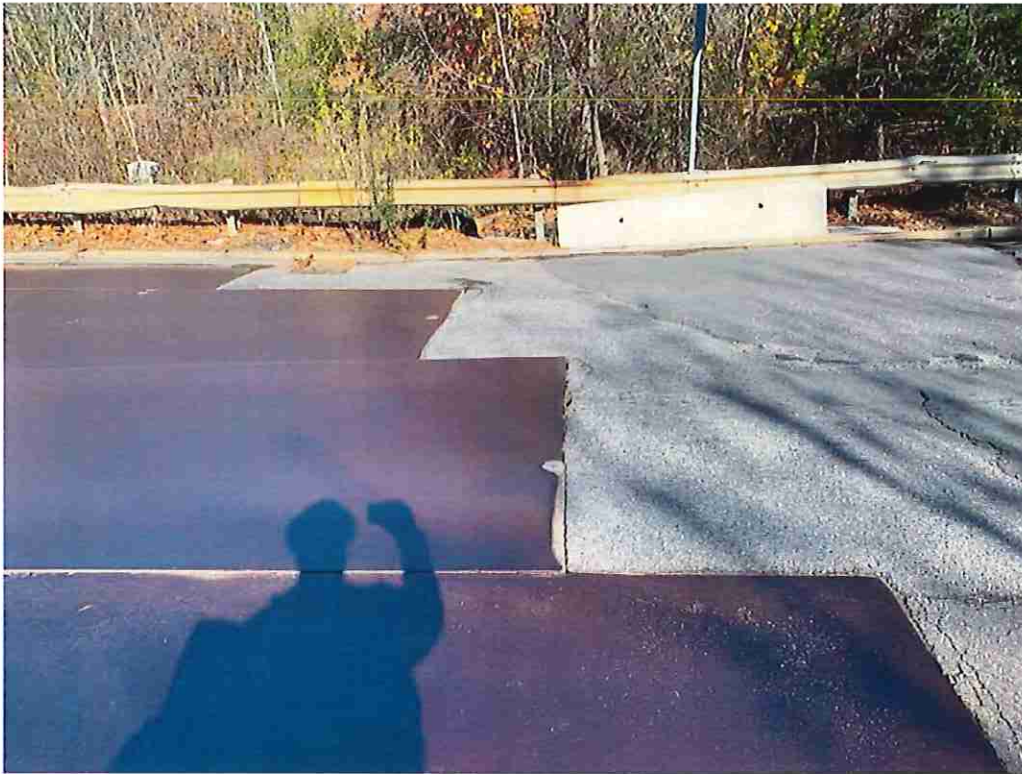
There is a depressed bituminous patch with radial up to 1/8" cracks at the northeast corner of P5. **See Photo 1.**

**Photo 1:** There is a depressed bituminous patch with radial up to 1/8" cracks at the northeast corner of P5.

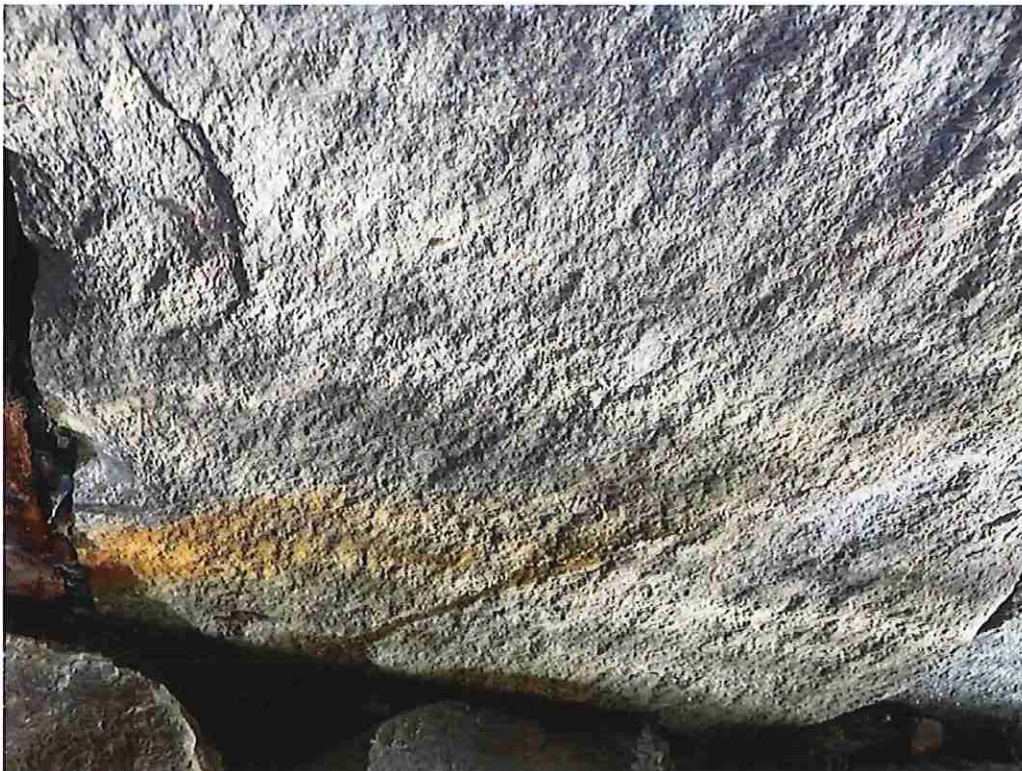
Slab 4 there is a diagonal hairline crack at the east end. **See Photo 2.**

**Photo 2:** Granite Slab 4, there is a diagonal hairline crack at the east end.

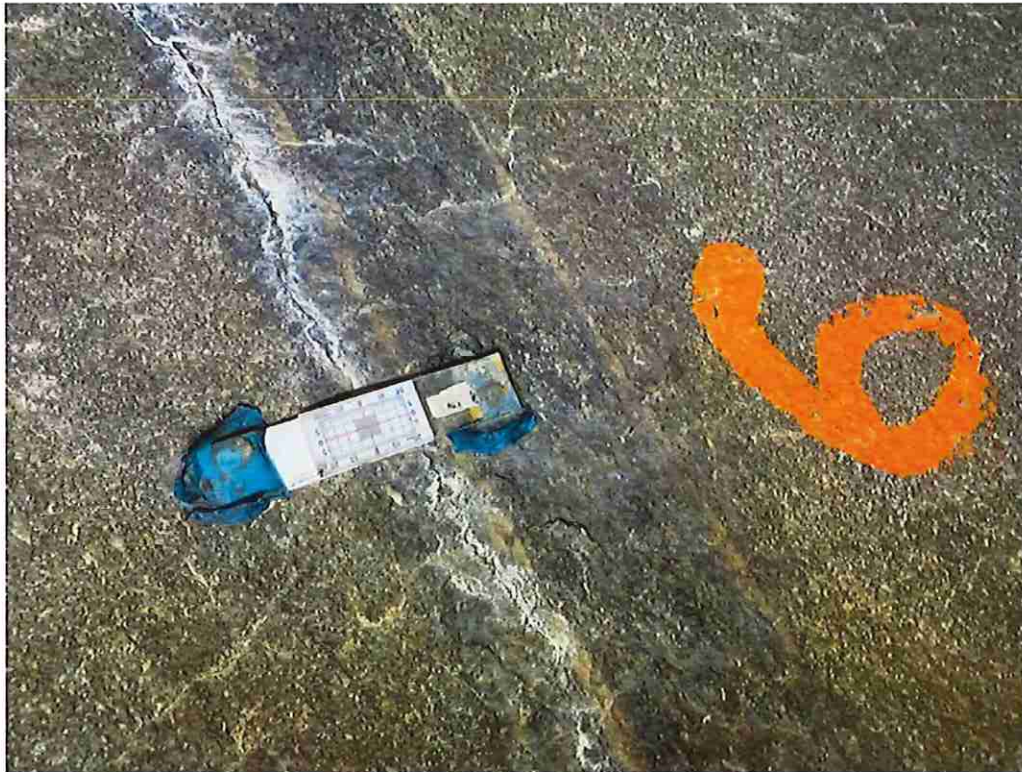
Granite slab 6: Transverse split with previous water leakage noted near midspan.

Slab 6 and 7 are monitored with crack gauges. The crack gauges indicated little to no movement since installation. The crack gauge at Slab 7 read 0.05 mm from zero. **See Photos 3 & 4.**

**Photo 3:** Granite Slab 6 crack gauge installed with little to no movement since installation.

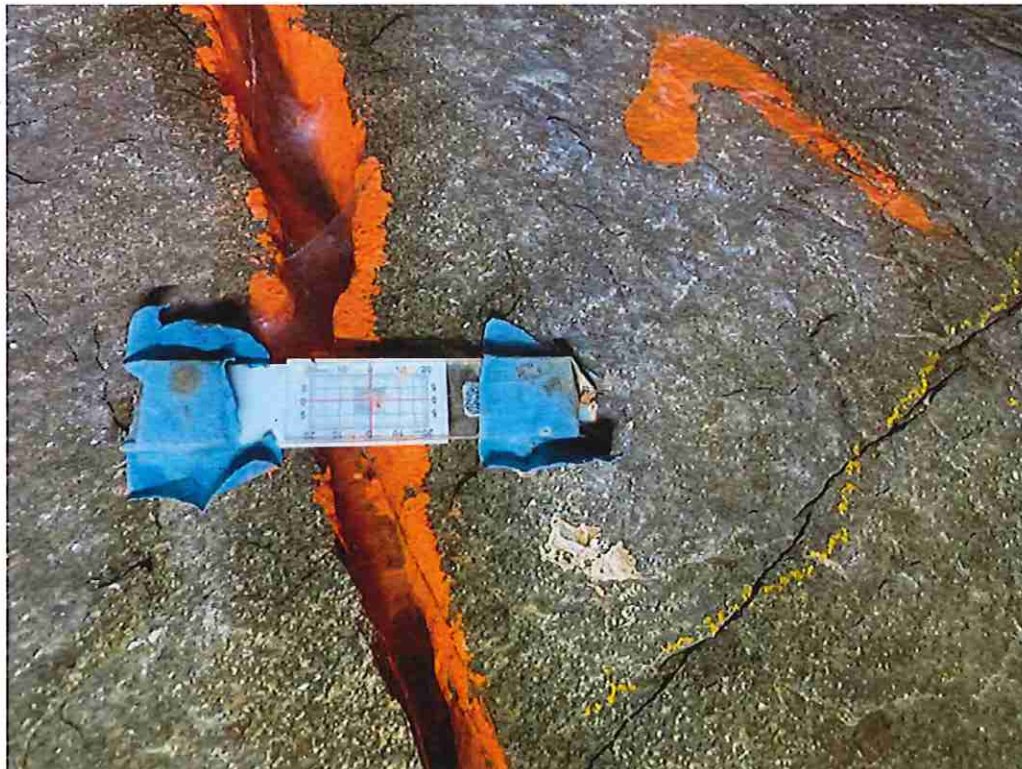
**Photo 4:** Granite Slab 7 crack monitor installed reading 0.05 mm of movement, there has been no change since the previous inspection.

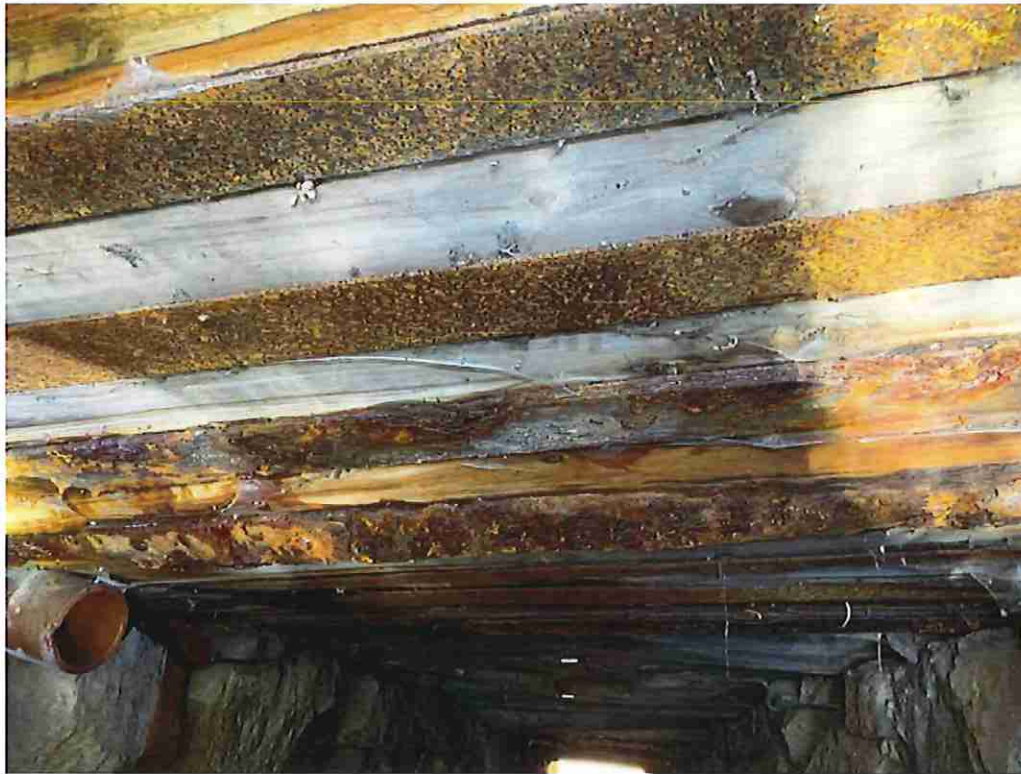
There is timber shielding between the steel I-beams preventing inspection of the web and top flanges. The beams typically exhibit minor rotation about the longitudinal axis, resulting in the bottom flanges no longer being level. **See Photo 5.**

**Photo 5:** The beams typically exhibit minor rotation about the longitudinal axis, resulting in the bottom flanges no longer being level (Note the timber shielding in between beams).

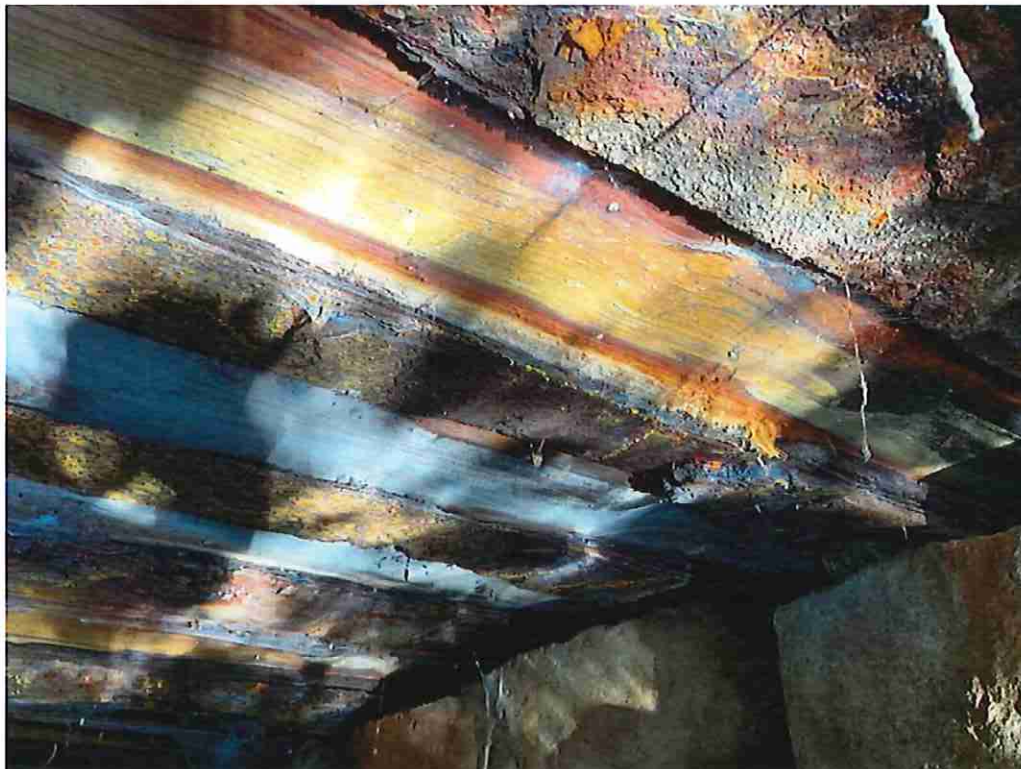
**Photo 6:** Heavy section loss up to 100% at the east end bottom flanges of beams 7-8.

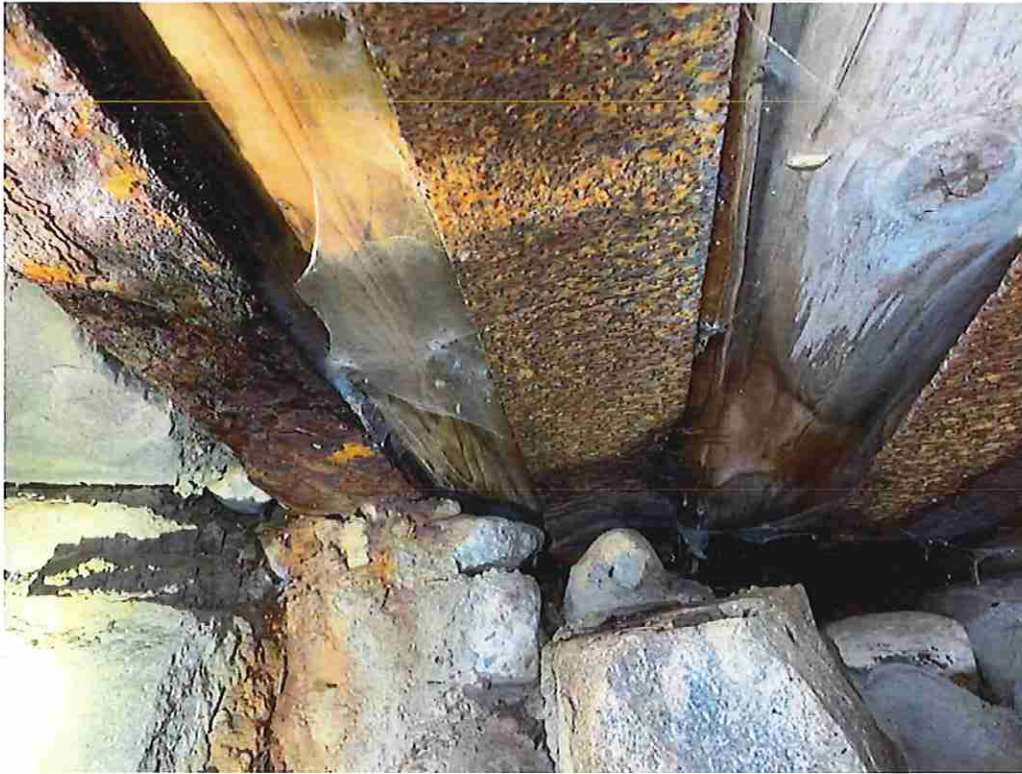
**Photo 7:** Heavy section loss up to 100% at the west end of the bottom flanges of beams 6-8.

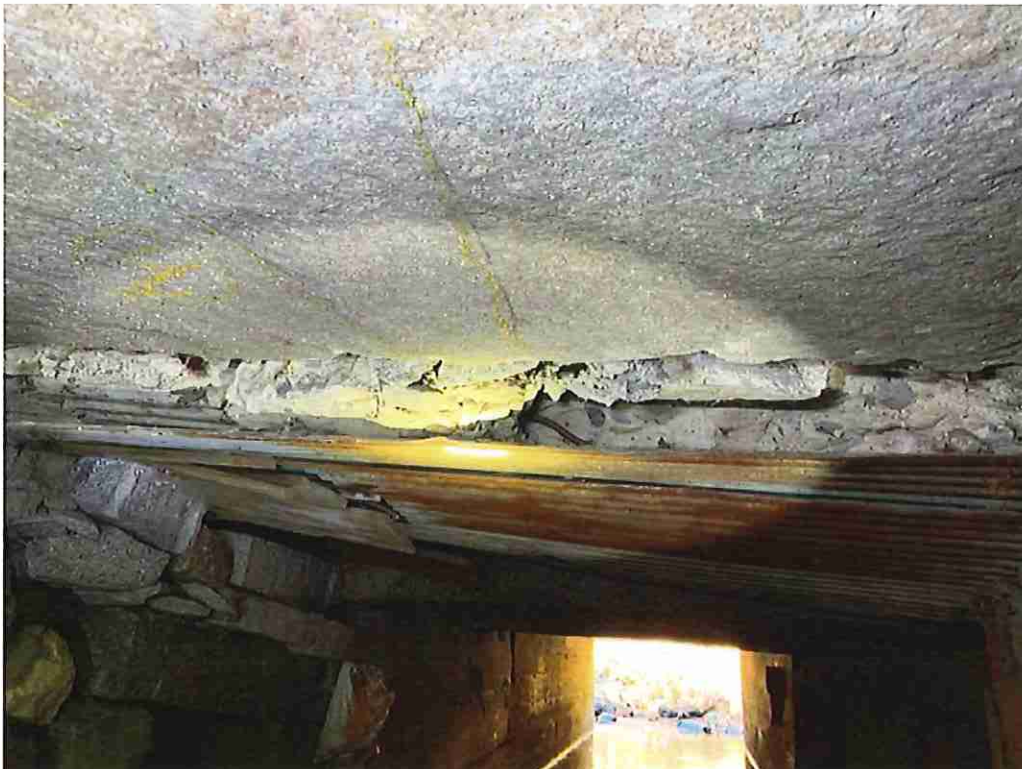
The reinforced concrete slab which acts as part of the superstructure below the westbound roadway is missing 50% of the stay in place forms on the north side of the slab.

There are two spalls with exposed rebar along the south edge measuring up to 2'-6" long x 9" high x 6" wide. There is a 24" long x 16" wide delamination at the northwest corner. **See Photo 8.**

**Photo 8:** Reinforced concrete slab, There are two spalls with exposed rebar along the south edge measuring up to 2'-6" long x 9" high x 6" wide.
