STRUCTURES INSPECTION FIELD REPORT

SPECIAL MEMBER INSPECTION

BR. DEPT. NO.
B-07-015=W-04-039

Structure B-07-015=W-04-039 (7VB) carries ST 60 Trapelo Road over Beaver Brook along the border line between the Town of Belmont and the City of Waltham. The approaches are west and east and the elevations are south and north. Beaver Brook flows from north to south.

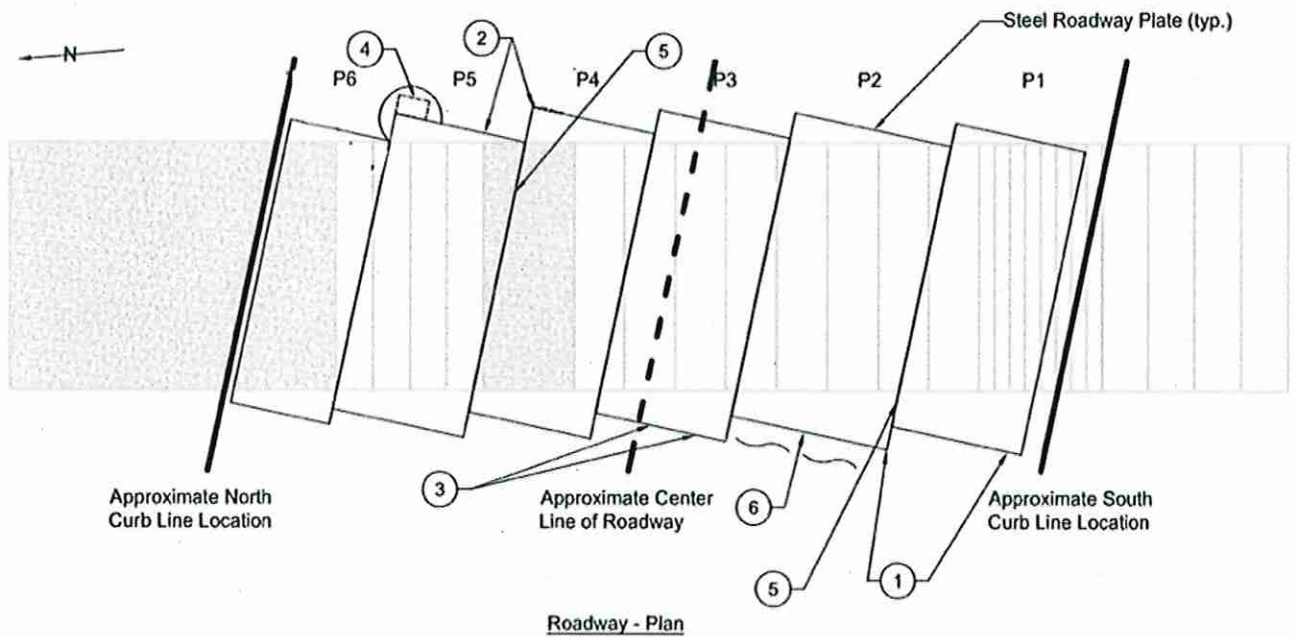
Sketch 1: Roadway Plate Conditions

The roadway plates are designated as P1 through P6 from south to north (**see sketch 1**).

There is a depressed bituminous patch with radial cracks, up to 1/8", at the northeast corner of P5.

1. Southwest corner deflects under live load
2. Northeast corner deflects under live load
3. Minor spalls adjacent to roadway plate
4. 2'-0" W x 7" L depressed bituminous patch with radial cracks $\frac{1}{8}$ " W
5. Full length broken tack weld (typ. 5" L)
6. Minor scrapes and gouges (typ.)

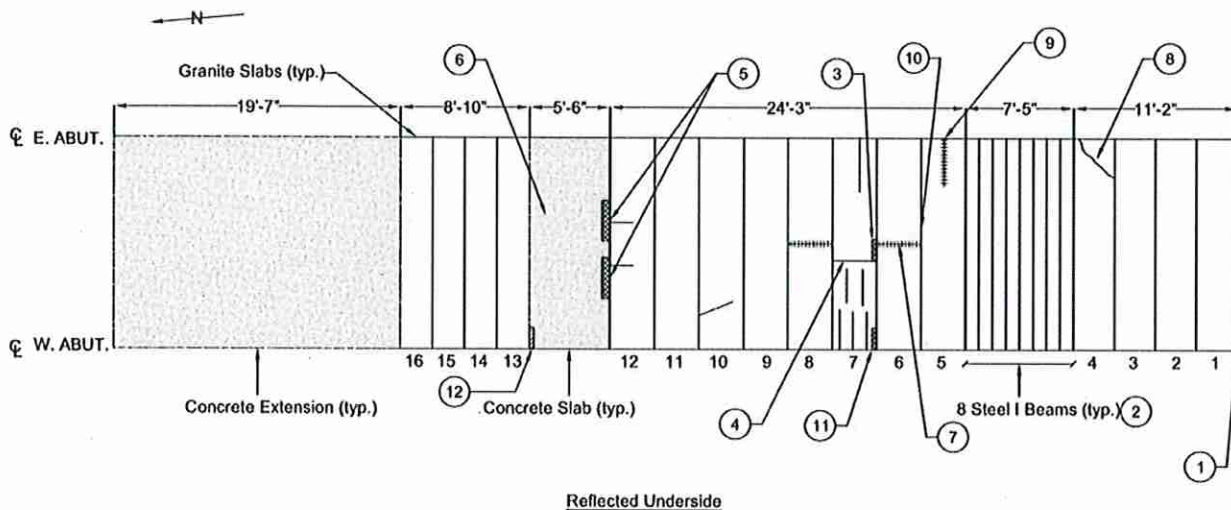
Sketch 2: Superstructure Conditions

There are isolated longitudinal and diagonal hairline cracks, some with efflorescence near the abutments. There are several up to full width transverse hairline cracks, some with efflorescence near mid-span (**see sketch 2**).

The southwest corner of Slab 1 is unsupported for 6".

1. Granite Slab end unsupported at the SW corner for 6"
2. See Sketch 3: Steel Beam Conditions
3. Granite Slab with a 20" L x 13" W x 2" D spall
4. Granite slab with up to 2" W x full depth crack. Crack gauge reads 0.05mm
5. Two (2) up to 30" L x 6" W x up to 9" D edge spall with exposed rebar
6. 50% of stay in place forms are missing
7. Full width hairline crack with efflorescence. Note: Crack gauge reads 0.00mm
8. 6'-0" L hairline crack
9. 2'-6" L hairline crack with minor efflorescence
10. Loose pointing between the beams
11. 2'-0" L x 5" W x 2" D spall
12. 2'-0" L x 16" W delamination

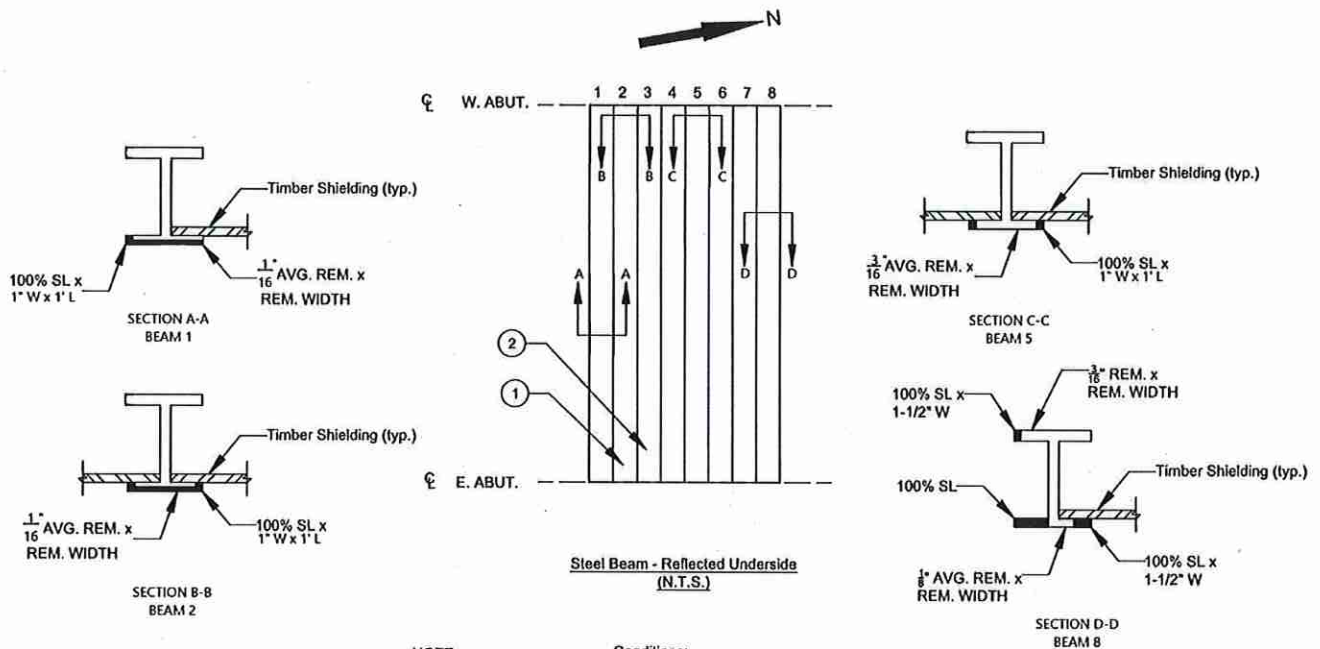
Sketch 3: Steel Beam Conditions

NOTE:
Interior web and top flange inaccessible due to timber shielding. Beams bottom flanges are typically rotated.

1. Bottom Flange: 100% section loss x 1" W at the south toes, 3/16" average remaining x remaining width
2. Bottom Flange: 100% section loss x 1/2" W at both toes, 1/8" average remaining x remaining width

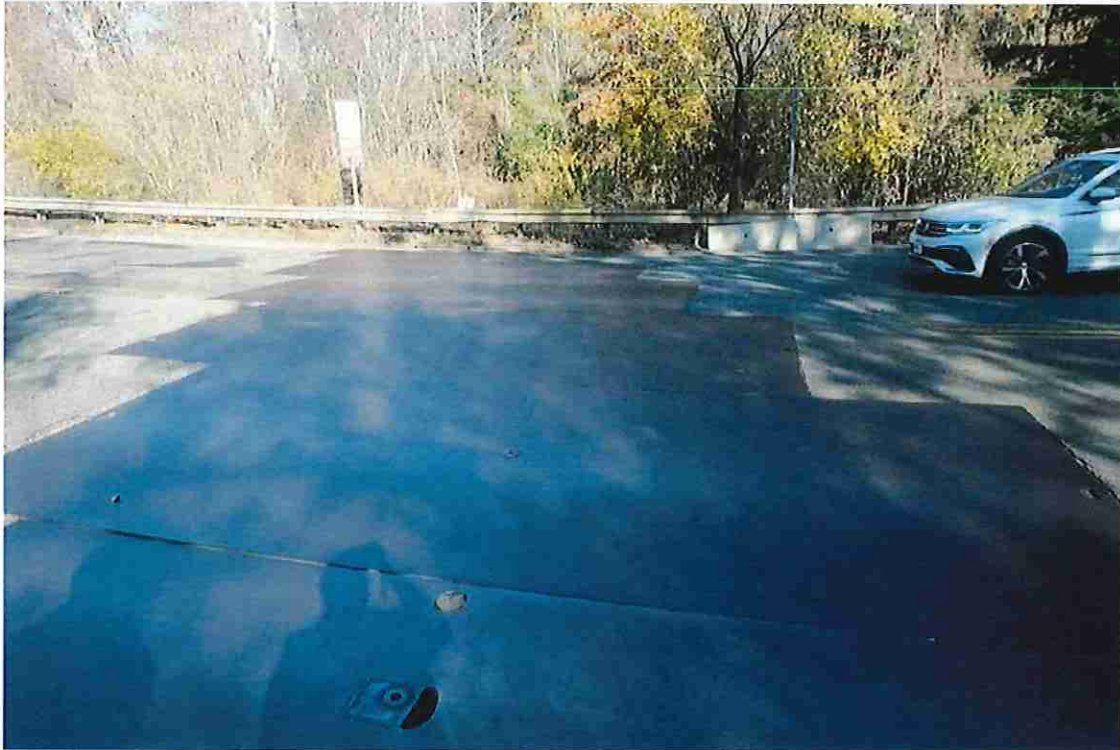
There are isolated fully broken tack welds between roadway plates. The plates with broken tack welds typically deflect under live load (**see photo 1**).

Photo 1: Typical condition of the steel plates. Note the height difference between P1 & P2 due to broken welds.

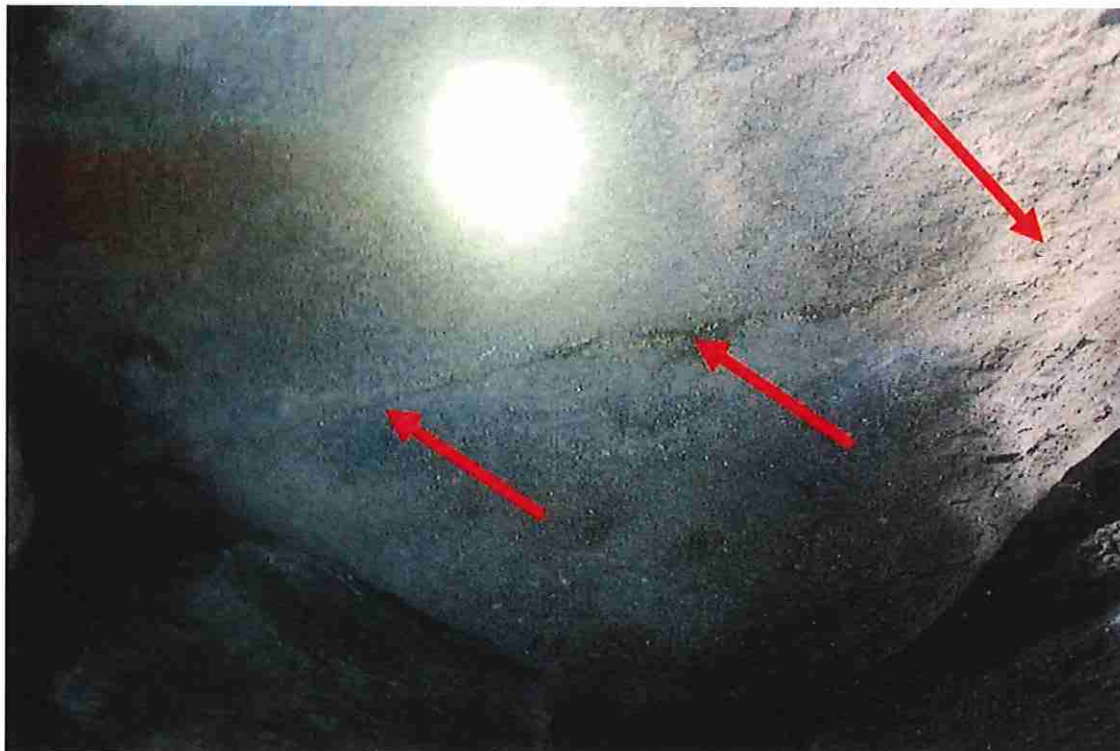
Slab 4: Diagonal hairline crack at the east end (**see photo 2**).

Photo 2: Granite Slab 4, there is a diagonal hairline crack at the east end.

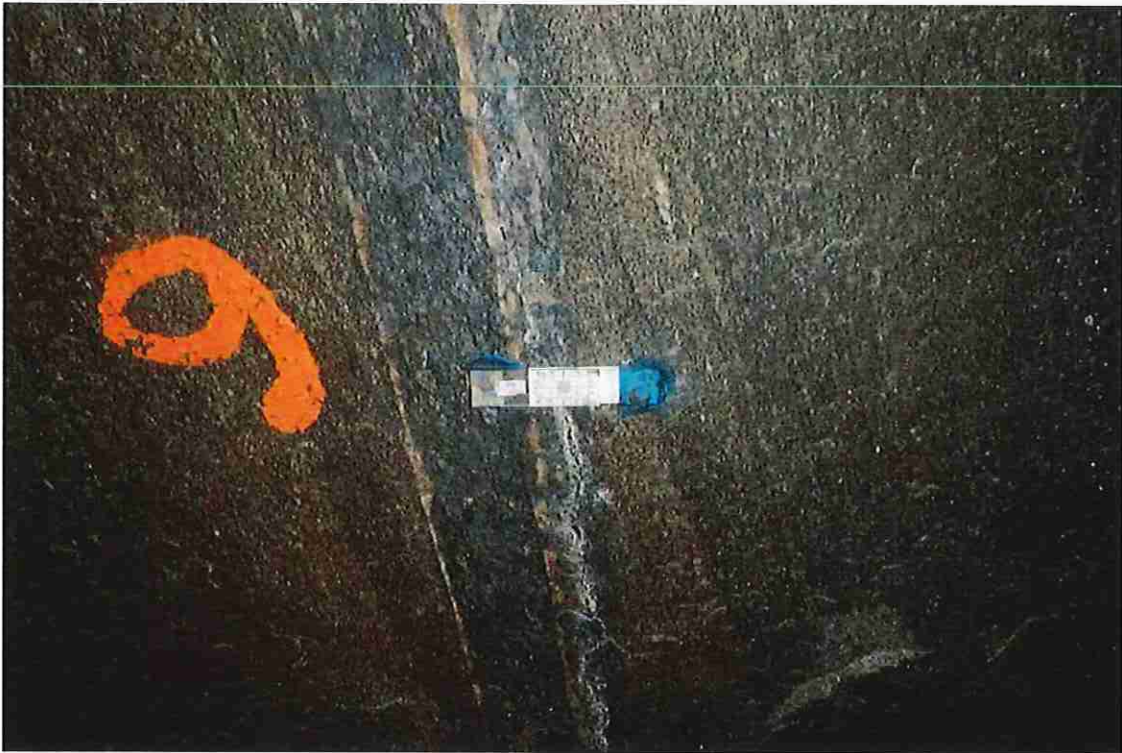
Slab 6; Transverse split with previous water leakage noted near midspan (**see photo 3**).

Photo 3: Granite Slab 6 - Split at mid-span.

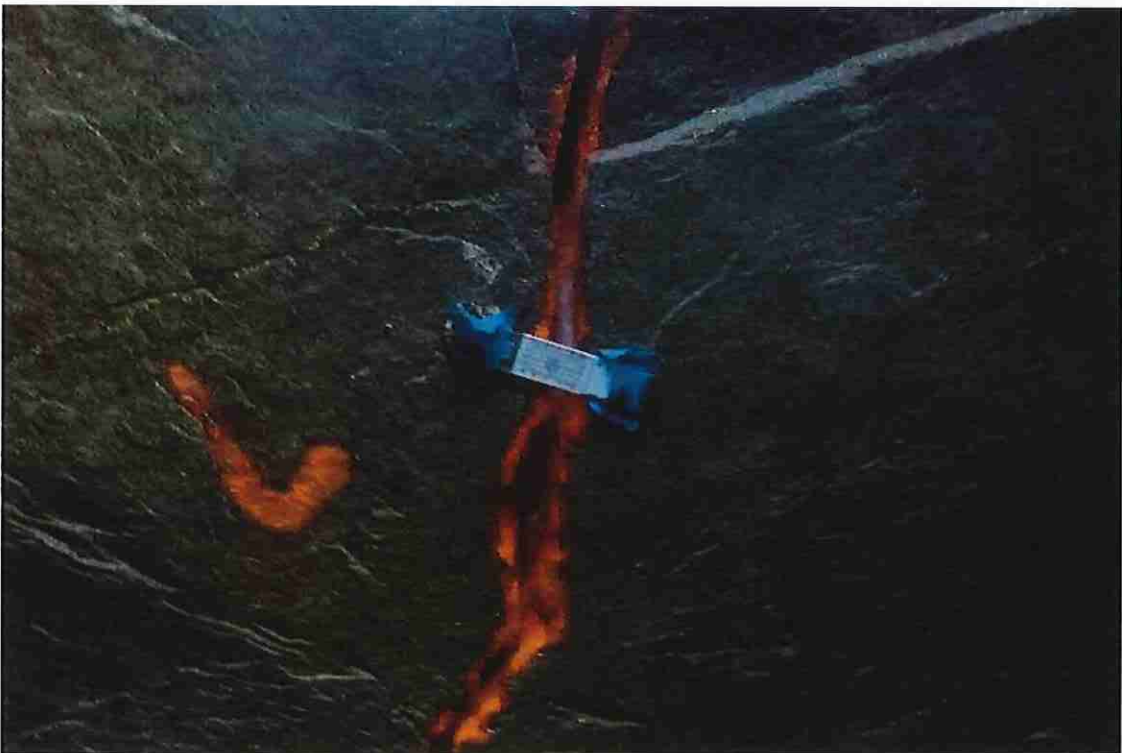
Slab 7; Transverse split near mid-span, up to 2" wide x full depth, with a 20" long x 13" wide x 2" deep spall at the south edge (**see photo 4**).

Photo 4: Granite Slab 7 - Split at mid-span.

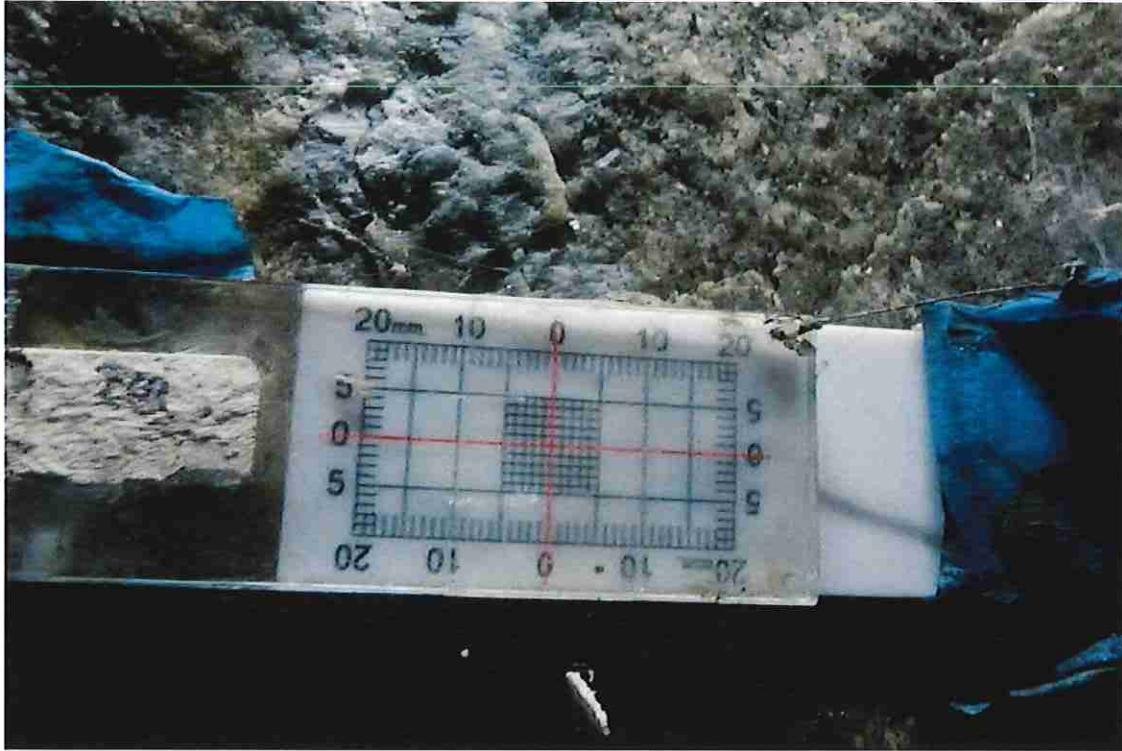
Slabs 6 & 7 are monitored with crack gauges. The crack gauges indicated little to no movement since installation. The crack gauge at Slab 7 read 0.5 mm from zero (**see photos 5 & 6**).

Photo 5: Granite Slab 6 - Split crack gauge.

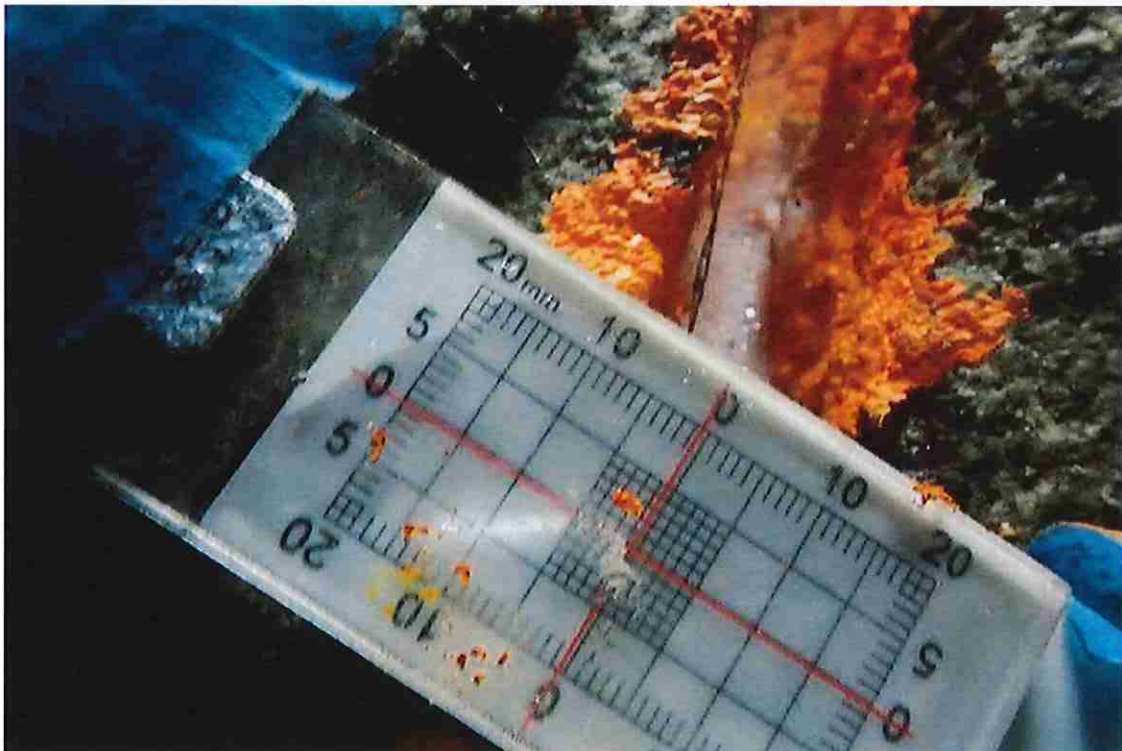
Photo 6: Granite Slab 7 - Split crack gauge.

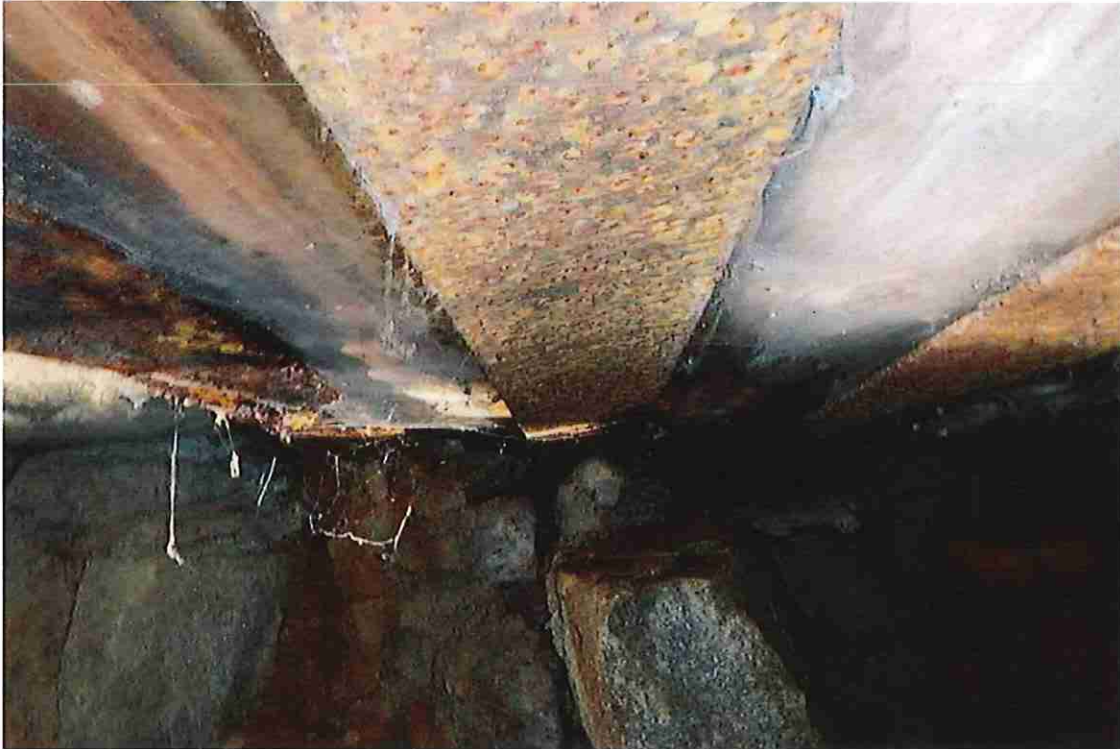
There is timber shielding between the steel I-beams preventing inspection of the web and top flanges. The beams typically exhibit minor rotation about the longitudinal axis, resulting in the bottom flanges no longer being level (**see photo 7**).

Photo 7: The beams typically exhibit minor rotation about the longitudinal axis, resulting in the bottom flanges no longer being level. Beams 1 - 3 shown. Note the timber shielding in between beams.

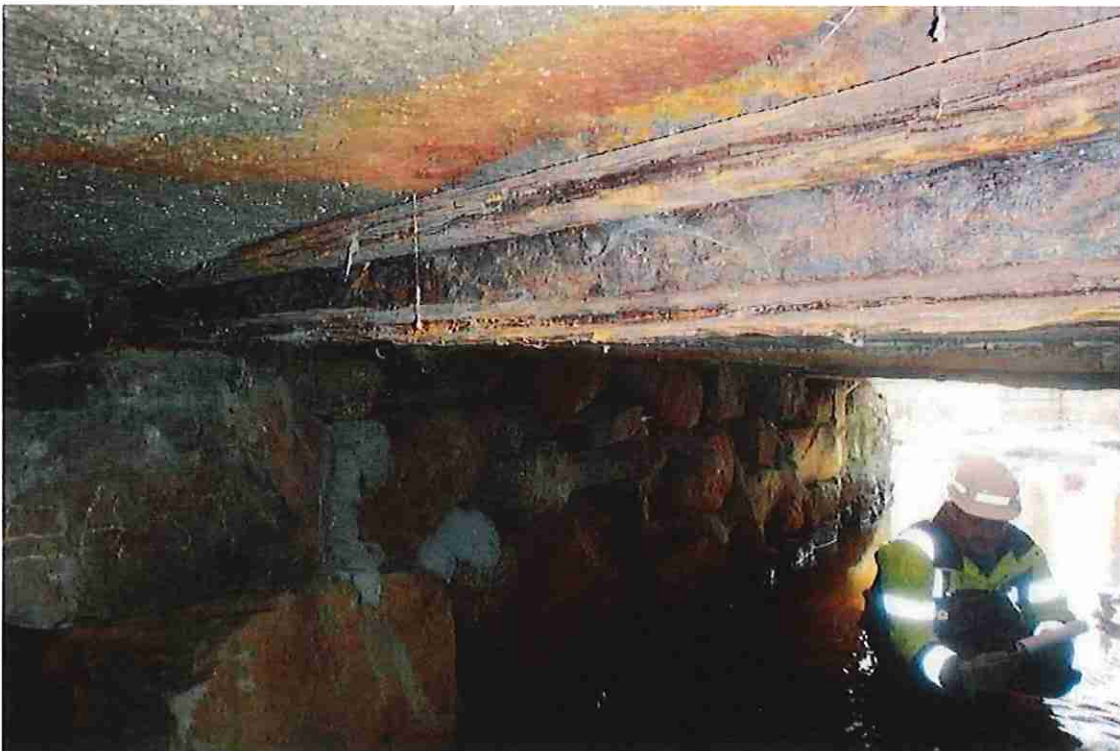
There is typically heavy rust and laminated rust throughout the beams with many having up to 1/4" remaining and down to 1/16" remaining. The top and bottom flanges of isolated beams near the abutments and at mid-span have up to 100% section loss x full width (**see sketch 3 and photos 8 & 9**).

Photo 8: Typical heavy section loss and lamintination to the steel at the east end bottom flanges Northern side of Beam 8 shown.

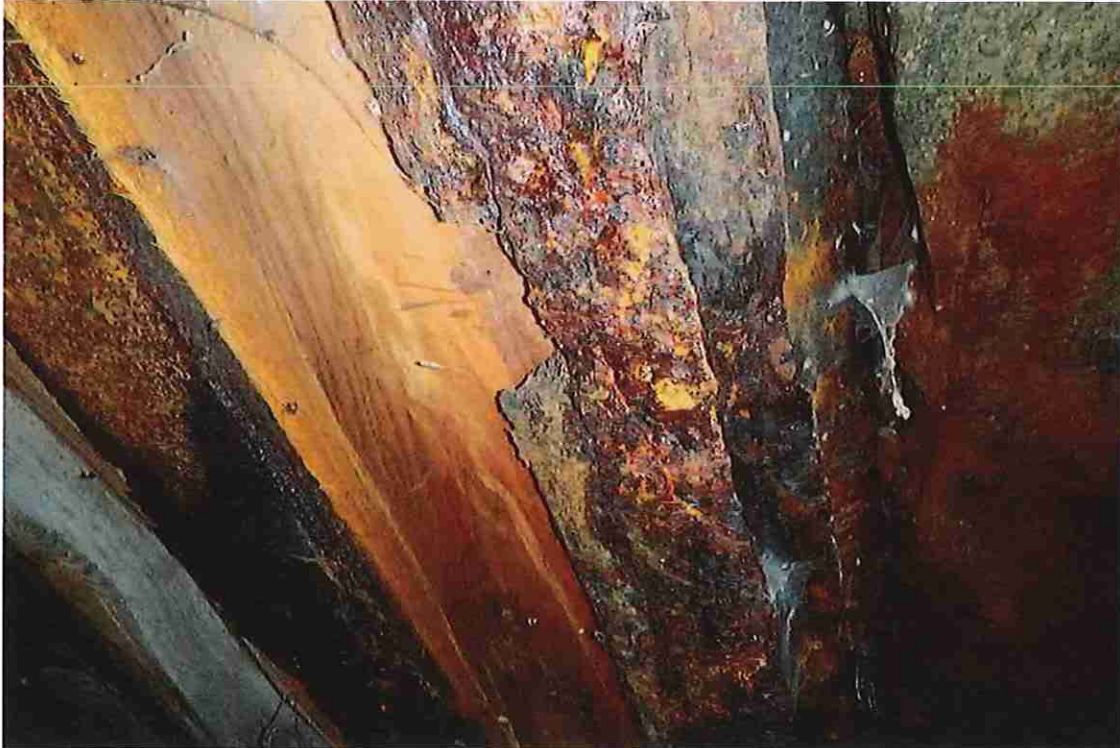
Photo 9: Heavy section loss up to 100% at the west end bottom flanges of Beams 7 (left) & Beam 8 (right).
