2-DIST  
04

B.I.N.  
7VB

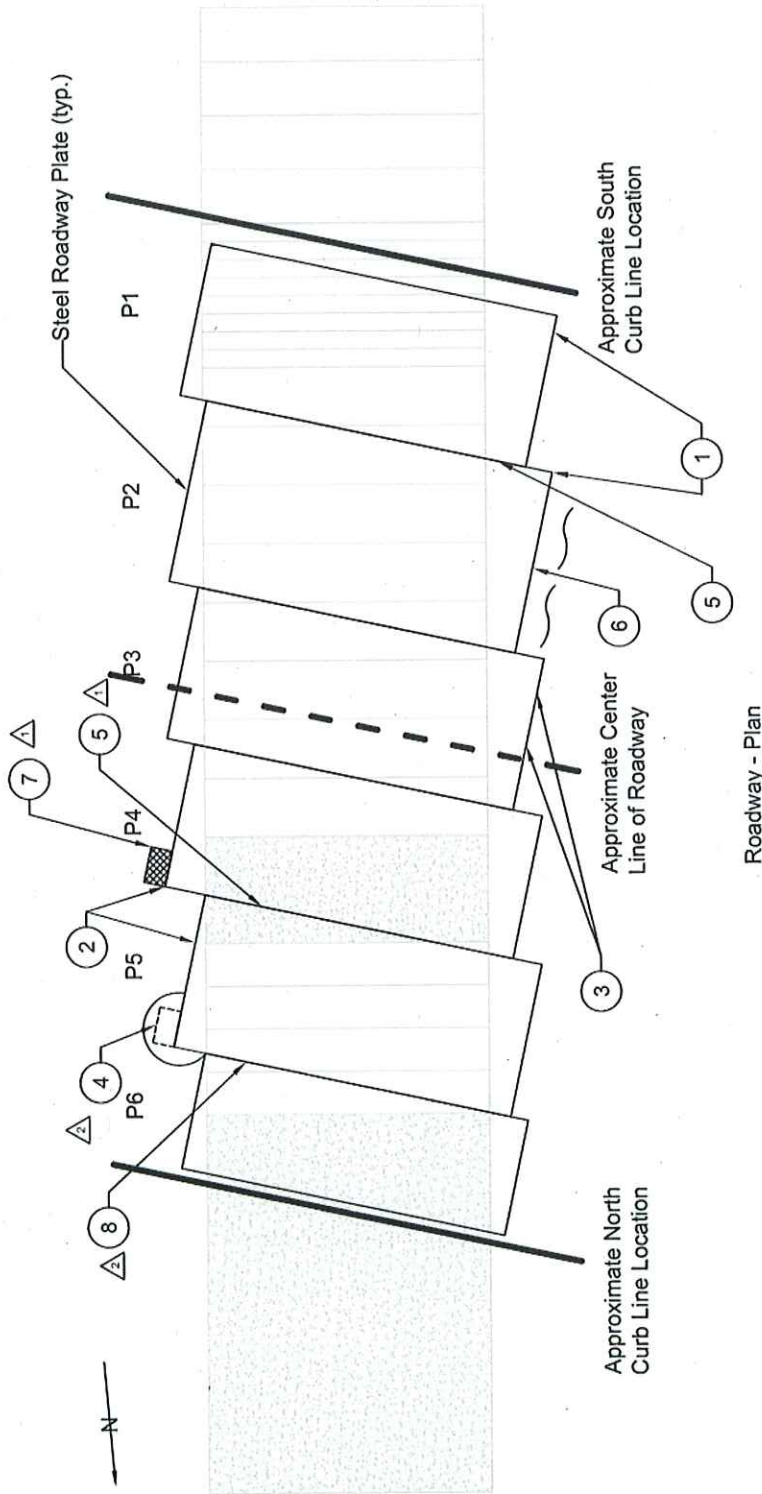
Sketch 1: Roadway Plate Conditions

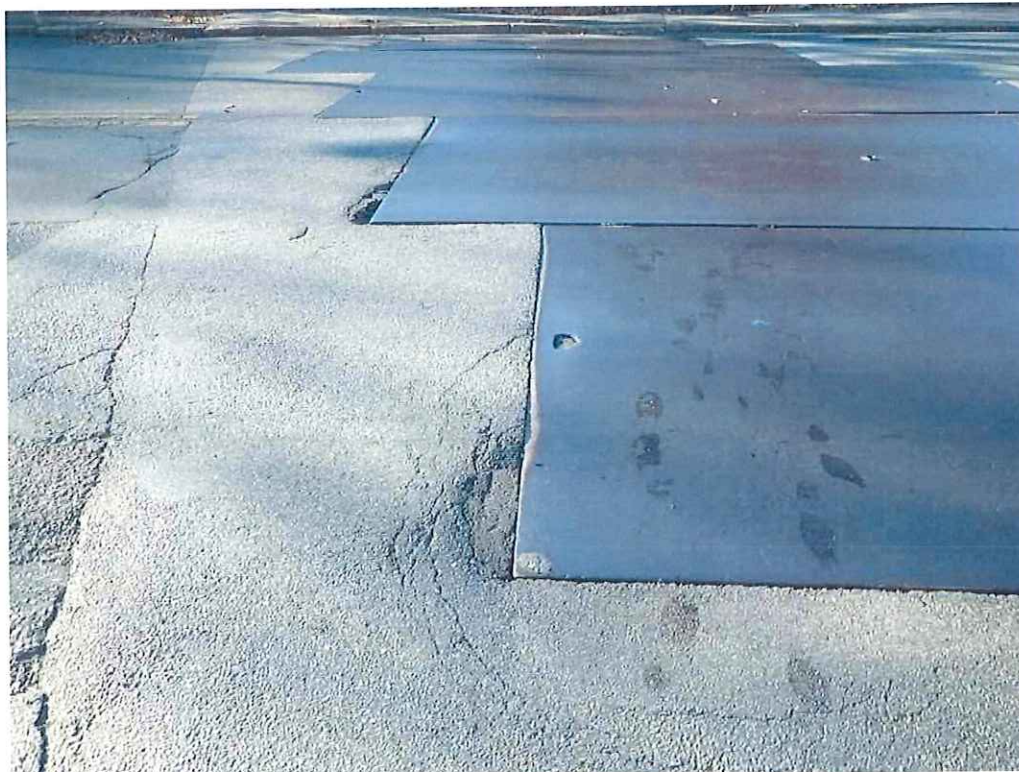
Photo 14: Steel Plate 4 and 5 at the northeast corner have 2'-4" W x 7" L x 2" D spall and 2'-0" W x 7" L patch with radial cracking, respectively.

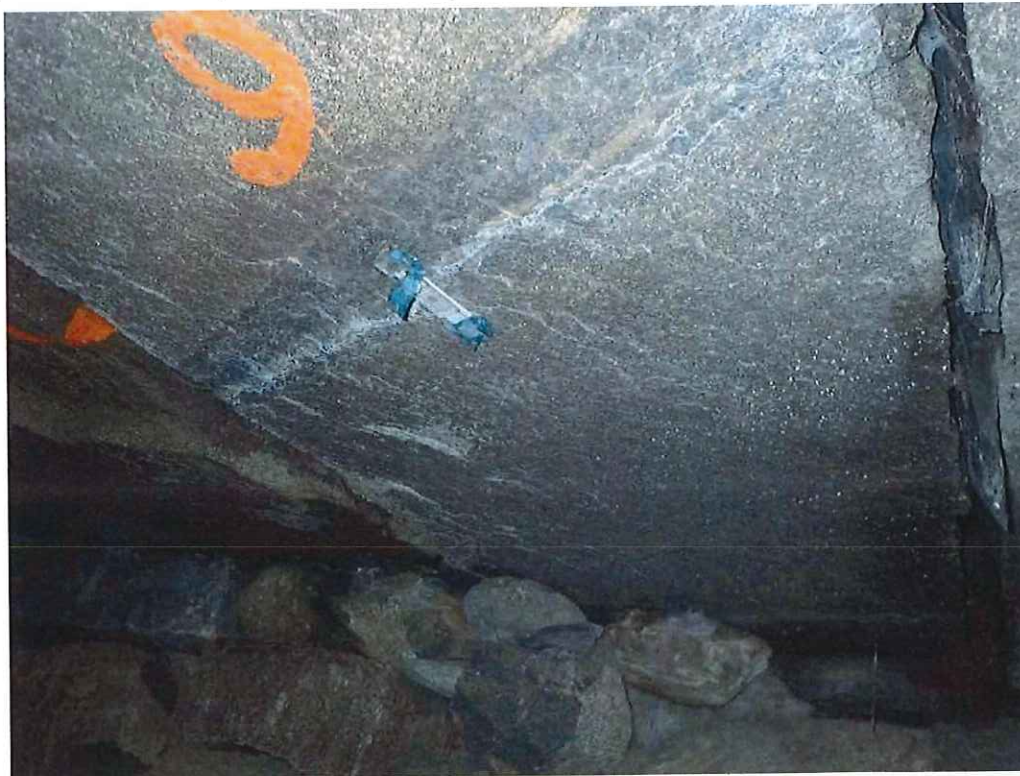
**Photo 16:** Slab 6 underside near Mid-span: Transverse hairline crack with efflorescence. Note: Crack Gauge.

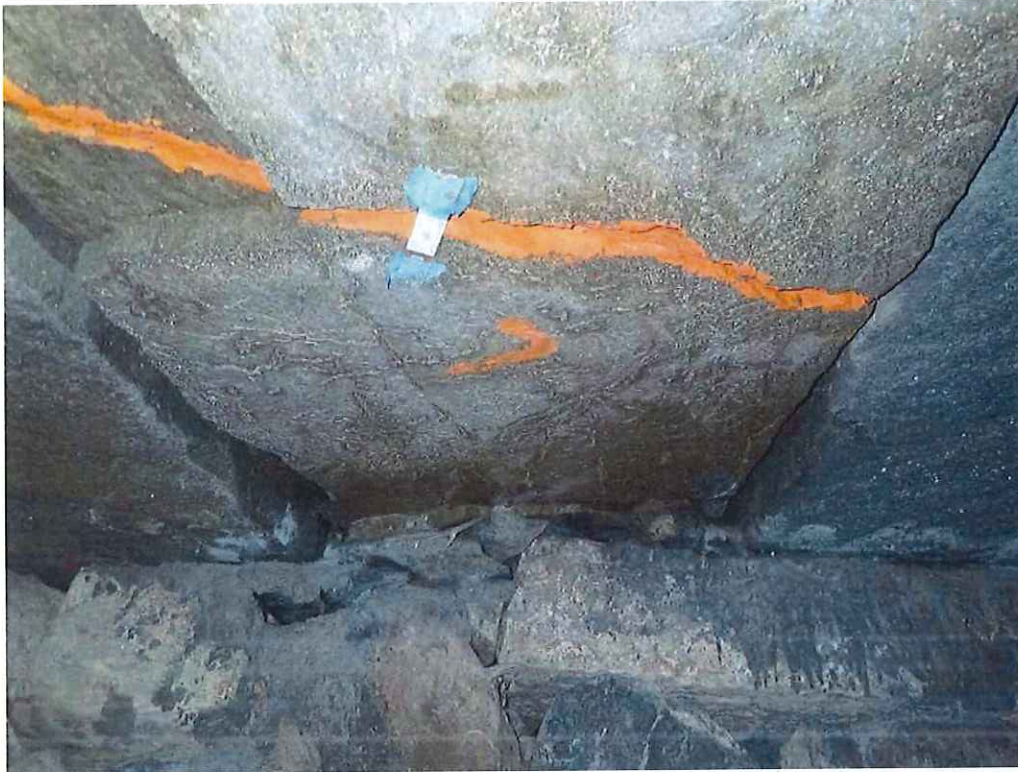
**Photo 17:** Slab 7 near Mid-span: Up to 2" W x FW x FD crack with a 20" L x 13" W x 2" D spall. Note: Crack gauge.

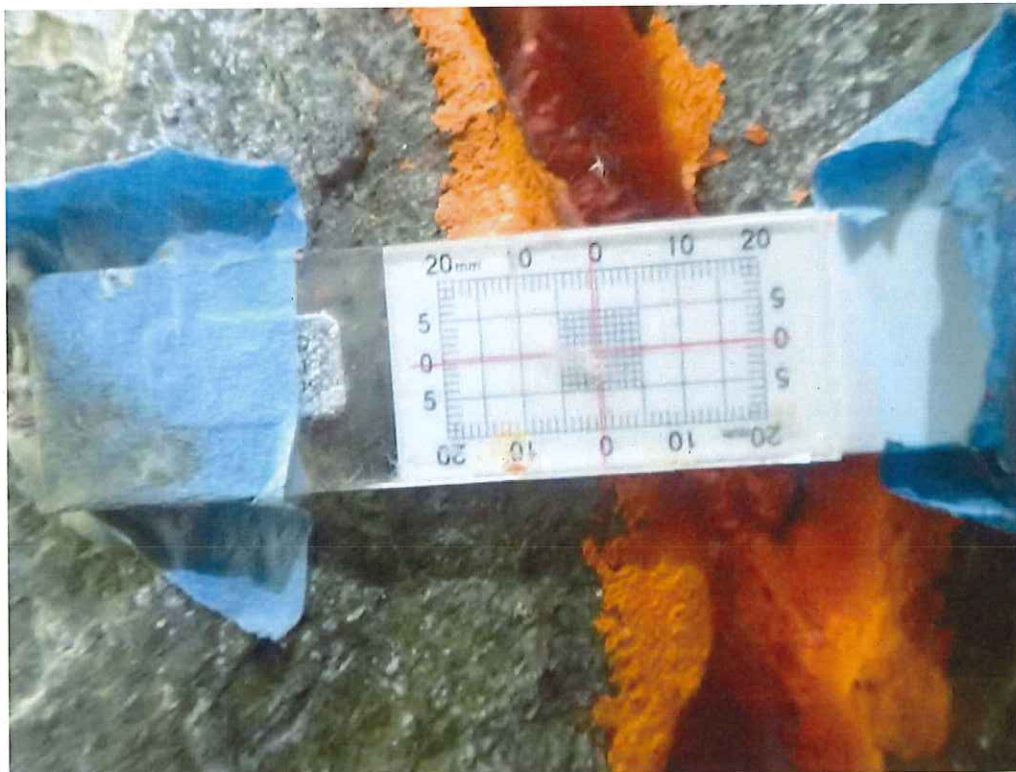
**Photo 18:** Slab 7 near Mid-span: Crack gauge shows minor movement (< 1 mm in both directions).

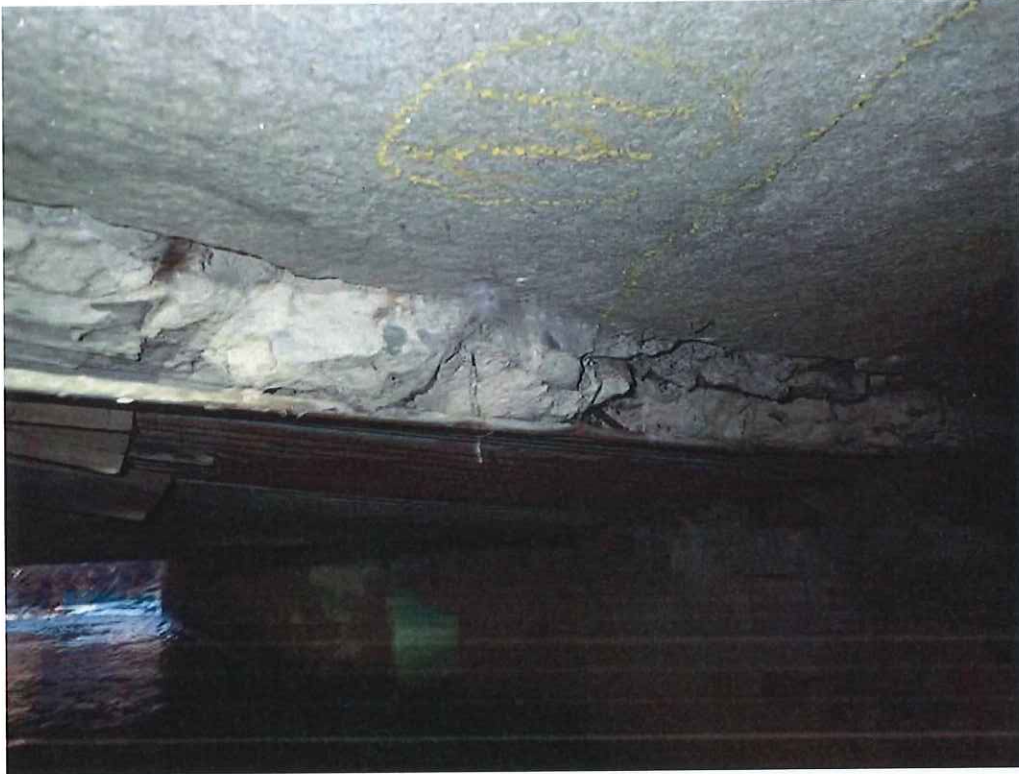
**Photo 21:** Concrete slab at the south edge: Two (2) up to 2'-6" L x 6" W x up to 9" D edge spalls with exposed rebar.

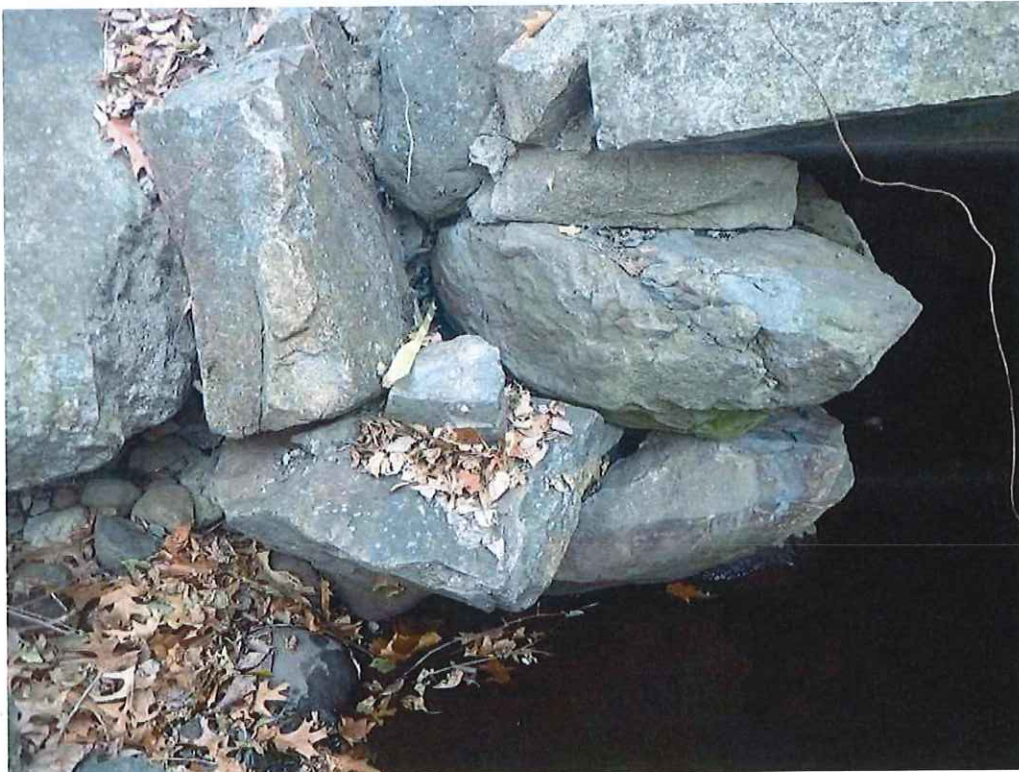
**Photo 22:** South face of West Abutment: 2'-0" L x 18" H x 14" D void with shifted stones

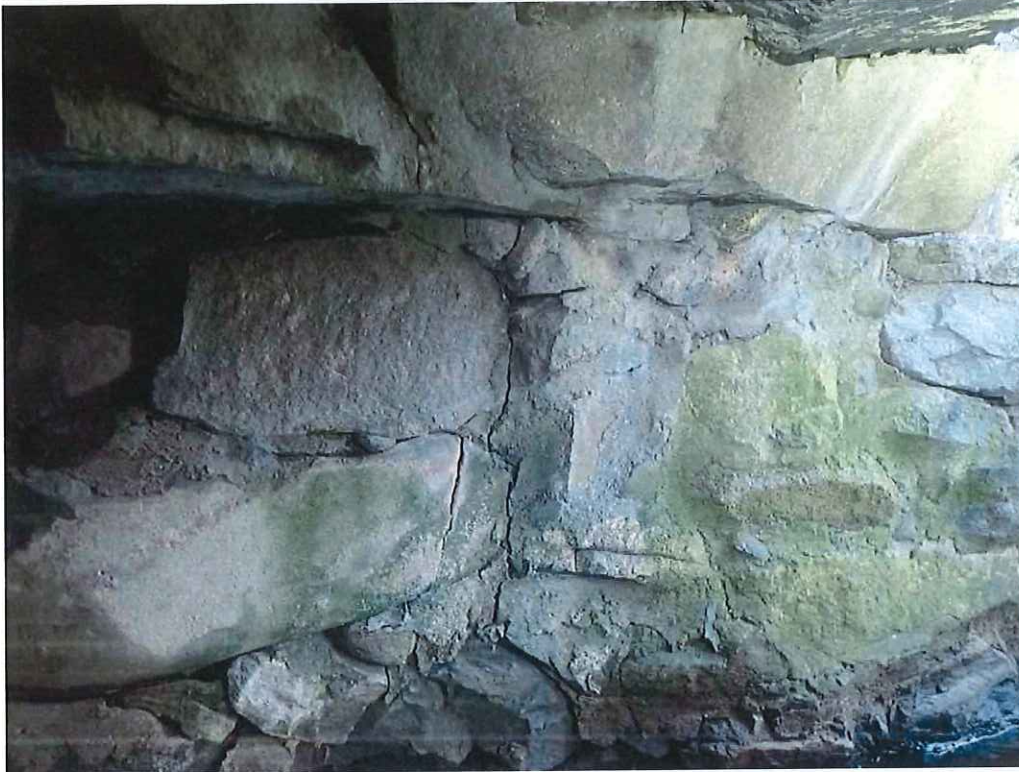
**Photo 23:** East Abutment below south edge of Slab 1: Multiple stones with vertical cracks up to 10" L x up to 1/4" W and an isolated 5" H x 1-1/2" W x 3" D spall.

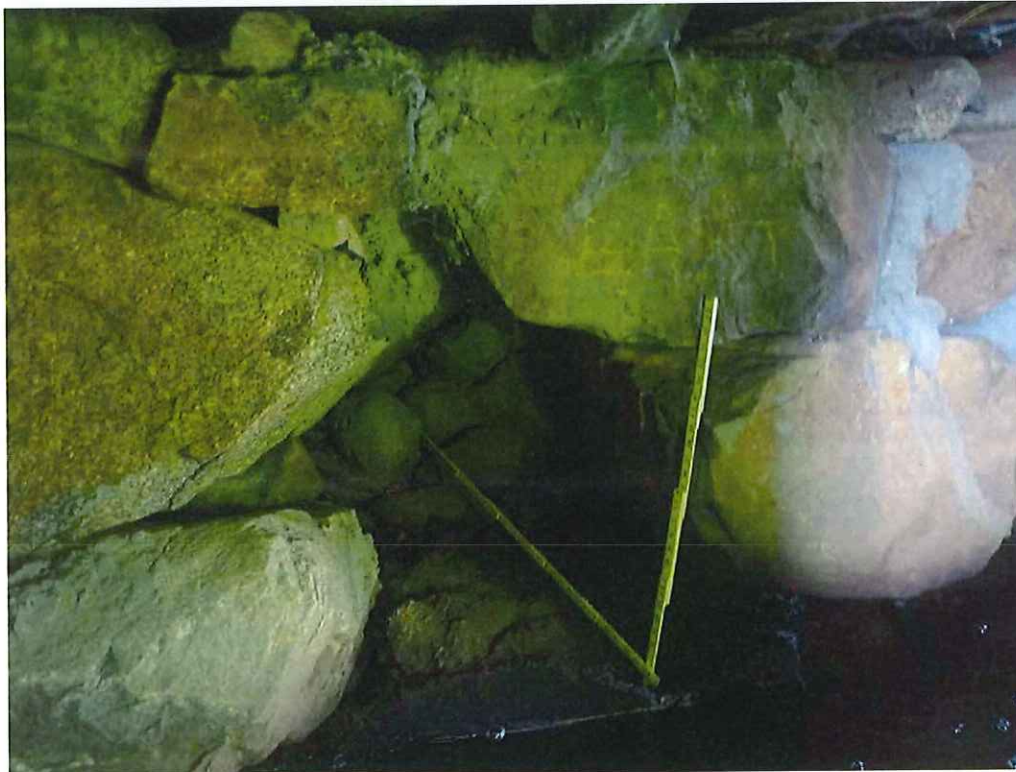
**Photo 24:** East Abutment below Slab 5 at the waterline: 2'-6" L x 2'-3" H x 3'-2" D void.
