Project Description

Belmont Town Hall

Metal Railing and Stone Retaining Wall Study
455 Concord Avenue, Belmont, MA 02478

February 12, 2018

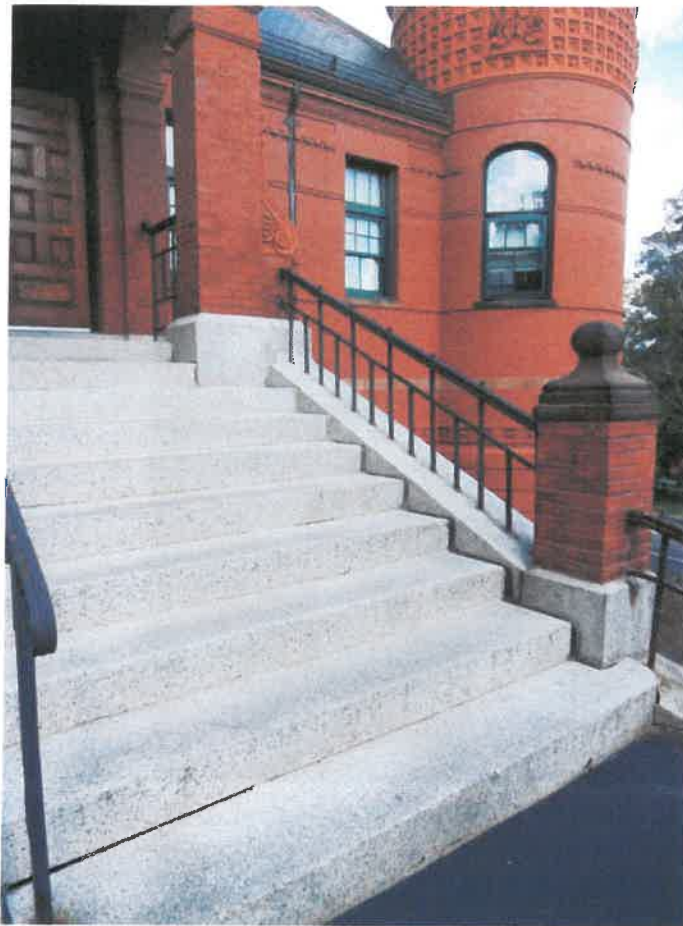
1. The straight railing sections at stairs and upper landing are generally good except for rust and lack of dimensional conformance to guardrail requirements.

3. For the straight sections of railing at the stairs and upper landing we recommend that some type of conforming guard rail be installed in addition to the historic railing. A glass guard rail is probably the least visible approach to meet the guard rail requirements.

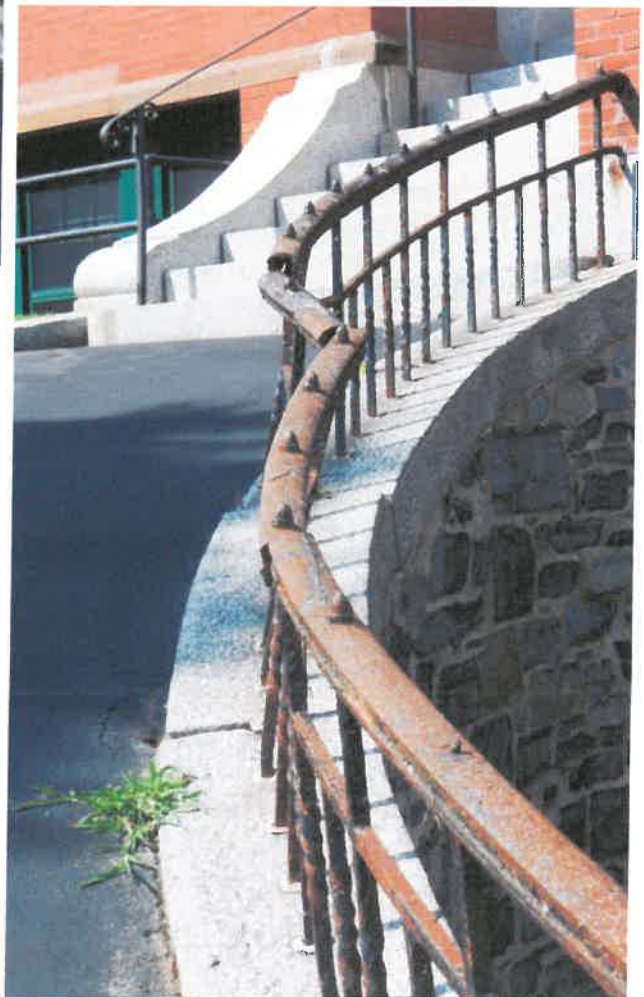
2. The curved section of railing is in very poor condition with many broken sections of the cast iron top rail or cap as well as a lack of dimensional conformance to guard rail requirements.

- g. The final sequence of painting and re-assembly needs to be developed.
2. For the curved section of railing, separating the walking area from the railing with a well planted landscape buffer is probably the only effective way which allows re-use of the historic railing and to meet the intent of the State Building Code.

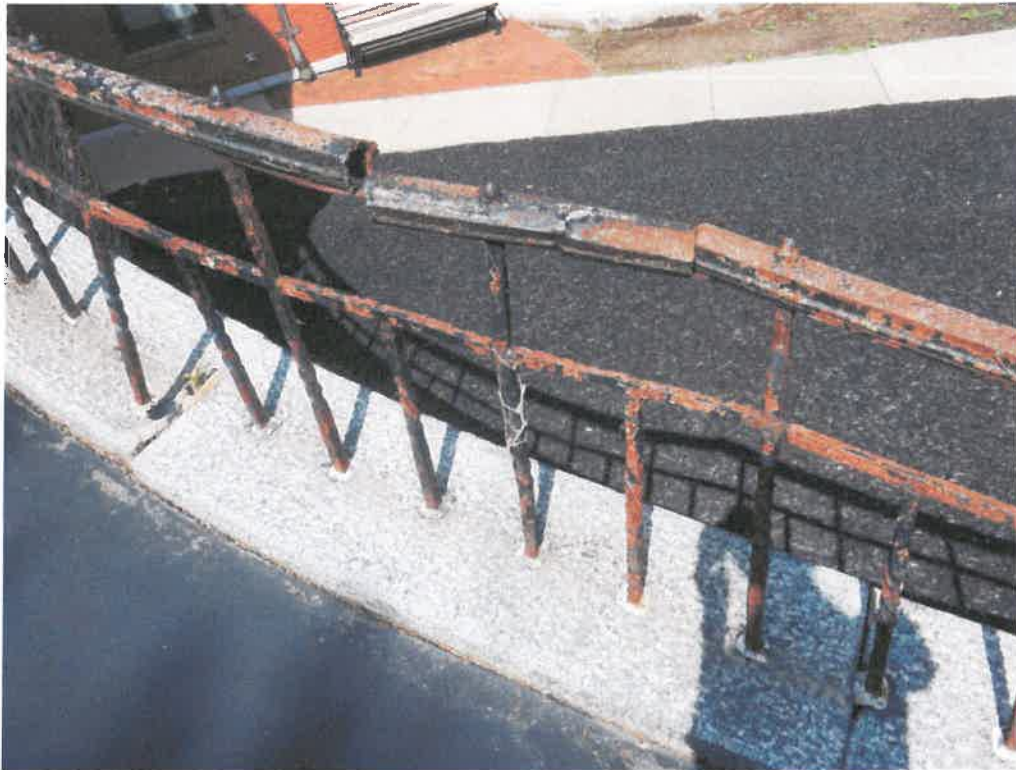
1. Close up view of railing showing broken top rail and ineffective attempts to weld.

- b. Replacement of the sub-rail with a new steel flat bar.
 - c. Replacement of all or most of the curved cast iron top rail.
 - d. Straightening and repair of the wrought iron pickets and elements and lengthening of the pickets by about 3” to allow conventional attachment to the granite.

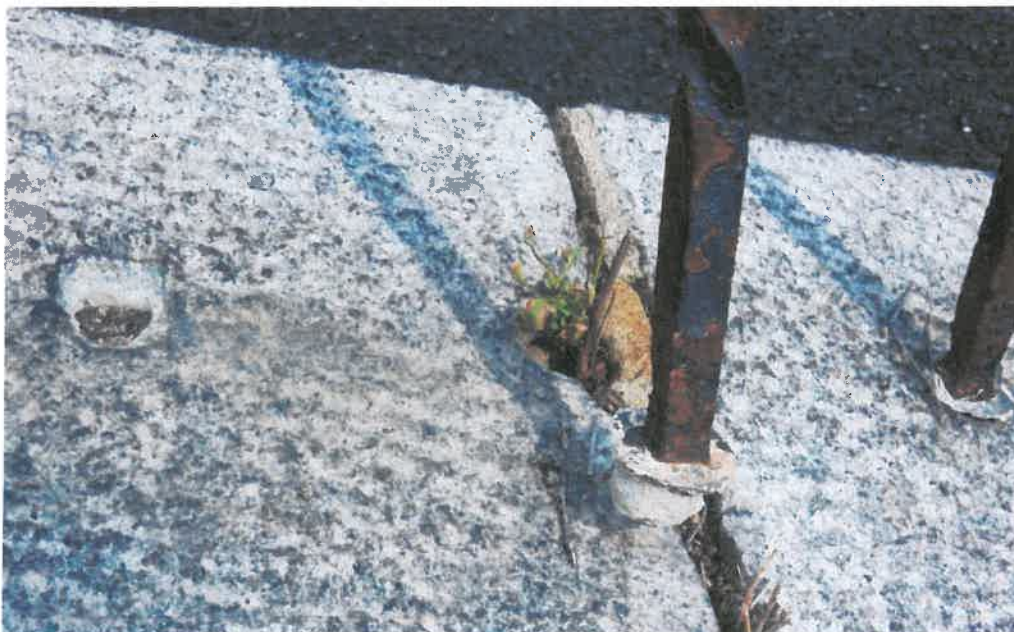
2. Close up view of railing pickets. Picket to the left is missing, center picket is bent and loose. Note lead around very shallow embedment of pickets.

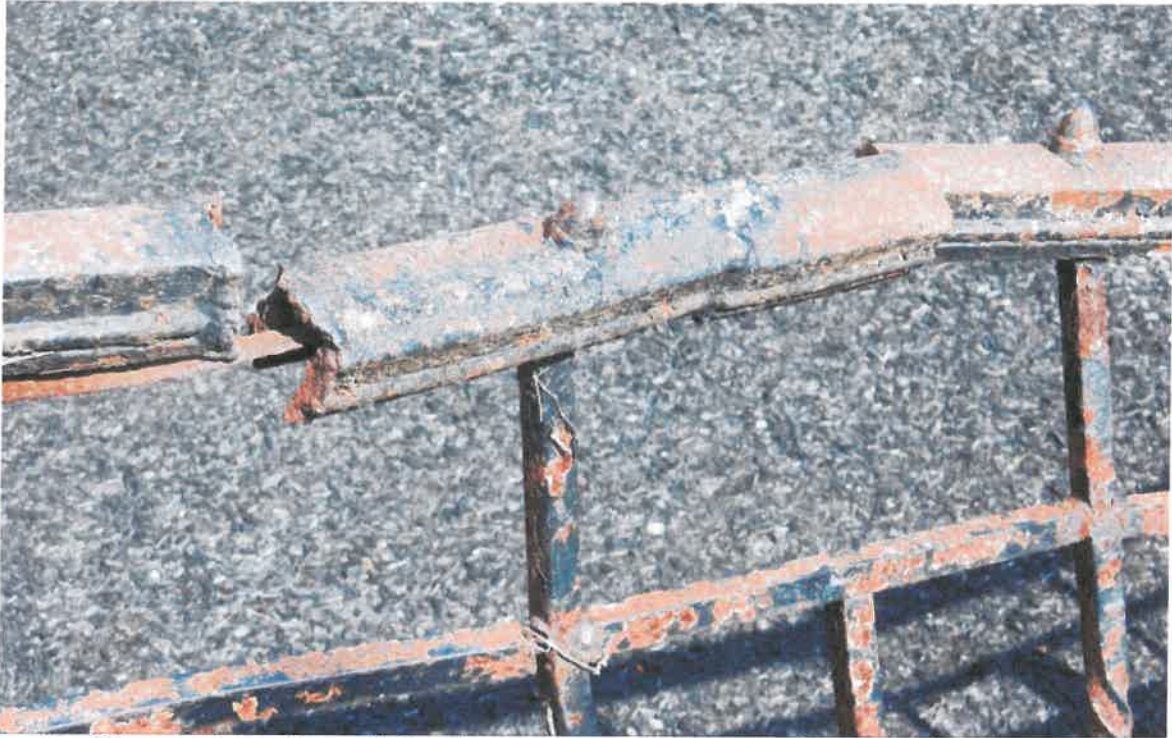
3. Close up view of top rail showing broken welds and severely rusted sub-rail.

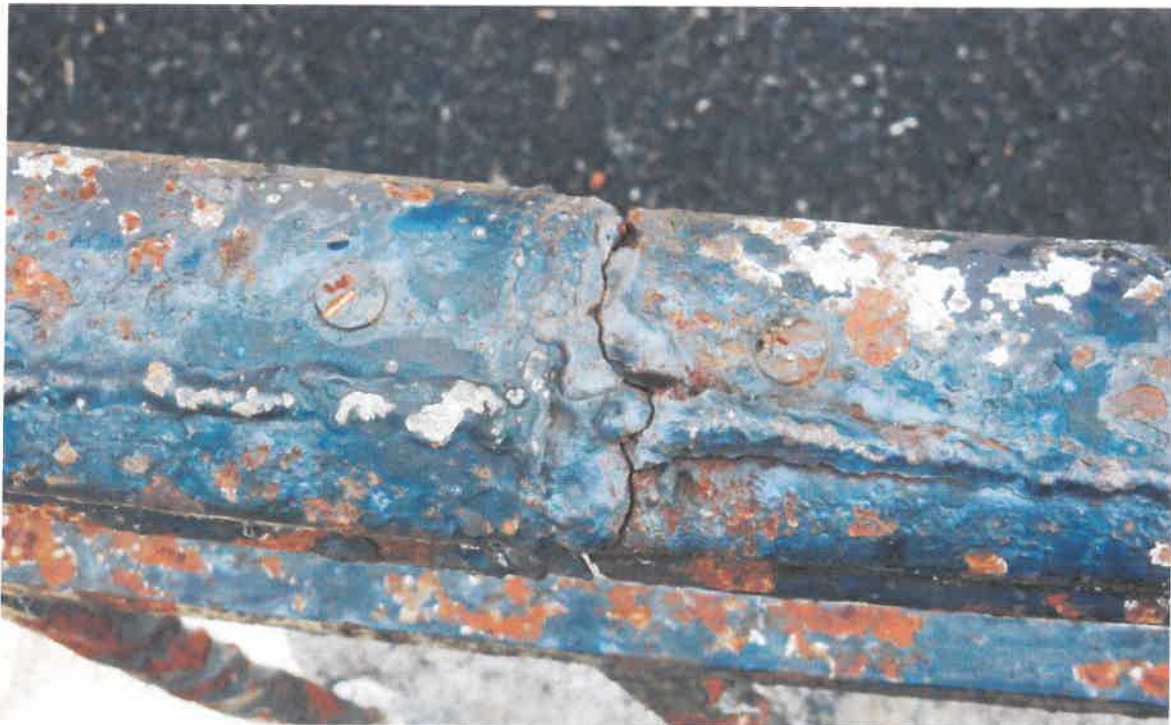
4. Close up view of top rails showing both welds and screws.

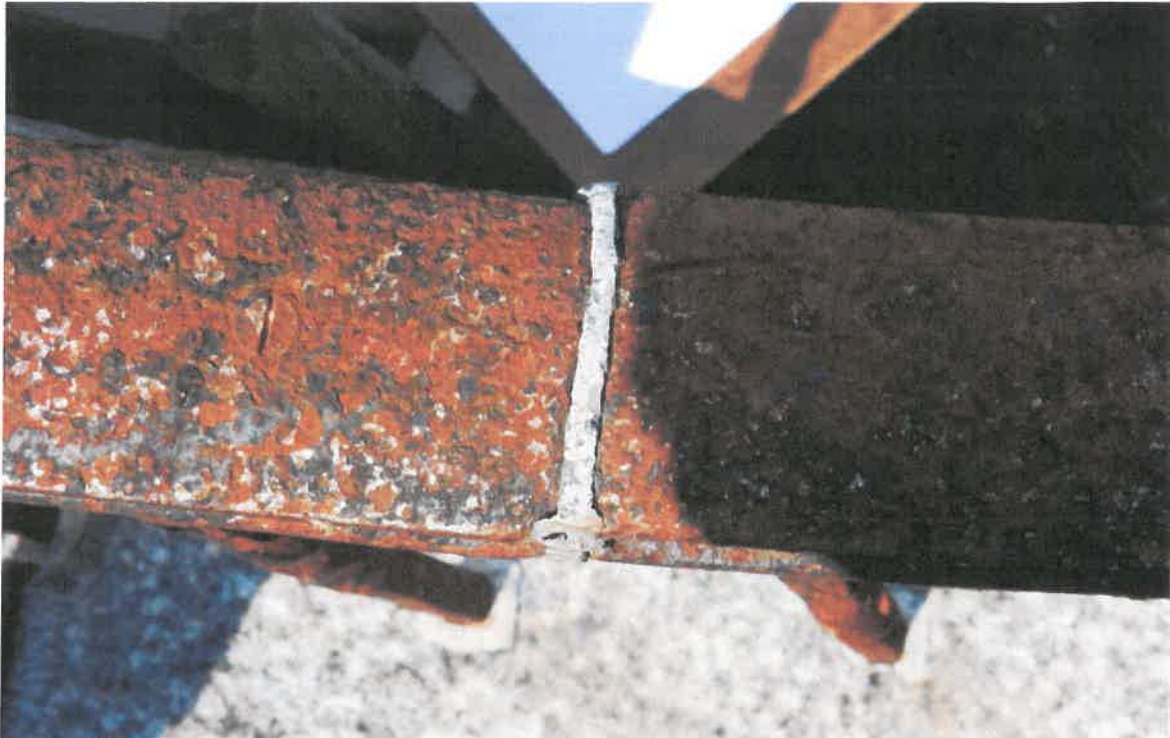
5. Close up view showing an original lead joint between sections of cast iron.

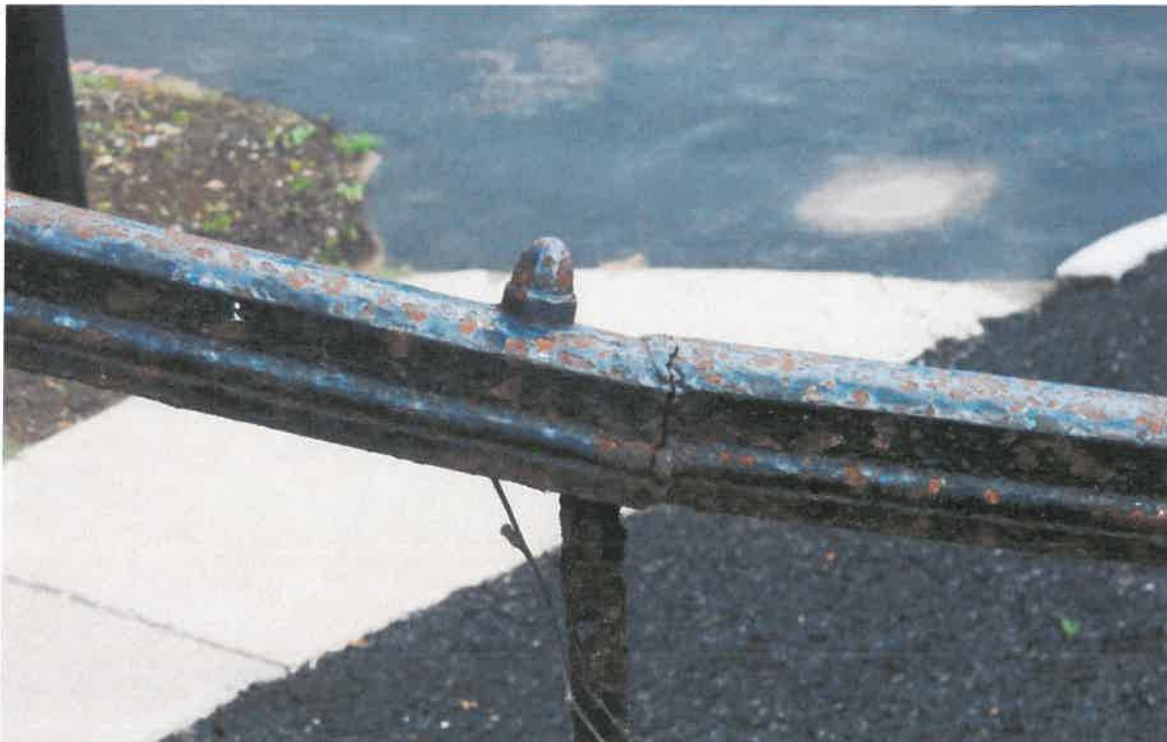
6. Close up view showing decorative (non-functional) bolts and broken weld.

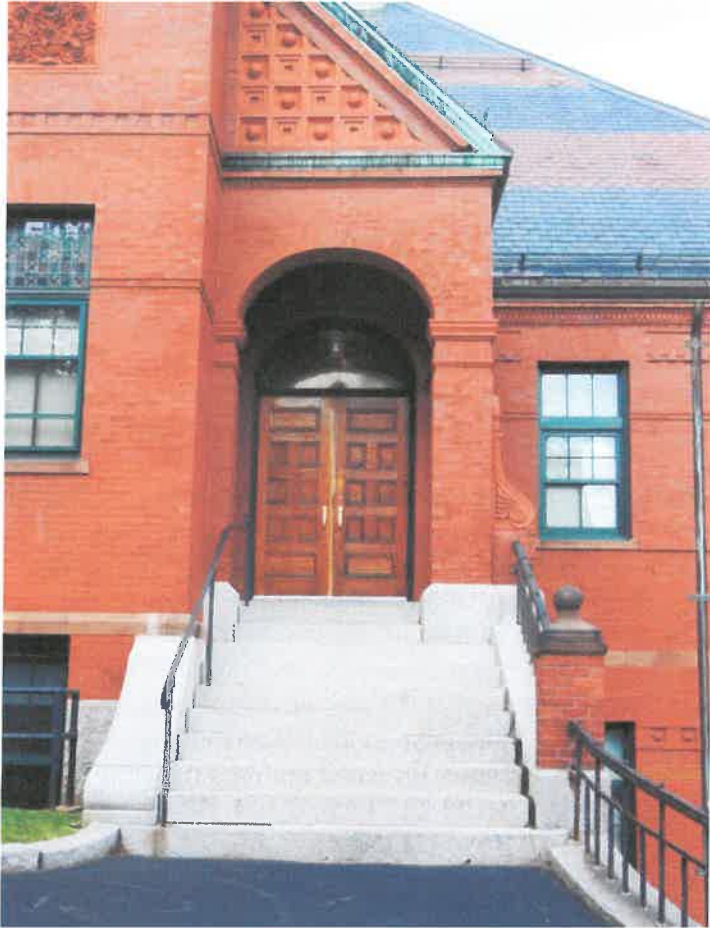
Overall the condition of the wall is fair to poor. Various repointing campaigns have taken place. It appears that all repointing has been with too hard of a mortar which has cracked and trapped water. The bottom brick pier has been hit by a plow or truck and knocked off its foundation. The entire pier has shifted and needs to be rebuilt. The coping stone at the bottom stair tread has moved approximately 1½”.

1. Overall view of granite stairs. The joint at the left side of the stairs is $\frac{1}{2}$ " compared to the joint at the right side of 2" indicating that the top of the retaining wall has moved $1\frac{1}{2}$ ".

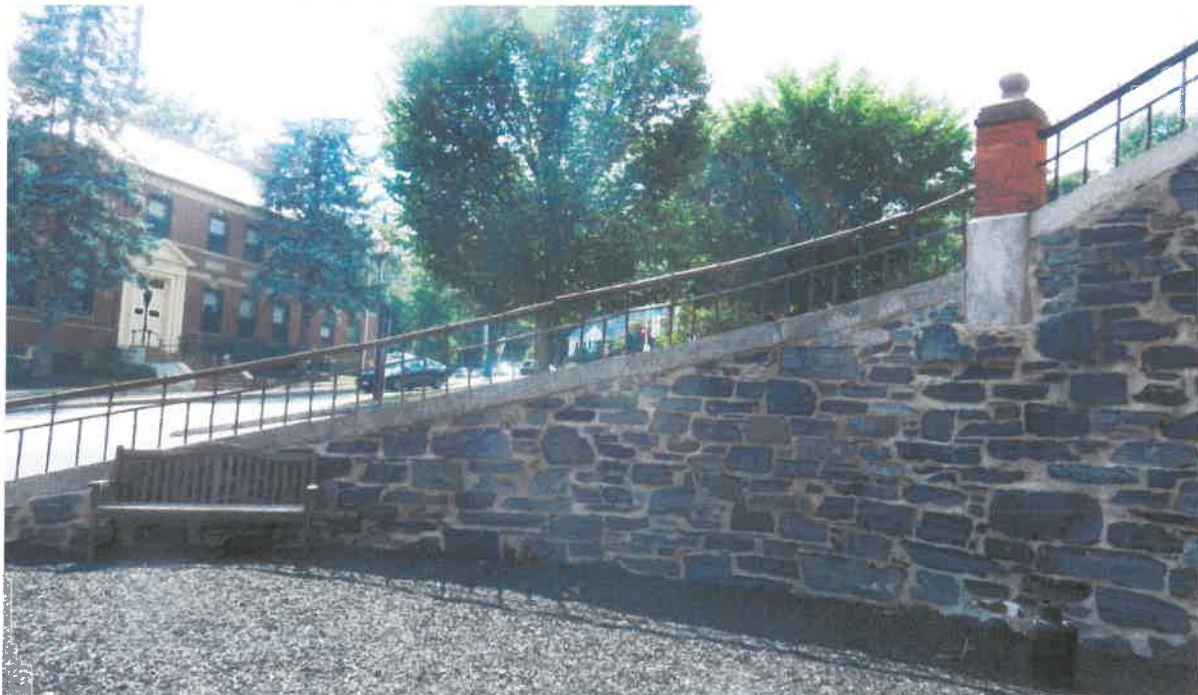
2. Overall view of retaining wall.

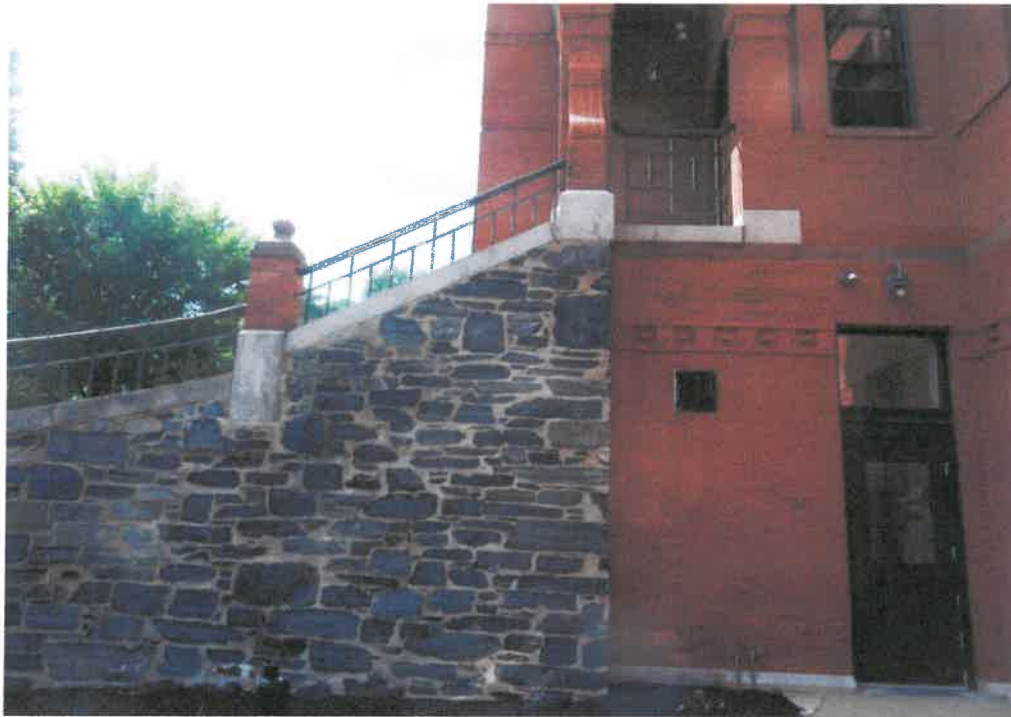
3. View of North end of the stone retaining wall showing connection with the buildings brick walls.

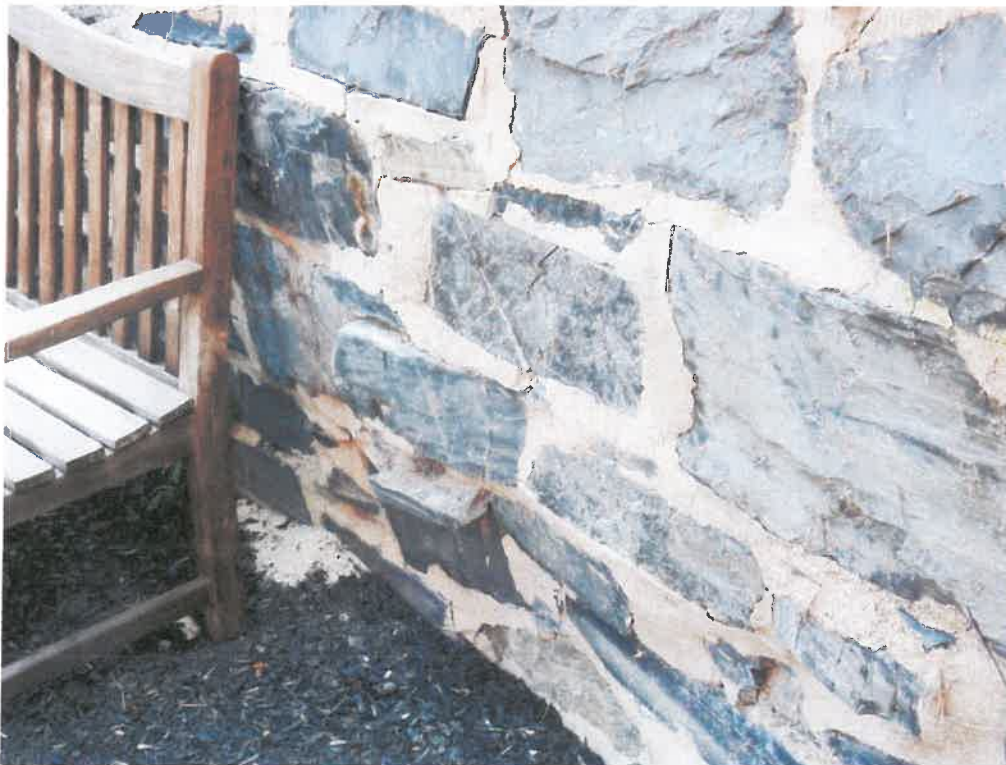
Based on field observations at a couple loose face stones, it appears that face stones have separated from the back-up masonry for about 50% of the wall. We did not see displacement of the back-up masonry but recommend some further exploration work during the design and contract document process.

4. Close up view showing cracked mortar joints and displaced stone work.

- i. Remove and reset the granite coping stone and rebuild top 12” of field stone. See Detail 2, Drawing A1.2
2. Remove and reset face wythe of field stone for approximately 50% of wall. See Elevation 1, Drawing A1.2
3. Remove 1 face stone at every 3’-0” o.c. max. each way and install ½” stainless steel threaded rod with nuts at both ends to tie the face wythe to back-up masonry.
4. Repoint 100% of masonry which is not rebuilt.
5. Disassemble and rebuild the 2 brick, granite and brownstone piers.
6. Supply and install spherical brownstone finial at lower pier.
7. Drill or install 2” diameter drainage holes near base of wall at 5’-0” o.c. max.

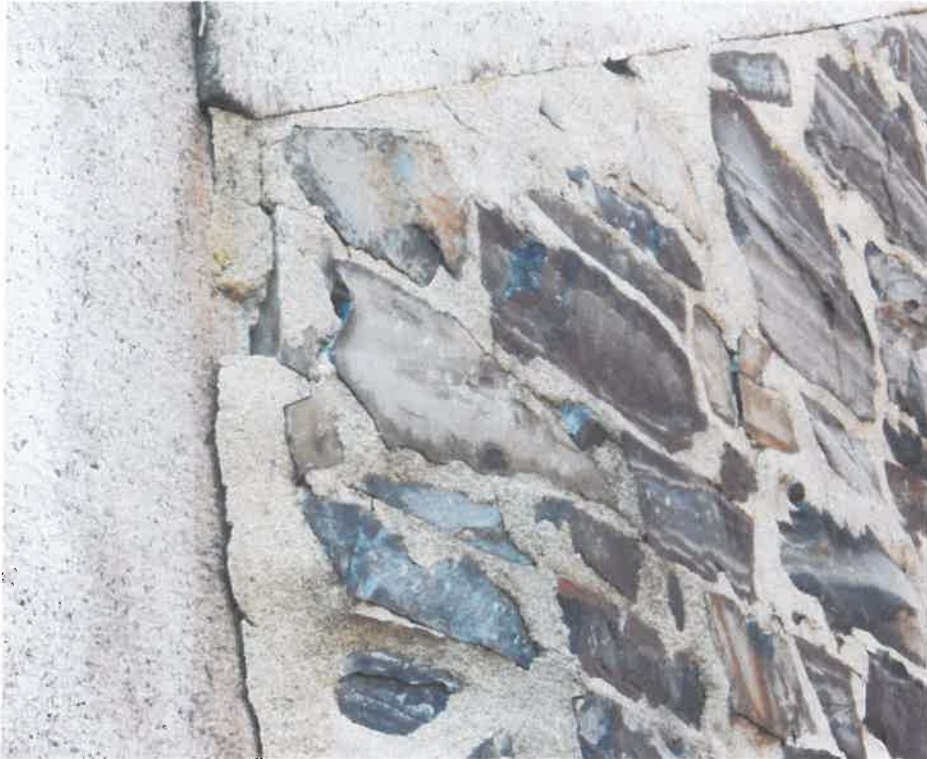
5. Close up view showing differential movement between granite pier and shale as well as between granite pier and granite coping stone.

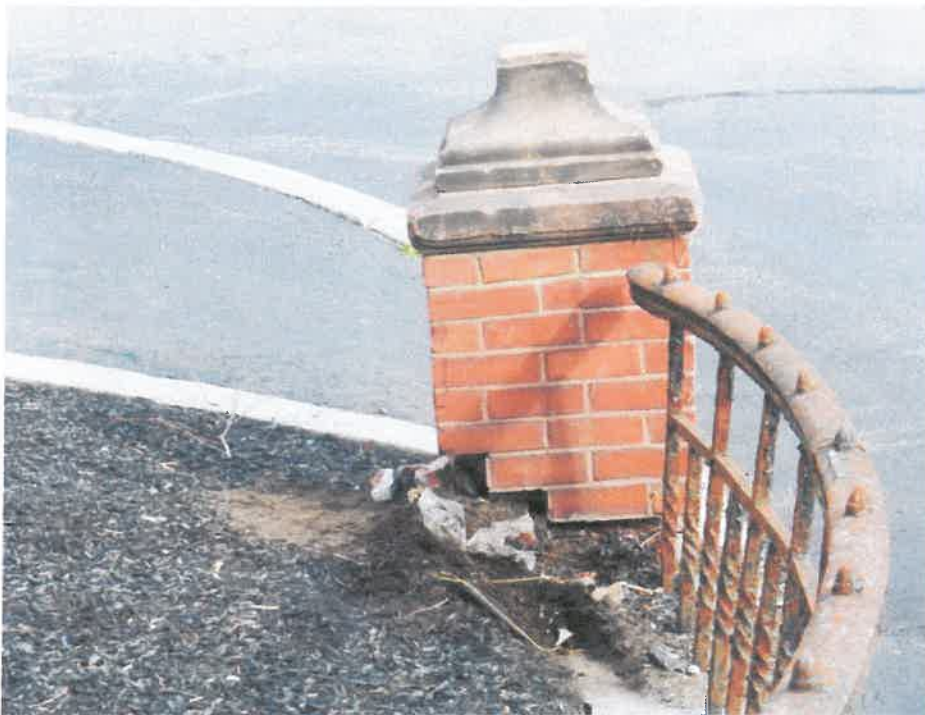
6. View of lower brick pier which has been knocked off of its foundation and is missing its spherical finial.
