EXISTING CONDITIONS ASSESSMENT

BELMONT, MA CIVIC COMPLEX

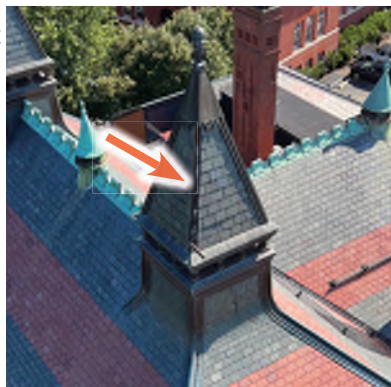
Image A-04: Missing hip cap at southern ventilation cupola. roof sheathing is exposed.

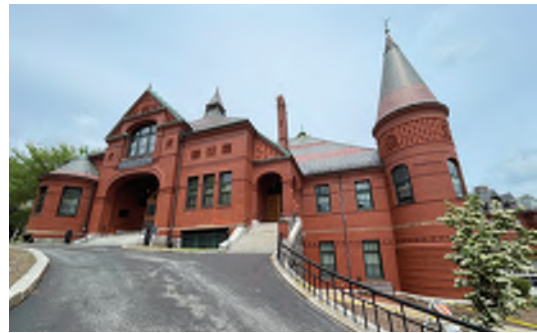
Image A-01: View of the south elevation of the Belmont Town Hall, constructed in 1881.

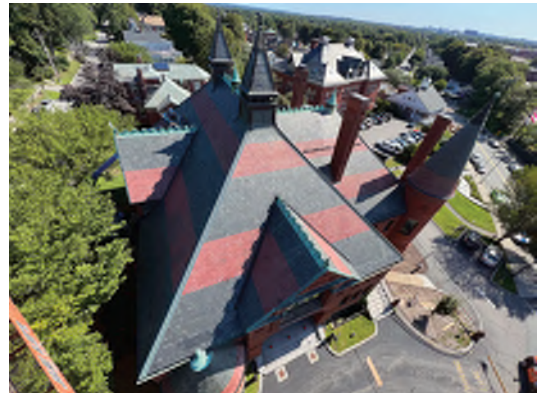
Image A-03: Aerial view of the roof showing recently replaced hip caps and valley flashing.

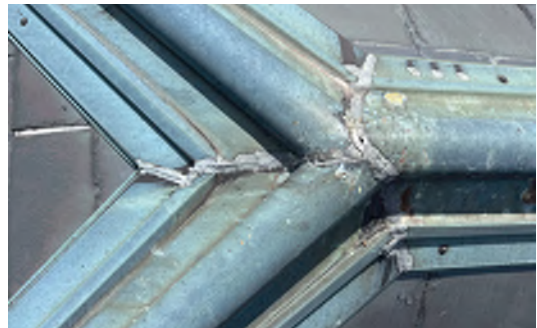
Image A-05: Broken solder seam at ridge cap over the northeast addition of the Town Hall.

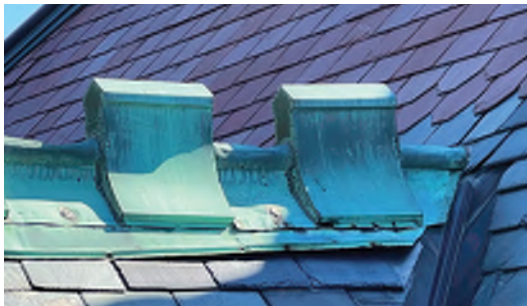
Image A-06: Original crenelated copper crestring is in poor condition due to age and weathering.

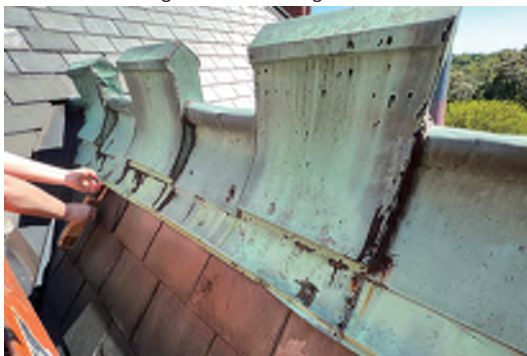
Image A-07: Ferrous nails were driven through the crestring to attach it to the roof. Mastic used to seal broken seams.

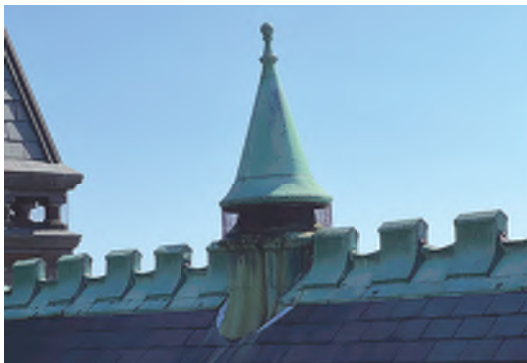
Image A-08: View of copper ventilation cupola integrated with the crenelated crestring at the north-south ridge.

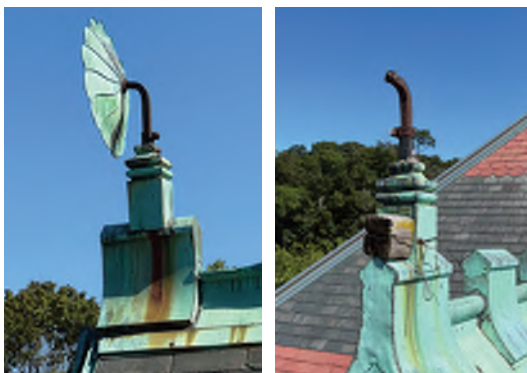
Image A-09: View of the original copper floral finial at the west gable end (Left) and the missing finial (Right)

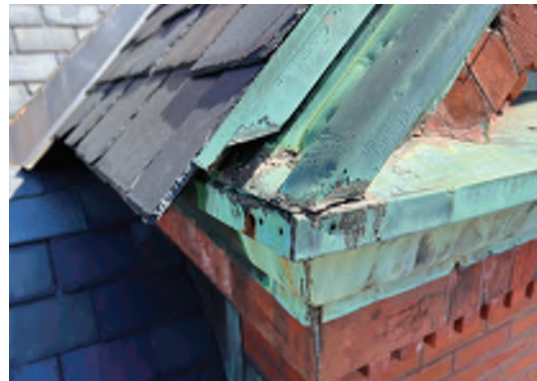
Image A-10: View of deteriorated decorative copper moldings at the south gable end. Condition is typical across building.

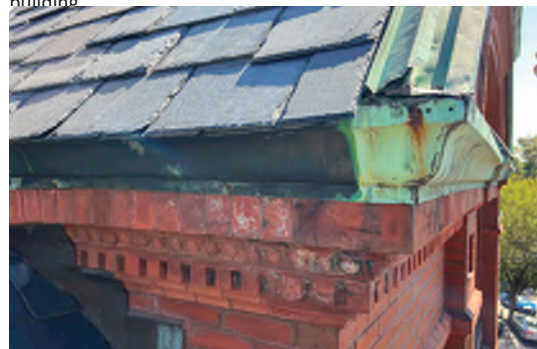
Image A-11: Damaged decorative brick cornice as a result of deteriorating copper and face nailing.

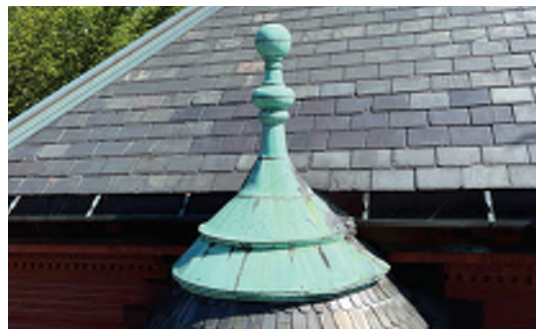
Image A-12: View of severely deteriorated original copper finial at south projecting bay window.

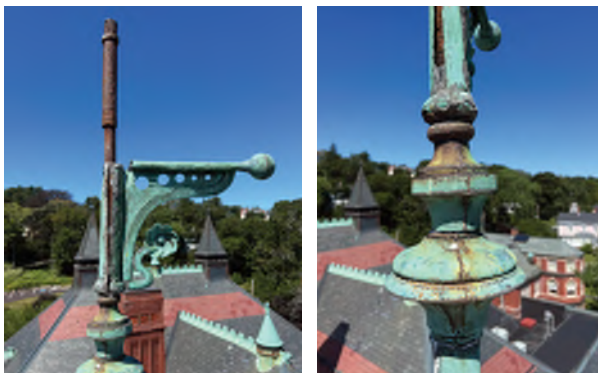
Image A-14: Significantly deteriorated original copper weathervane at the top of the turret. Much of the weathervane is missing.

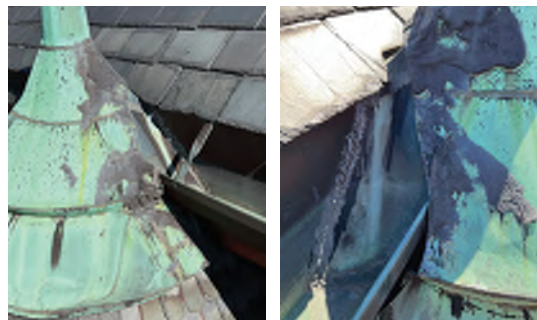
Image A-13: Heavy mastic and other patching to prevent water infiltration at questionable gutter intersection.

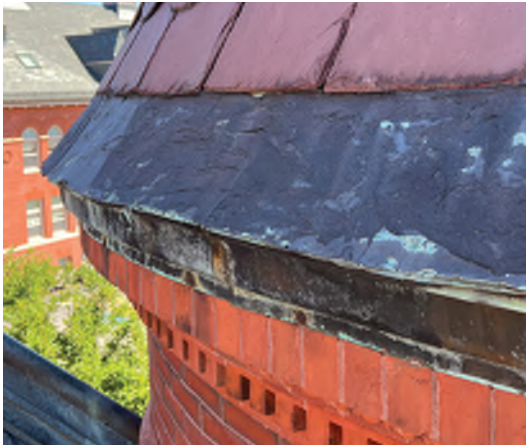
Image A-15: Heavy mastic wash over deteriorated copper skirt at the base of the turret roof.

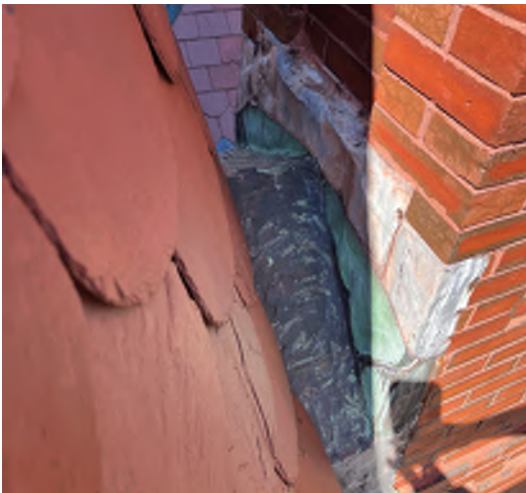
Image A-16: Deteriorated copper cricket and flashing between the turret and chimney. Heavily coated with mastic.

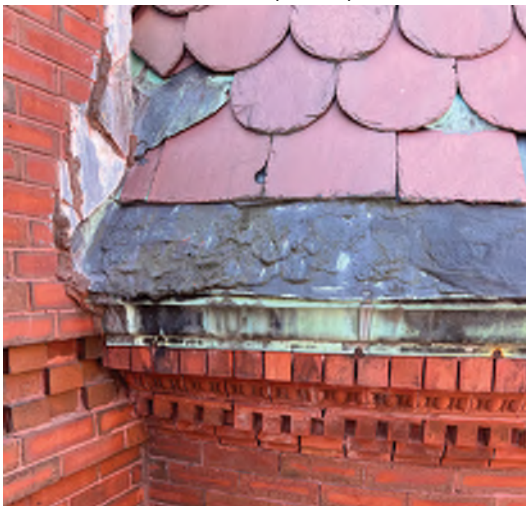
Image A-17: Severely deteriorated copper skirt, cornice, and flashing turret roof and chimney.

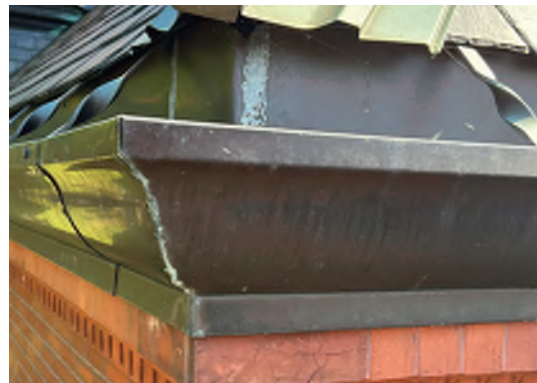
Image A-18: Typical k-style copper gutter at south west corner of the Town Hall. Note the open miter joint.

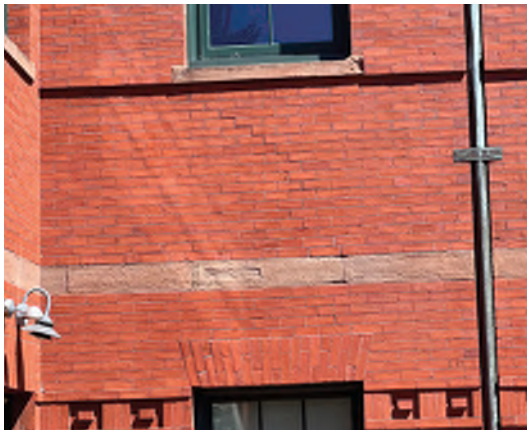
Image A-21: Slipping jack arch and step cracking at ground floor windows at south elevation

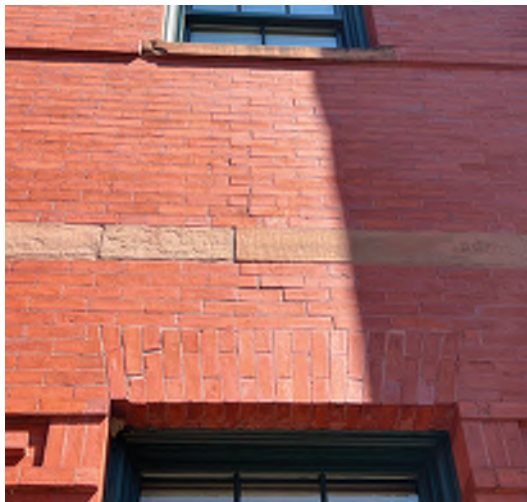
Image A-22: Slipping jack arch and step cracking at ground floor windows at south elevation Note widened joint at arch.

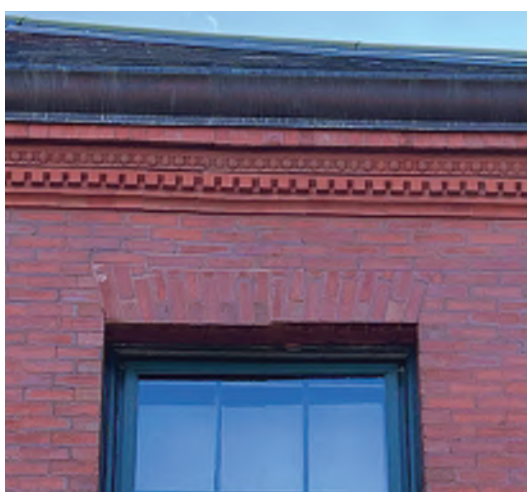
Image A-23: Slipping jack arch and step cracking at the second floor window at north elevation .

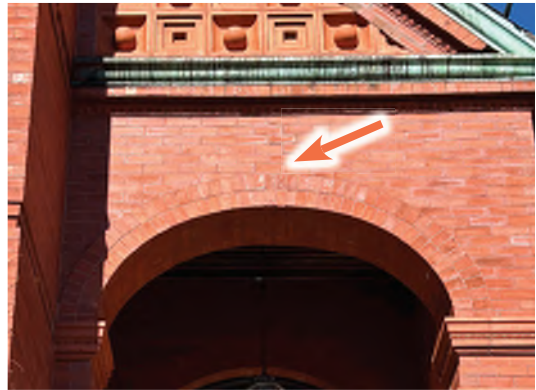
Image A-24: Slipping round arch and step cracking at the south portico. Note the broken keystone at the center of the arch.

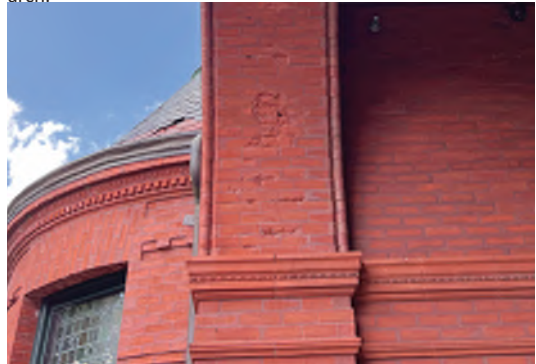
Image A-25: Isolated spalling at the west side of the intrados of the main entry arch.

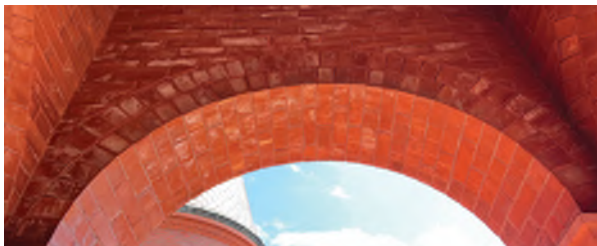
Image A-27: Area of efflorescence at interior brick masonry above east facing arch of south portico.

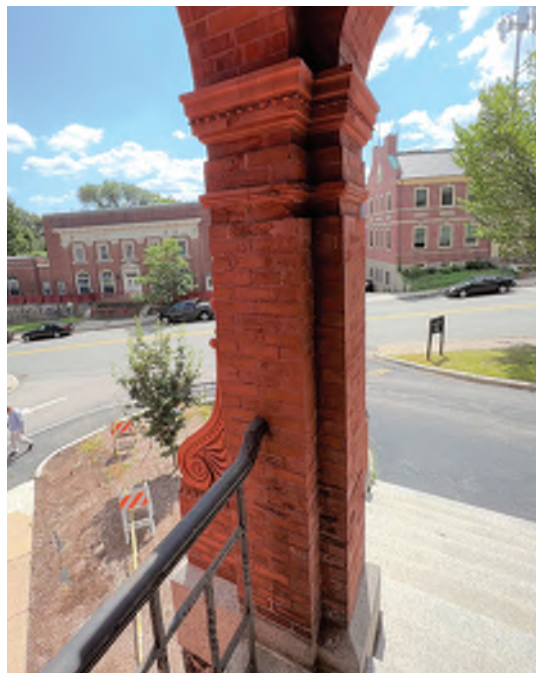
Image A-26: Deteriorated and spalling brick masonry at the interior of support column at south portico.

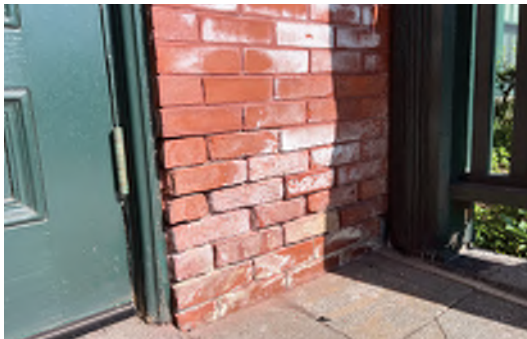
Image A-28: Deterioration and efflorescence at base of east entry vestibule causing by rising damp and de-icing salts.

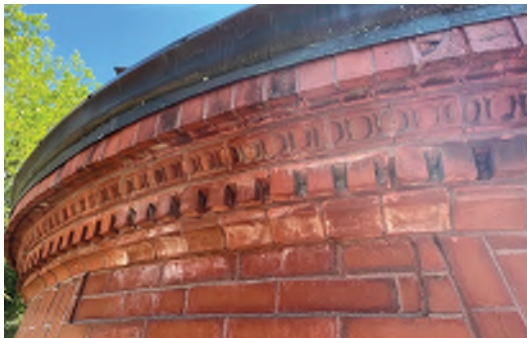
Image A-29: Mortar deterioration and efflorescence at decorative brick cornice caused by prior leaking gutters.

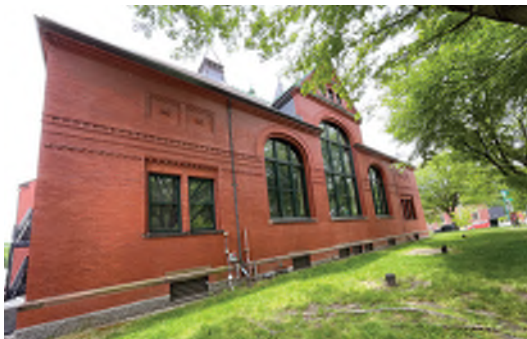
Image A-30: View of west elevation showing varying types brick banding that circumvent the Town Hall.

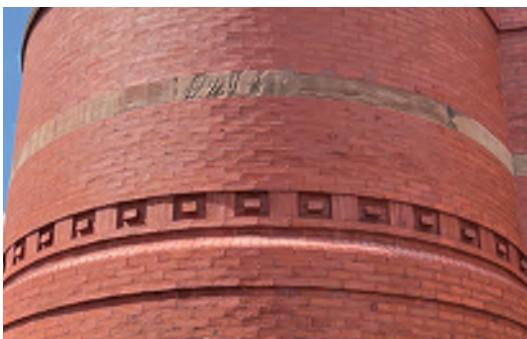
Image A-31: View of brownstone and brick banding at the turret. Note the erosion at the brownstone band.

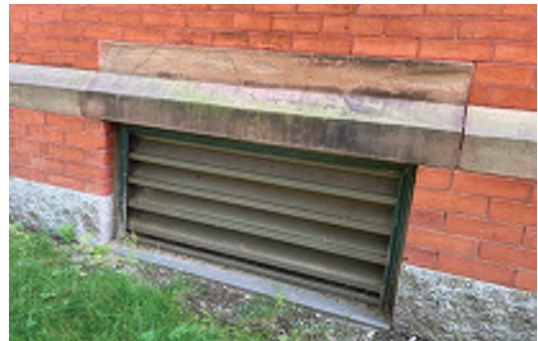
Image A-32: Staining, scaling, and open joints at brownstone watertable typical across the building.

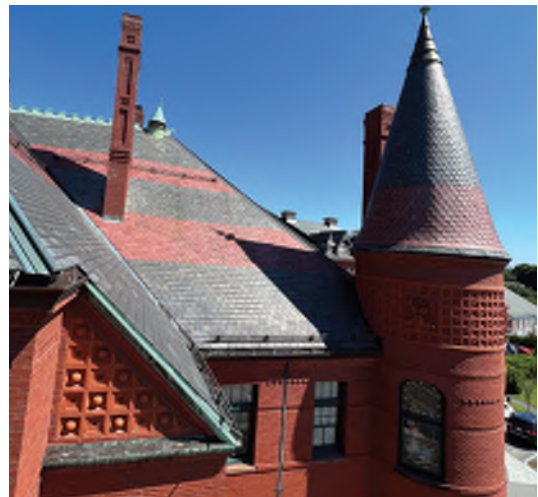
Image A-33: Aerial view of the southeast corner of the building showing different geometric terra-cotta decorations.

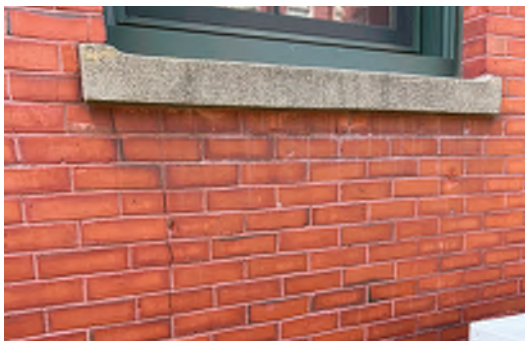
Image A-37: Vertical cracks in brick masonry below the first floor cast stone window sills at the north elevation.

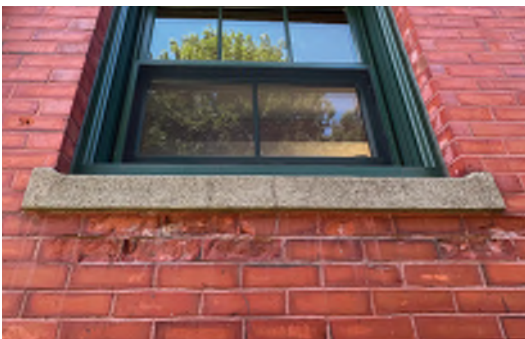
Image A-38: Spalling at brick masonry below the cracked first floor cast stone window sills at the north elevation.

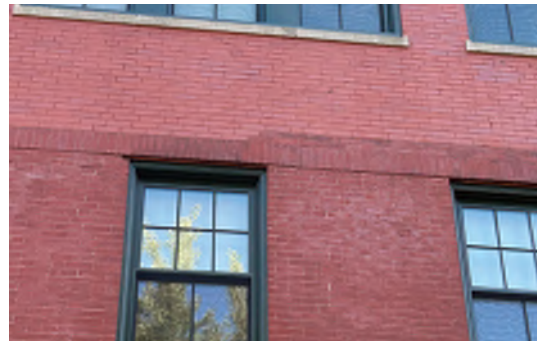
Image A-39: Area of bulging brick masonry at second floor window at north elevation due to rust jacking.

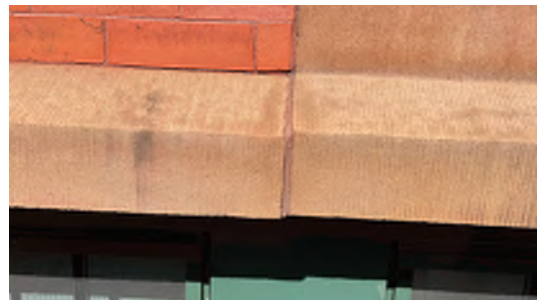
Image A-40: Movement at the modified brownstone lintel at the south elevation due to rust jacking

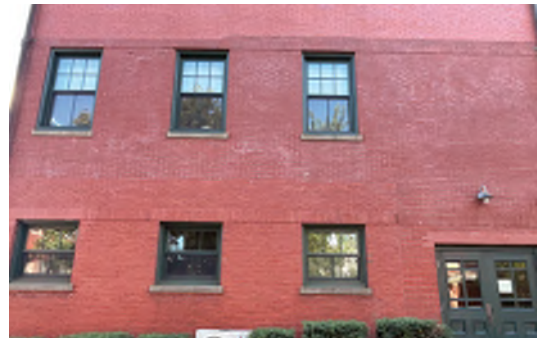
Image A-41: Efflorescence appears to be more prominent at second phase of addition.

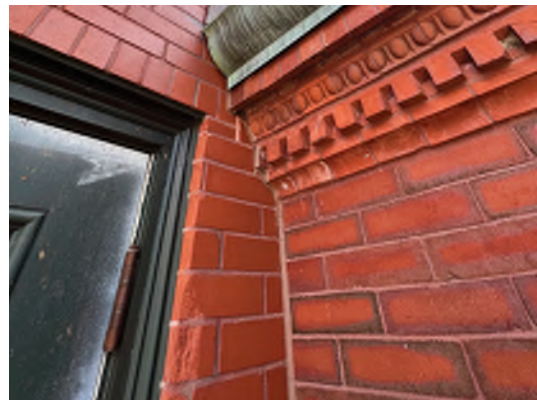
Image A-42: Spalling and deterioration of the masonry opening around the door to the fire escape.

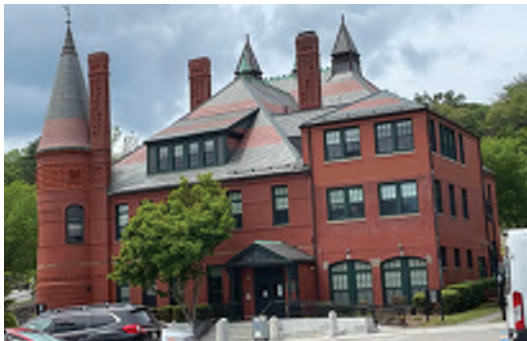
Image A-43: View of the east elevation where showing the various types of new aluminum windows on the building.

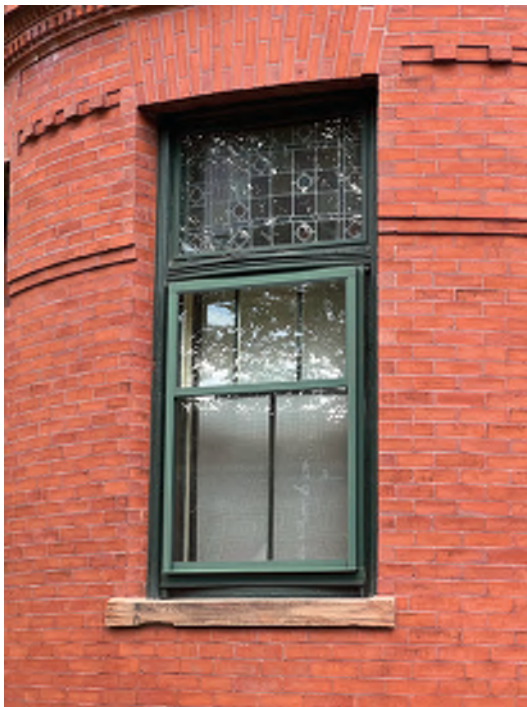
Image A-44: View of original wood window at south projecting window bay with stained glass transom.

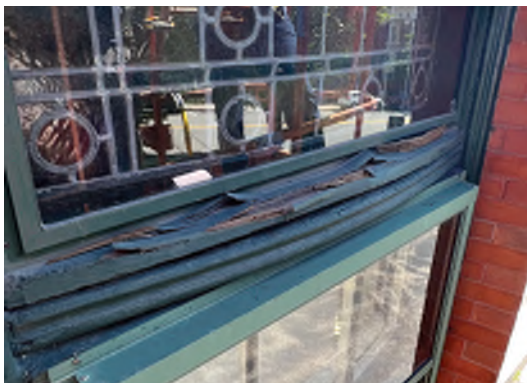
Image A-45: Spalling at brick masonry below the cracked first floor cast stone window sills at the north elevation.

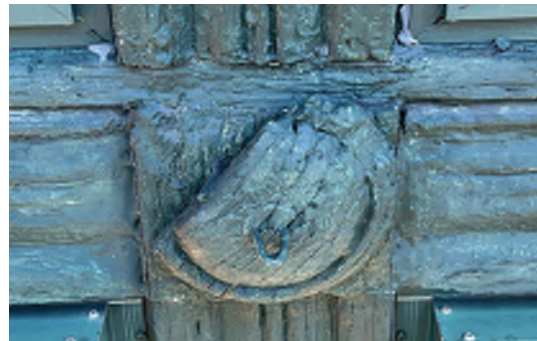
Image A-46: View of the deteriorated wood trim and bullseye rosettes at the south gable end's stained glass windows.

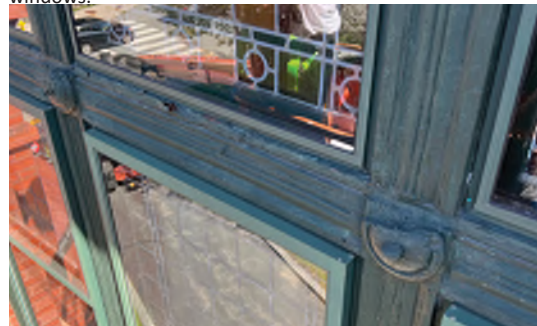
Image A-47: View of the deteriorated wood trim and bullseye rosettes at the south gable end's stained glass windows.

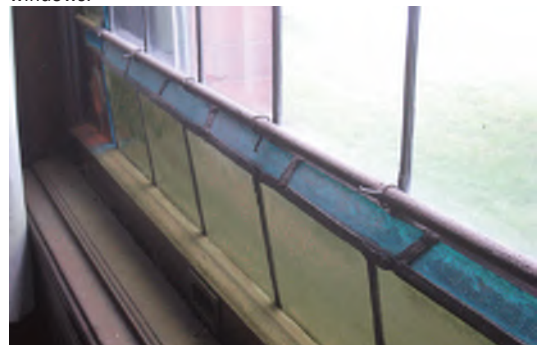
Image A-48: Buckling and deteriorated lead joints at large stained glass windows at the west elevation.

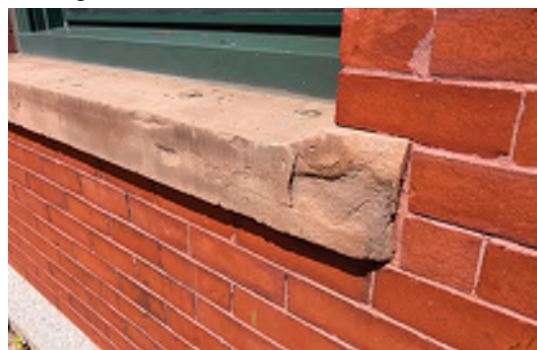
Image A-49: Deterioration of brownstone sills across the Belmont Town Hall.

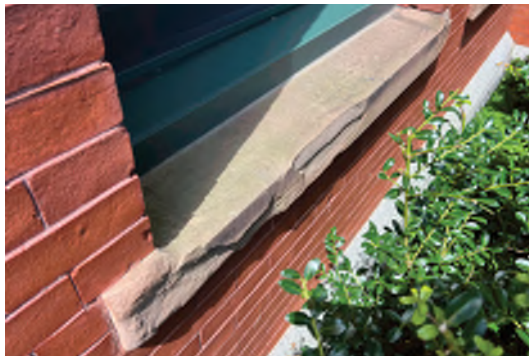
Image A-50: Cracking and spalling caused by the pressure of the load traveling down the edges of the masonry openings.

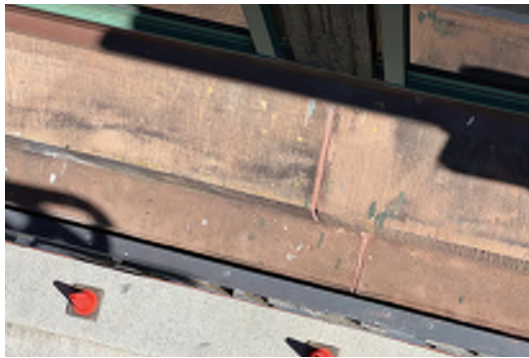
Image A-51: Sky-facing joints at large brownstone sills are susceptible to water infiltration and deterioration.

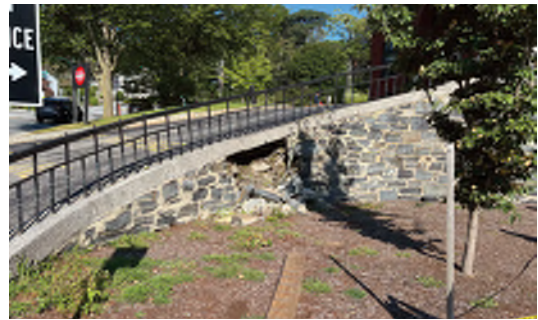
Image A-52: Collapsing retaining wall between the driveway and the courtyard at the southeast corner of the building.

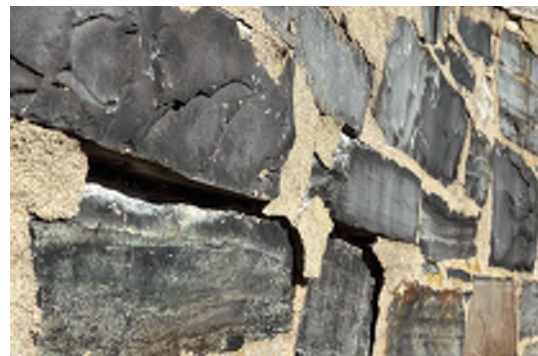
Image A-54: Bulging stone masonry at south retaining wall. Mortar is cracking and falling away from the stone.

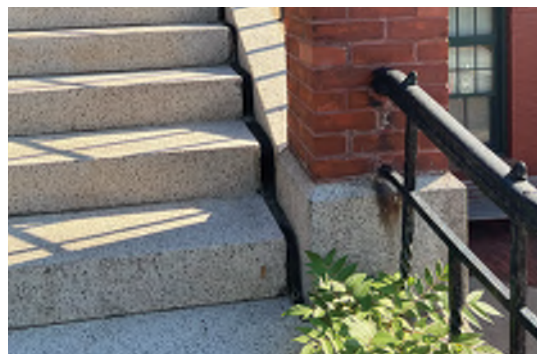
Image A-55: Wide cracking joint between the cheek wall and the granite steps at south portico infilled with sealant.

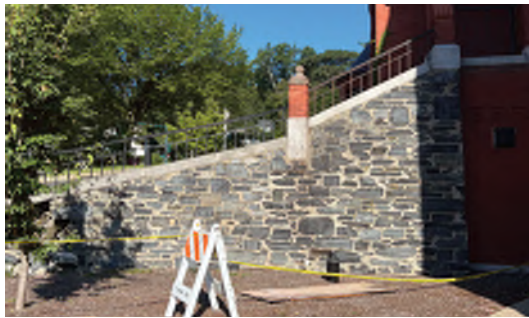
Image A-56: View of the cheek wall at the south portico integrated with the retaining wall.

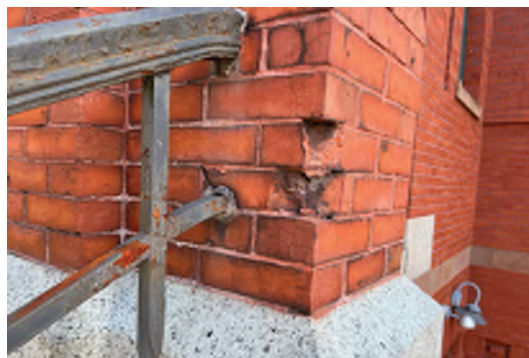
Image A-57: brick deterioration caused by twisting metal handrails as a result of the failing retaining wall.

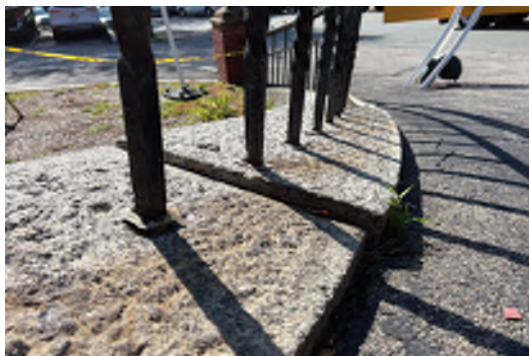
Image A-58: Original metal handrails embedded in the granite coping stones at the south retaining wall.

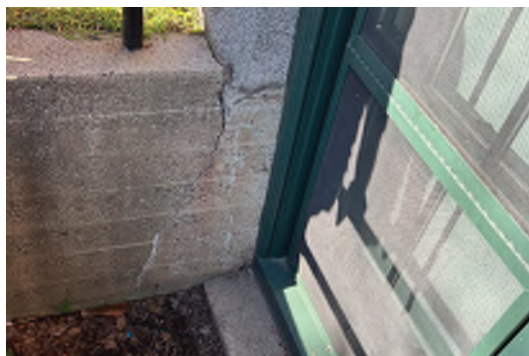
Image A-59: Crack at the concrete window well wall at the foundation on the south elevation.

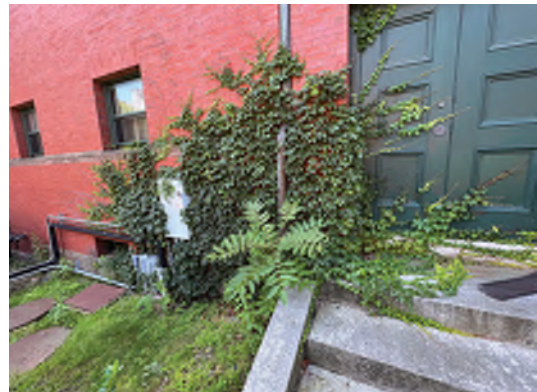
Image A-60: Vine overgrowth at brick masonry and granite stairs along the north elevation.

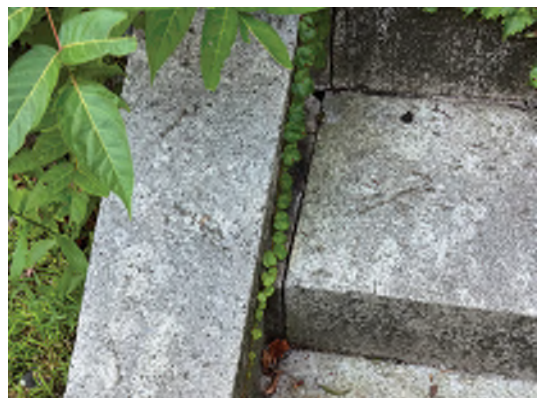
Image A-61: Wide cracking joint between the cheek wall and the granite steps. Vegetation is growing through the cracks.

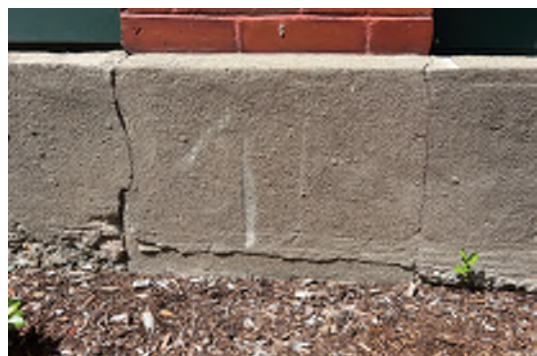
Image A-62: Cracks in the parge coat at the concrete foundation where the bay doors were infilled.

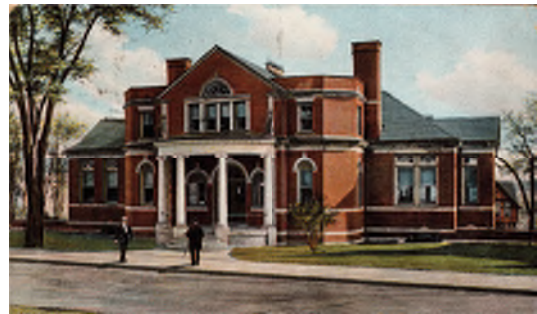
Image B-01: Belmont School Administration Building, then Underwood Public Library, circa 1915

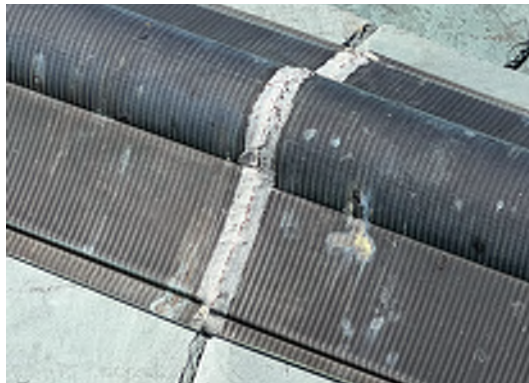
Image B-05: Broken solder seam at ridge cap. Copper appears to be in otherwise good condition.

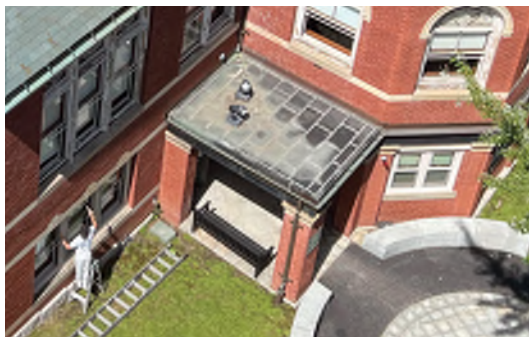
Image B-06: Flat seam copper roof over east portico. Evidence of ponding present around spotlights.

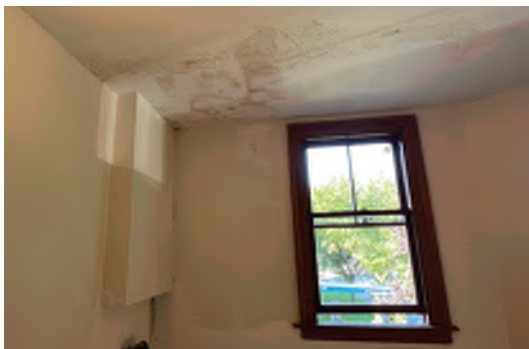
Image B-08: Interior damage at southwest stairwell caused by chronic roof leaks.

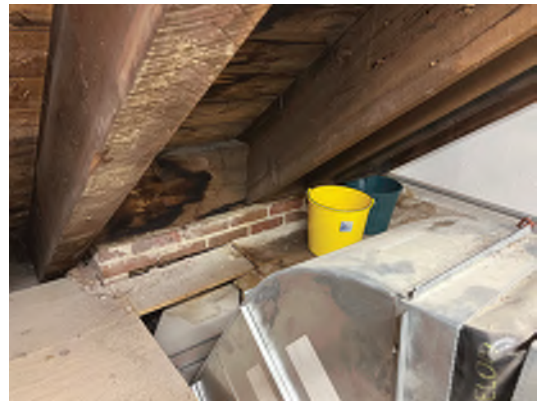
Image B-09: Interior leaks at attic level of School Admin Building. Buckets are used to capture leaks.

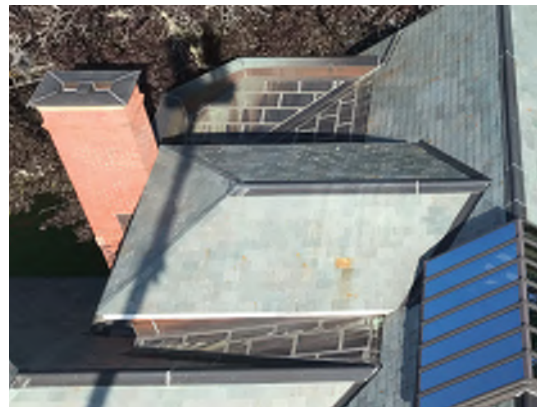
Image B-10: Roof of elevator override directly abutts south chimney focusing water and snow on rear chimney wall.

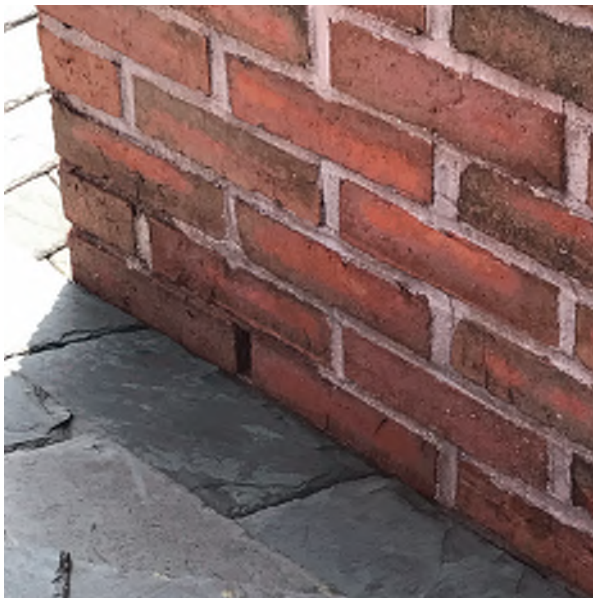
Image B-11: Open mortar joint at the rear face of the south chimney caused by water and snow accumulation off of the elevator override.

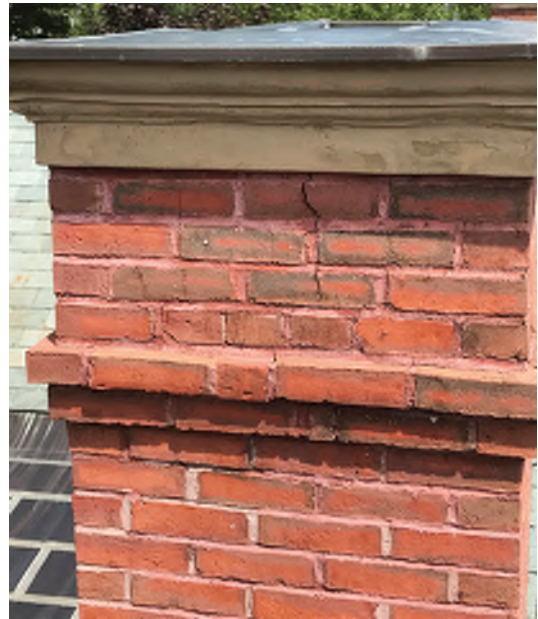
Image B-12: Significant structural cracking at the top of the south chimney. Note the deteriorated capstone.

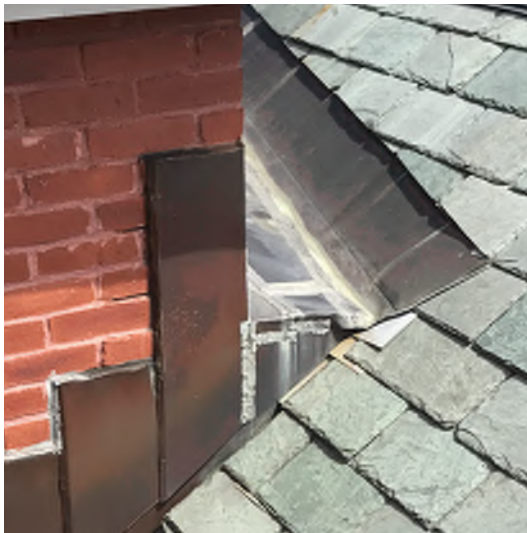
Image B-13: Vulnerable flashing transition at the southeast corner of elevator override. Broken seams, open joints, etc.

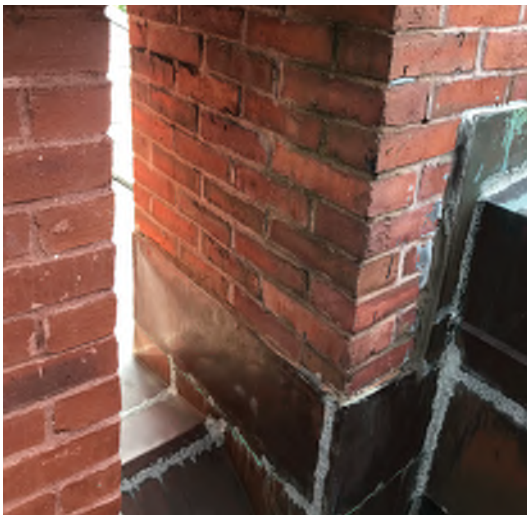
Image B-14: Poorly detailed copper counterflashing detail at chimney. No visible clips and new sealant joints required.

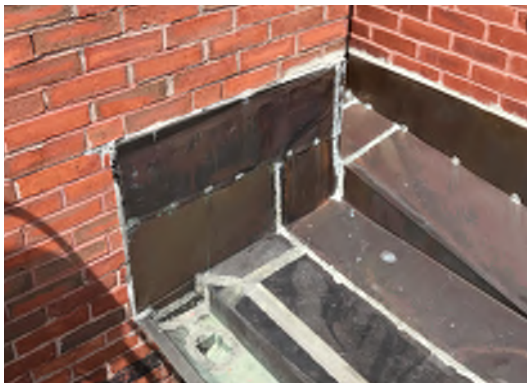
Image B-15: Poorly detailed copper counterflashing detail at chimney. No visible clips and new sealant joints required.

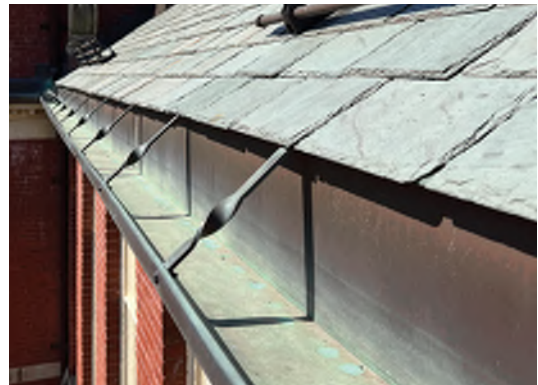
Image B-16: Approx 20 year old copper downspouts in good condition. No corrosion, pinholes, or metal deterioration.

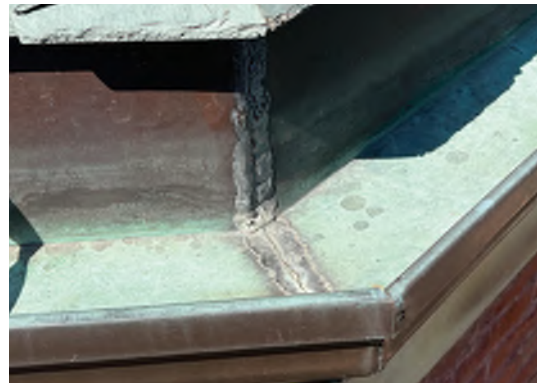
Image B-17: Broken solder seam at mitered corner of copper gutter.

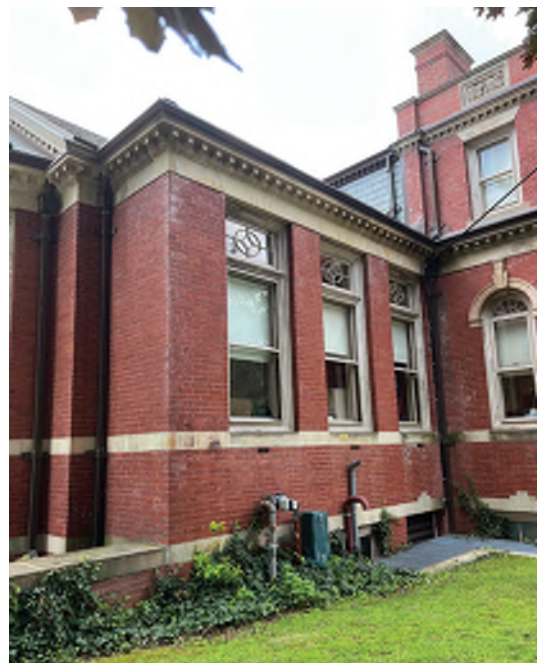
Image B-18: View of northwest corner of the building showing deterioration to sandstone cornice and brick masonry.

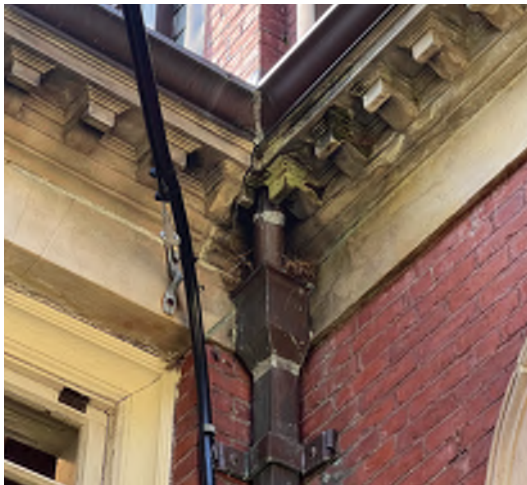
Image B-19: Blocked collector box at downspout causing significant damage to sandstone cornice and brick masonry.

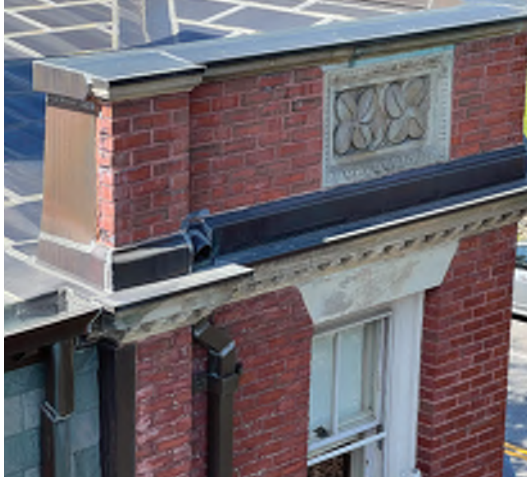
Image B-20: Through-parapet drainage detail suspected of compromising/damaging brick and sandstone masonry.

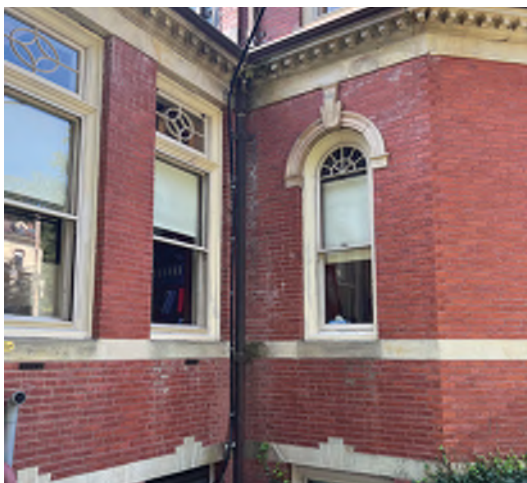
Image B-21: Severe brick masonry and mortar deterioration caused by ineffective copper gutters and downspouts.

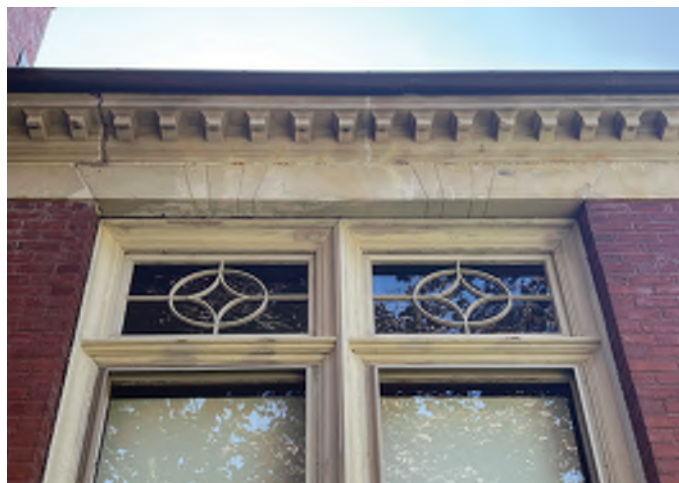
Image B-22: Deteriorated and cracked mortar joints at sandstone cornice caused by ineffective copper gutters and downspouts.

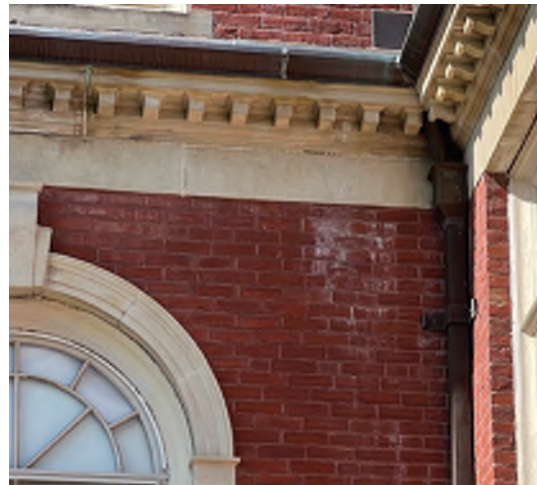
Image B-23: Staining and efflorescence at sandstone cornice and brick masonry caused by leaking gutter and downspout.

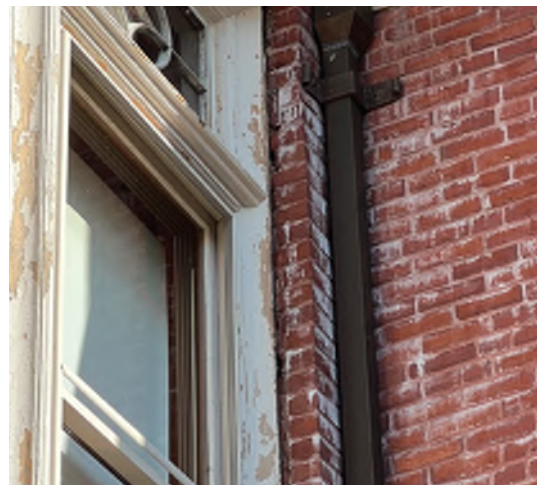
Image B-24: Spalled brick and eroded mortar joints at opening caused by leaking downspout and collector box.

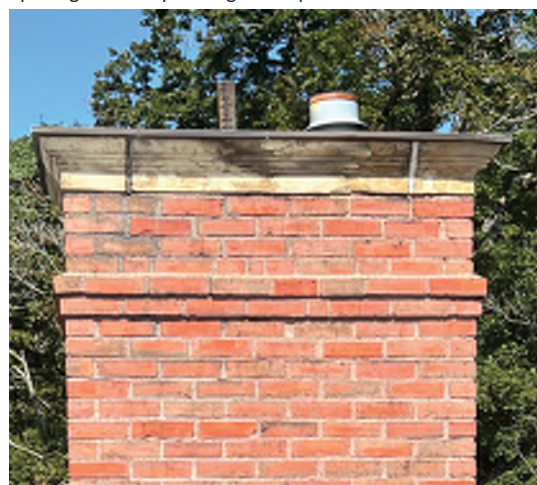
Image B-25: Deteriorated capstone at chimney.

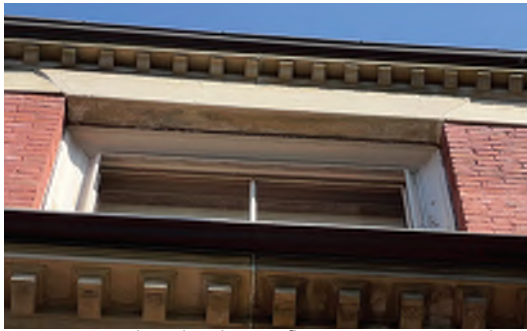
Image B-26: Bulging lintel at top floor or east projecting bay.

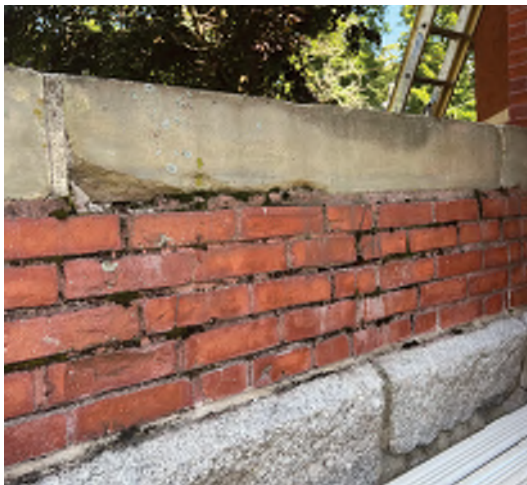
Image B-27: Severely deteriorated south site wall caused by water infiltration through sky-facing joints.

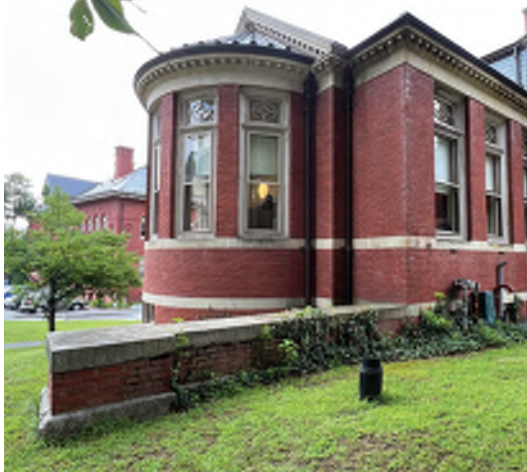
Image B-28: Severely deteriorated north site wall caused by water infiltration through sky-facing joints.

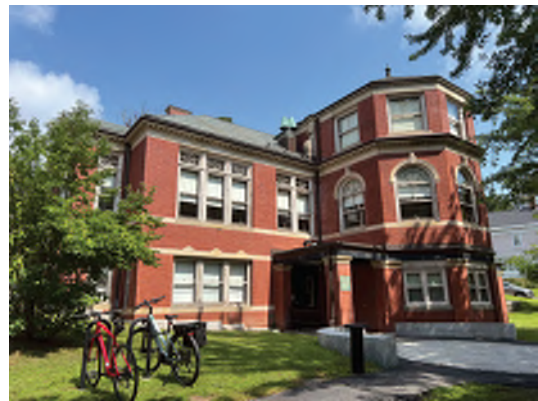
Image B-29: View of the southeast corner of the building showing various types of original and new windows

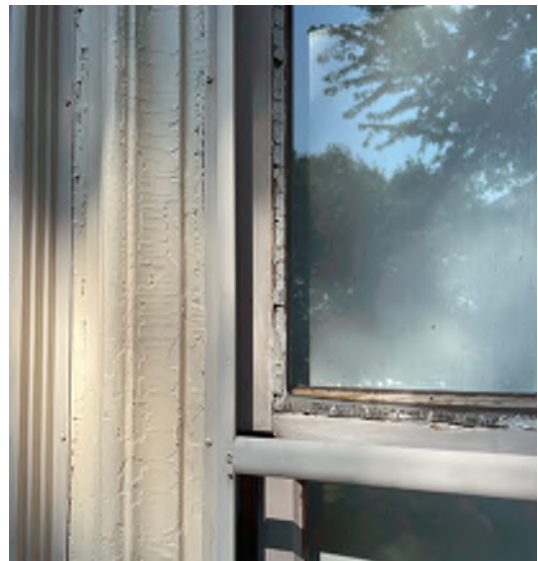
Image B-30: Close up of original window showing cracked glazing putty, aluminum storm window, and wood trim.

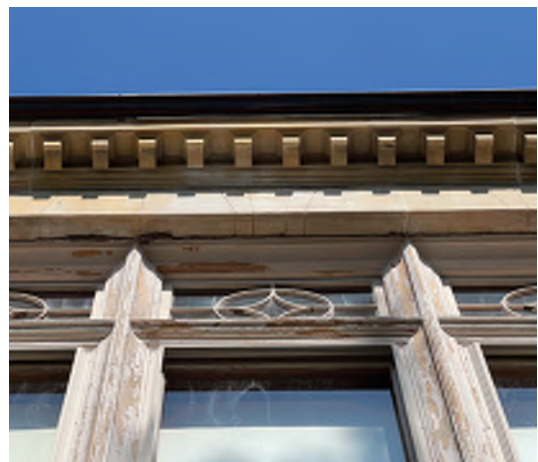
Image B-31: View of upper transom windows showing deteriorated caulking and brickmoulds.

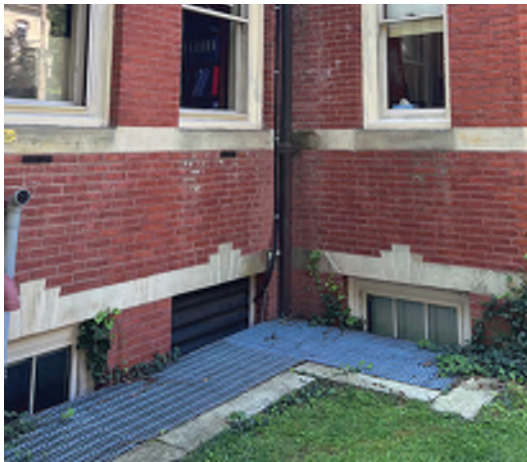
Image B-32: Grate over areaway leading to mechanical room.

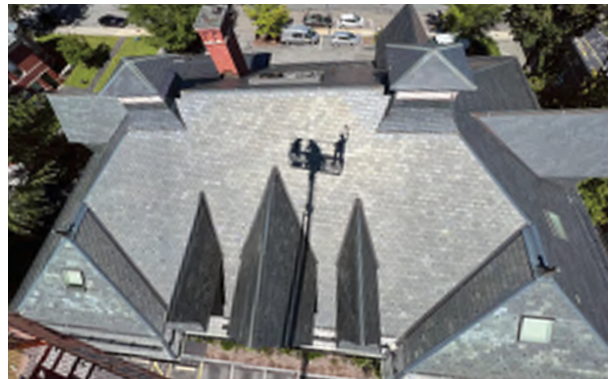
Image C-01: The Homer Building is comprised entirely of black slate in at least two textural varieties.

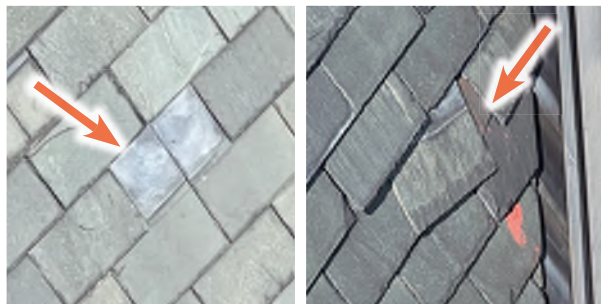
Image C-05: Select slates are missing entirely (or loose), often sliding down to be caught by the snowguard rails.

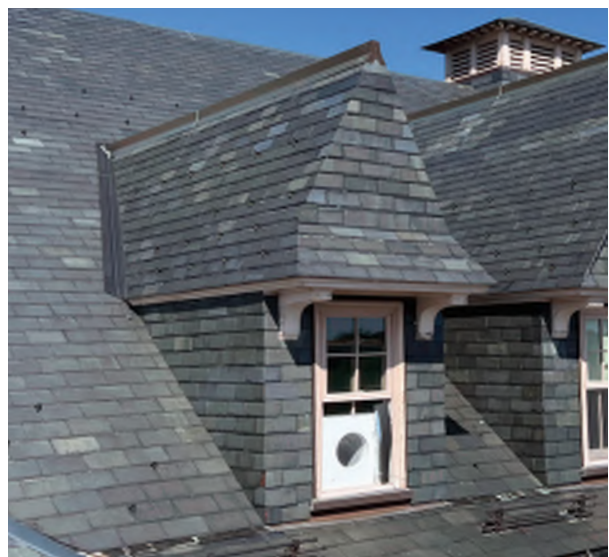
Image C-03: A unique, slate-clad dutch-gable dormer is a notable architectural feature on the southern facade.

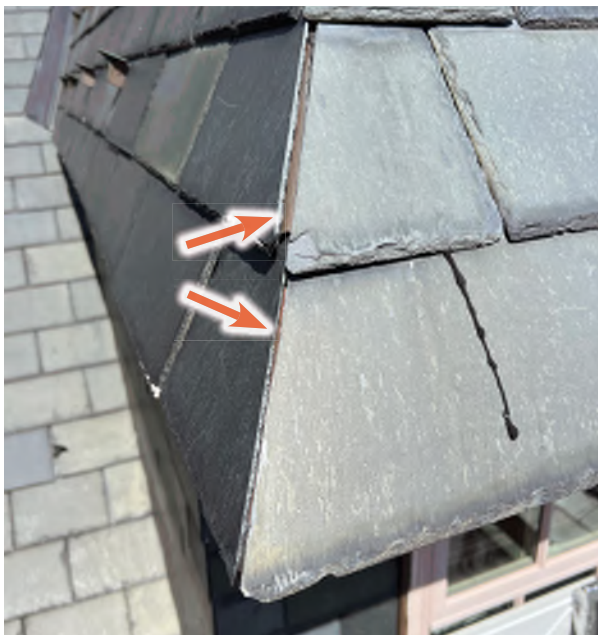
Image C-08: Interwoven flashing between the slate courses on the dutch gable dormer is a quality detail and water-resistant.

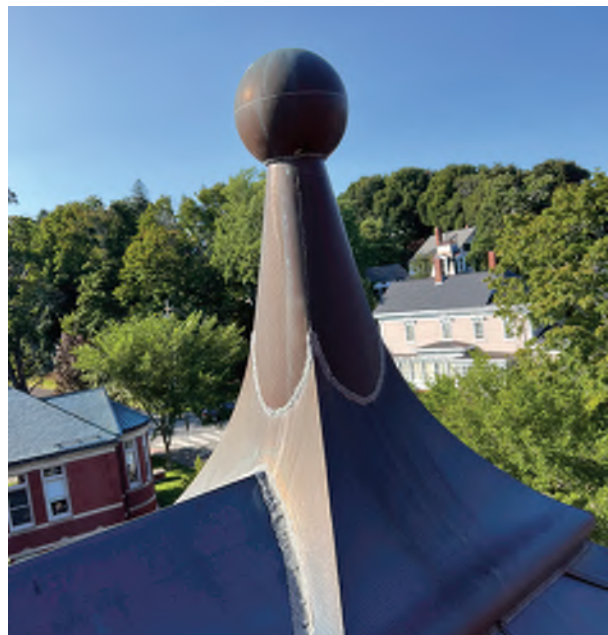
Image C-09: The rilled copper at ridge caps and finials are intact and in good shape..

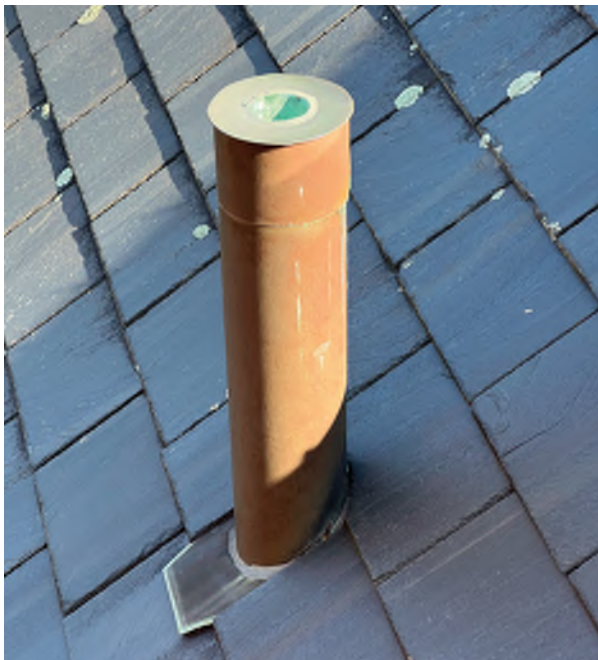
Image C-10: Copper vent pipes are in good shape, well-flashed, with solder joints intact.

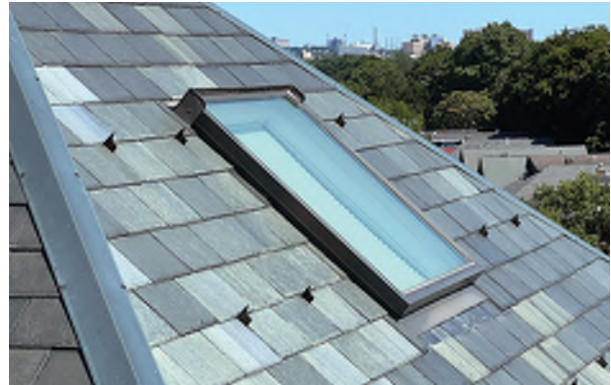
Image C-11: Modern skylight punctuate the slate roof in a few locations, with no reported leaking..
