EXISTING CONDITIONS ASSESSMENT

BELMONT, MA CIVIC COMPLEX

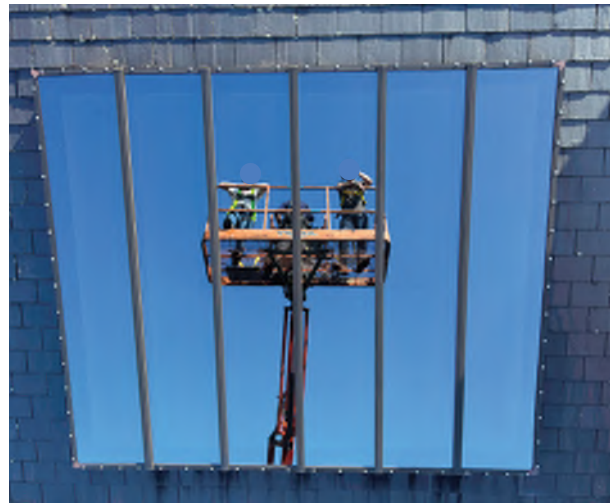
Image C-12: A large, generous modern skylight adorns the north roof slope, with no visible damage or compromised flashing.

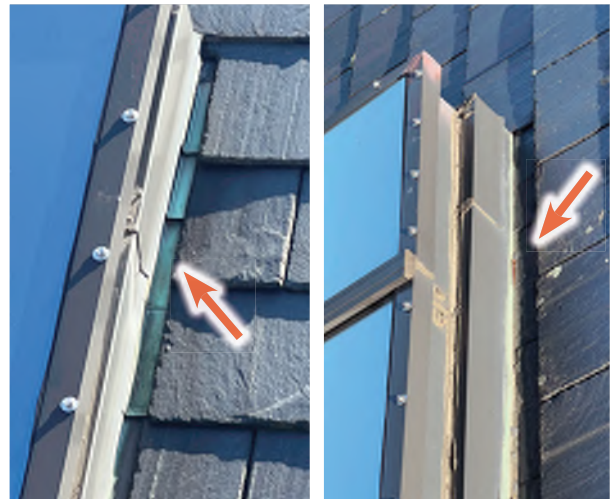
Image C-13: The large modern skylight appears to sit on an older copper curb, intact and without reports of leaking.

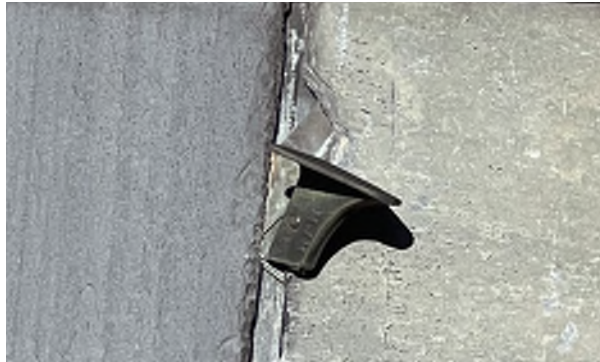
Image C-14: Bent retro-fit snowguard pads are prevalent and generally ineffective at snow-retention.

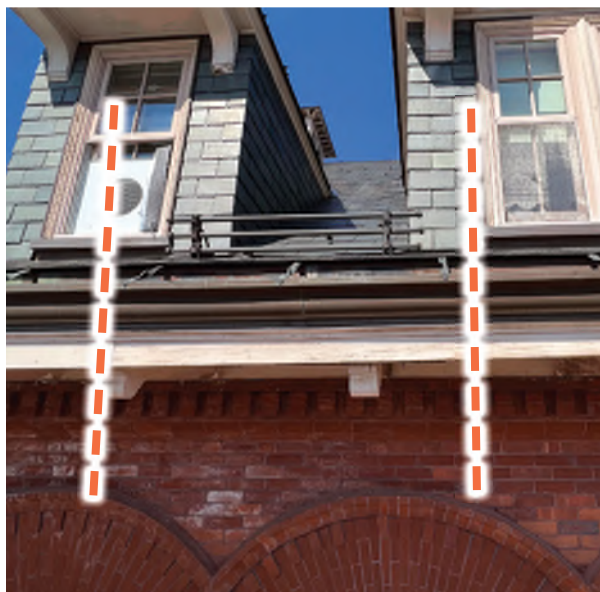
Image C-16: Wood and masonry deterioration appear to related directly to snowguard fences in areas between dormers.

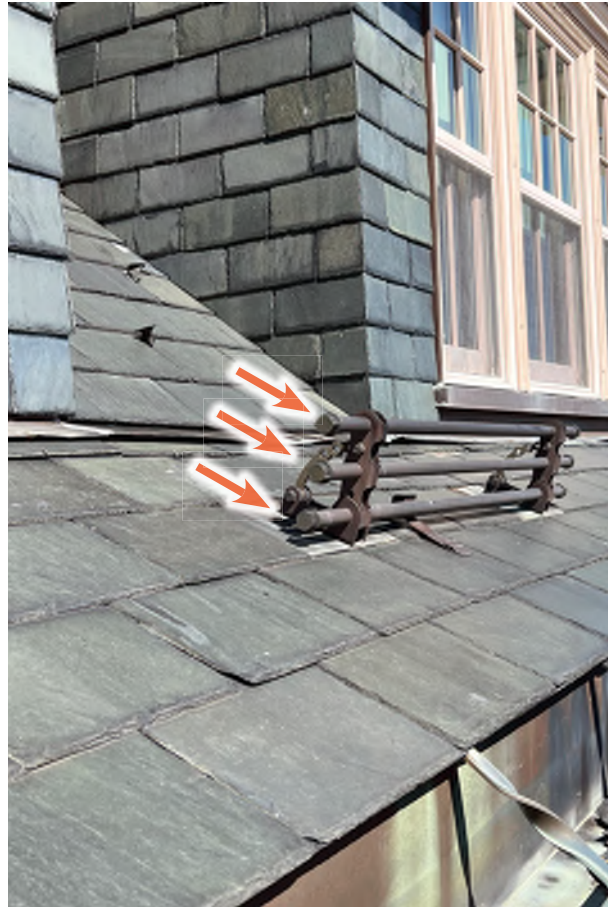
Image C-17: The 3-pipe snowguard fences can be easily detached without removing their brackets.

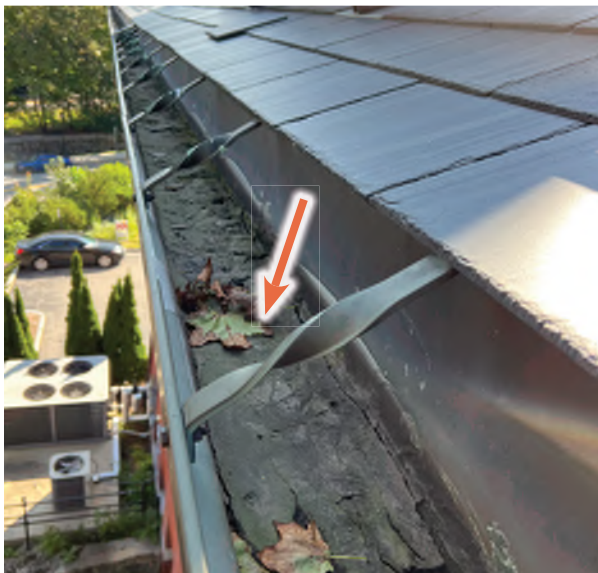
Image C-19: Compact gutter sediment and debris suggest improper pitch, allowing collection over time.

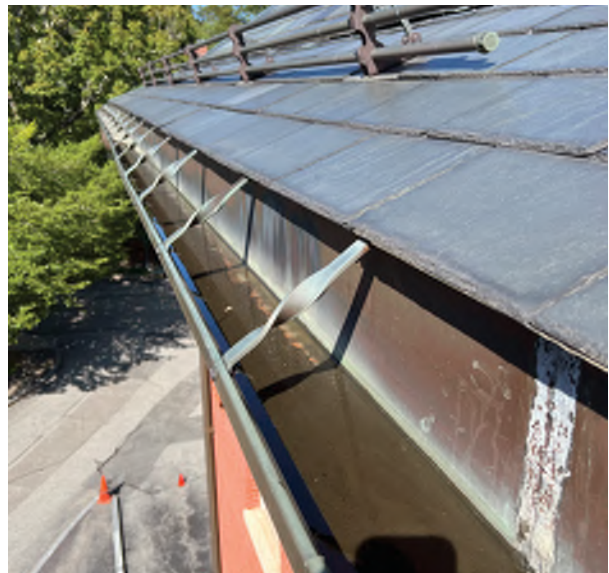
Image C-18: Ponding water in the gutters suggest improper drainage pitch.

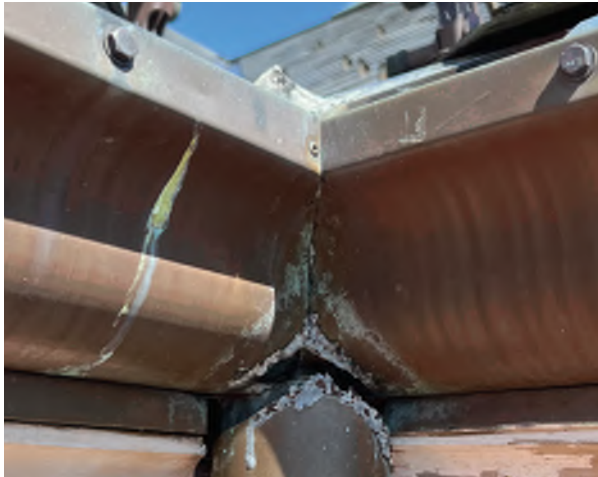
Image C-20: Aside from the discoloration, the copper is relatively recent and retains most of its sectional mass.

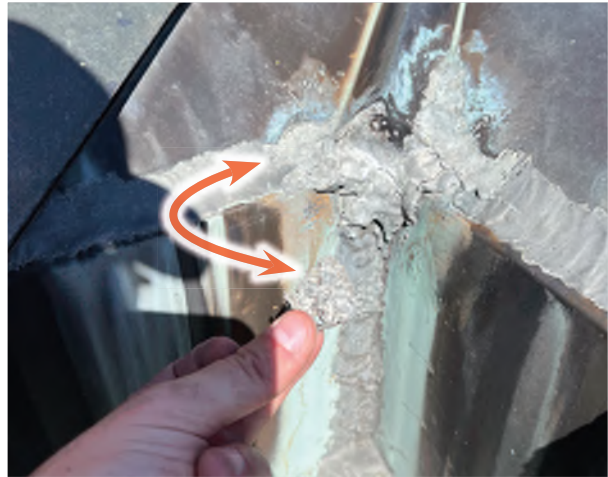
Image C-23: Large chunks of broken-off solder are indicative of unskilled application.

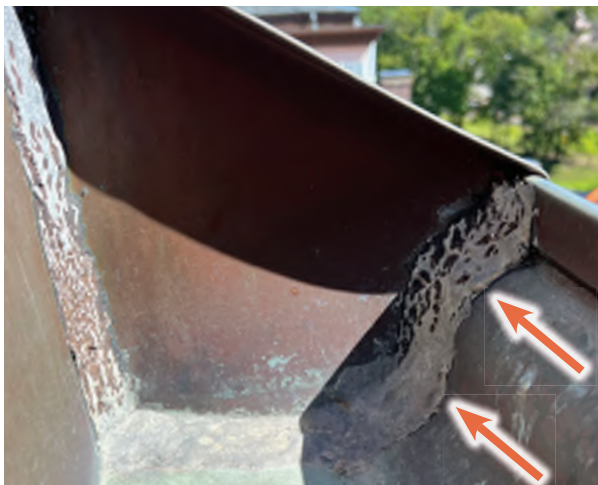
Image C-21: Hairline cracks at solder joints are a site for water to infiltrate the wood cornice below.

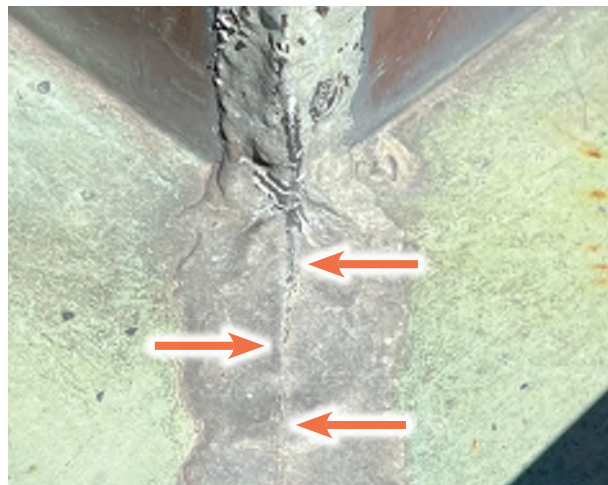
Image C-24: Hairline cracks at gutter miters suggest poor/inconsistent solder penetration.

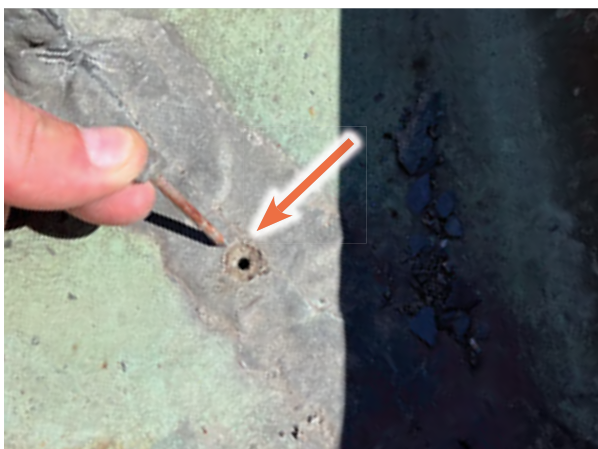
Image C-22: Nail holes in the solder joints render them virtually useless.

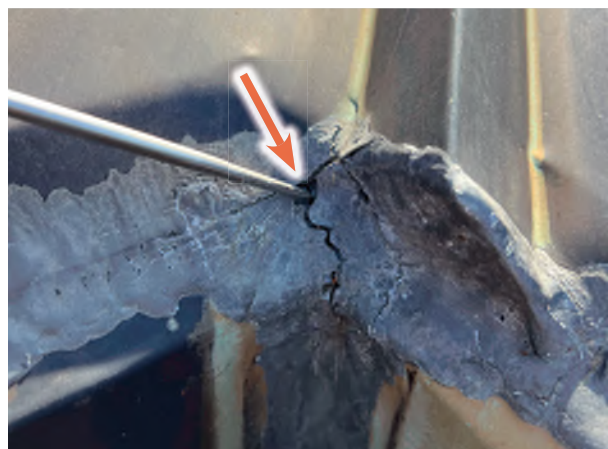
Image C-25: Large cracks at the intersection of copper valleys and gutters allow considerable water to enter and rot the woodwork.

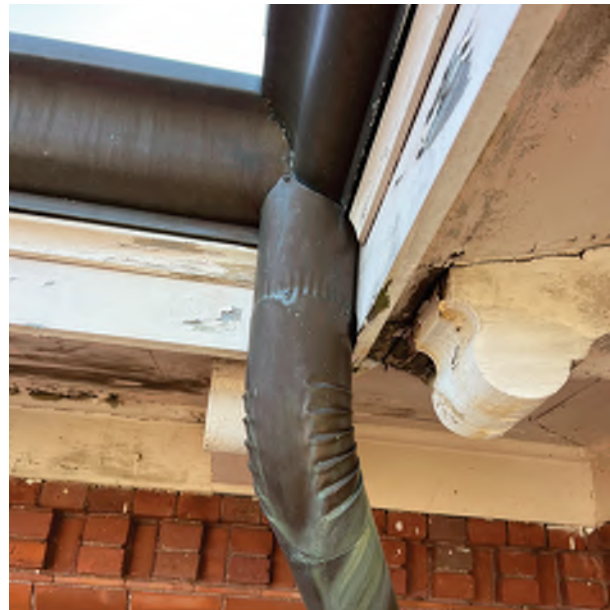
Image C-26: Copper downspout elbows are intact and appear to perform as they should.

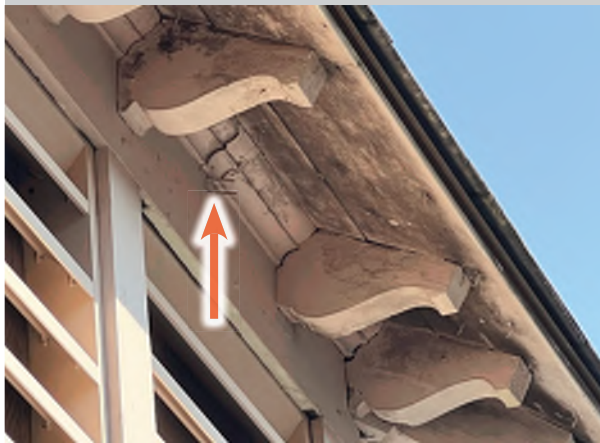
Image C-29: Missing brackets at the ventilator towers require replacement, and repainting overall.

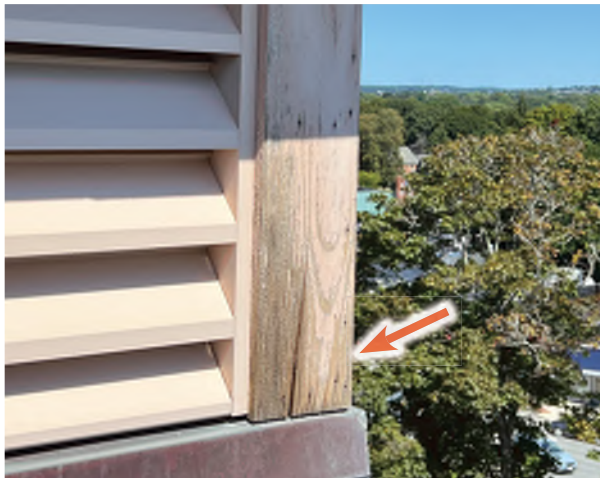
Image C-30: Low-quality wood corner boards have reached the end of their life.

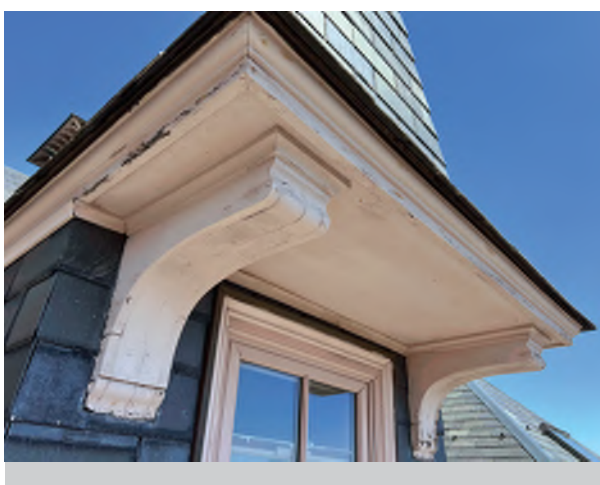
Image C-31: Most paint on the dormers require light scraping and a new coat.

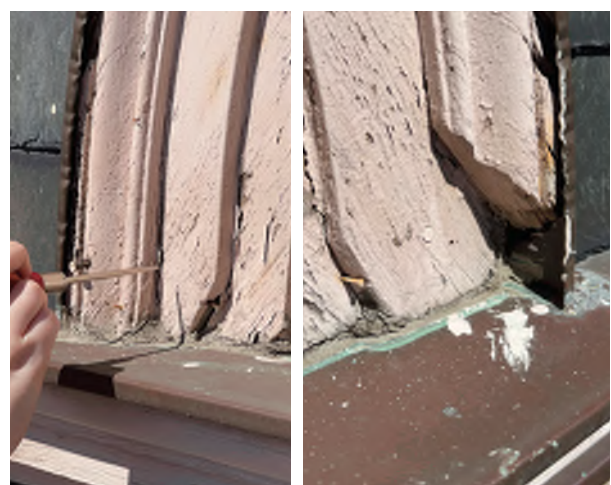
Image C-32: The arched dormer window casings would do well to receive epoxy consolidation for prolonged life.

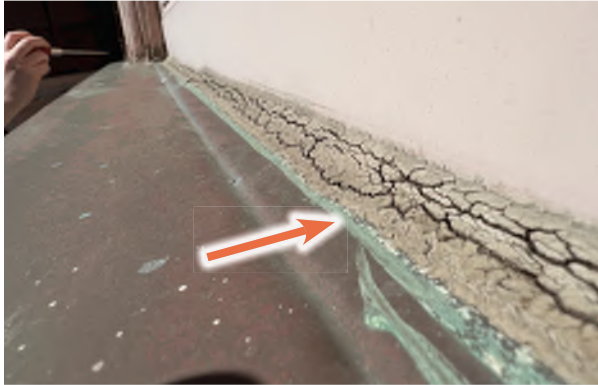
Image C-33: Cracked sealants between aluminum or vinyl windows and copper require replacement overall.

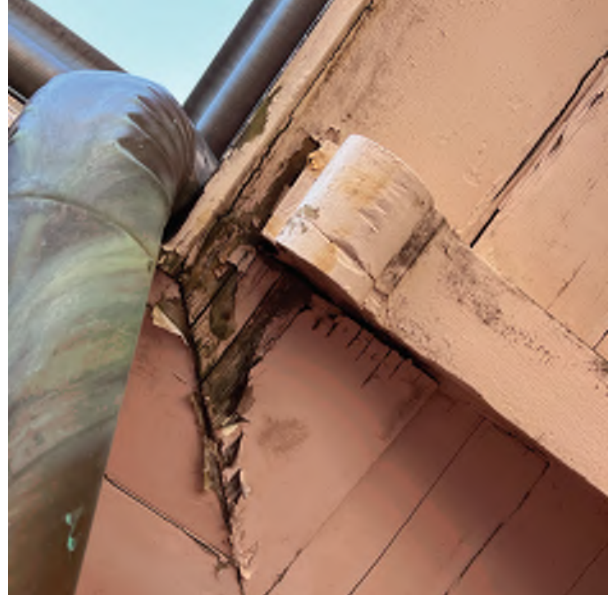
Image C-36: The worst of the cornice damage occurred at the inside corners of gutters where water is unimpeded.

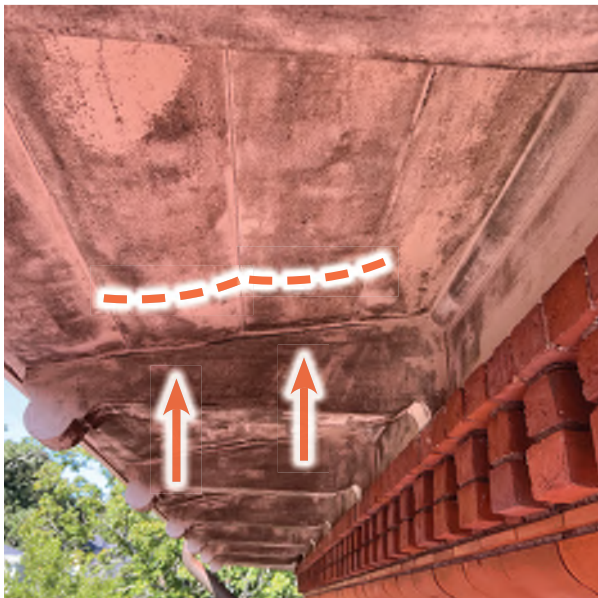
Image C-34: Cupping soffit boards suggest they have been damp in years past, possibly due to low-quality woods used in replacement..

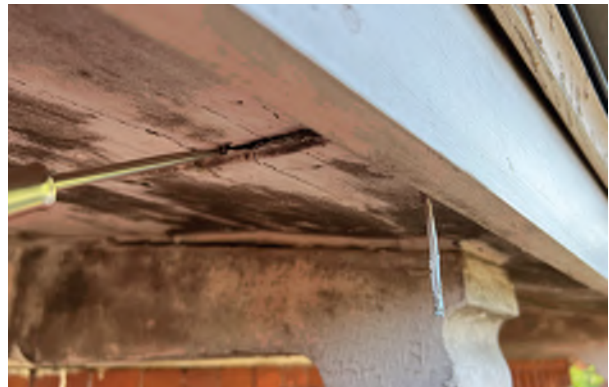
Image C-37: Soft end grain at soffit boards are pierced easily by an awl, suggesting they have been damp for some time.

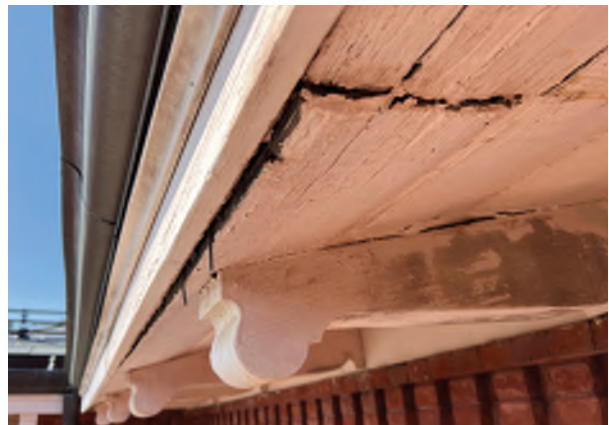
Image C-38: The worst of the woodwork is easily visible from below, requiring replacement.

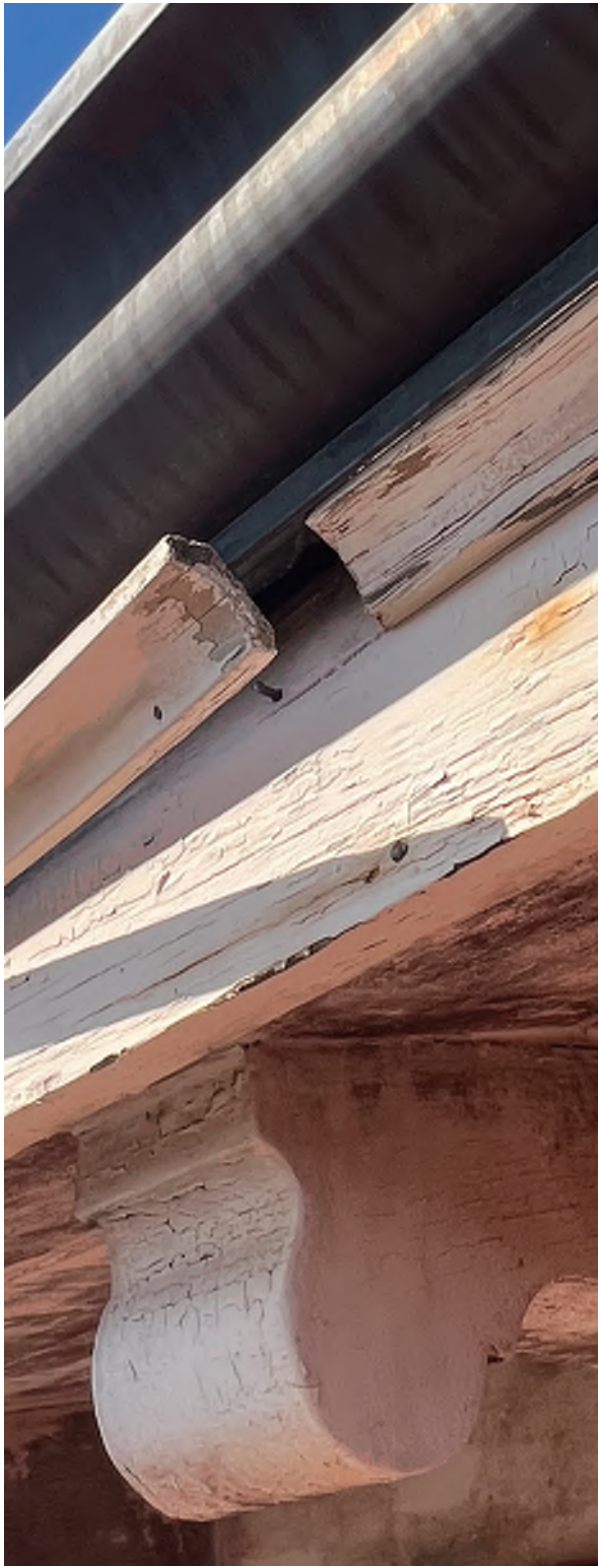
Image C-39: Thin and inexpensive bedmoulds for the gutters have not stood the test of time since gutter installation.

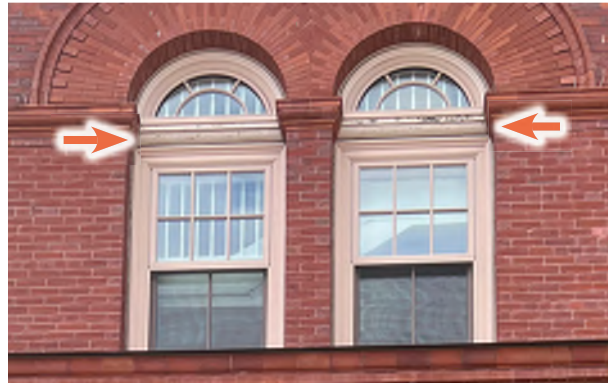
Image C-40: Two pairs of windows retain the sole visible woodwork, long since replacement by modern units.

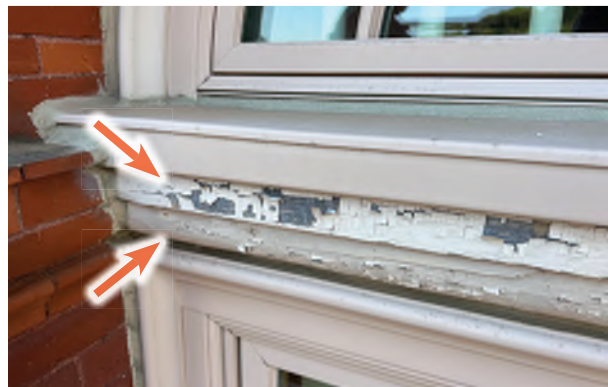
Image C-41: Though small, the remaining window wood transoms should be cared for and repainted.

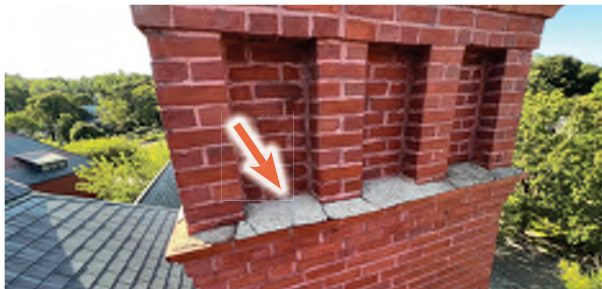
Image C-44: A deteriorating mortar wash at the chimney should be replaced to ward off standing water.

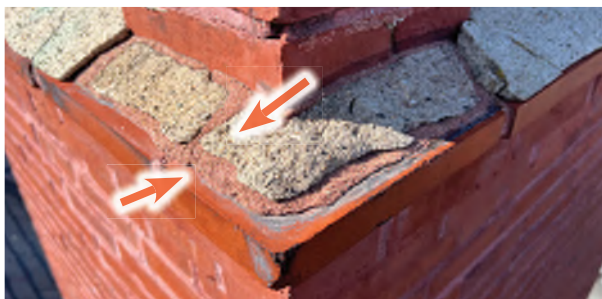
Image C-45: An earlier red-tinted mortar wash and the chimney should be re-applied.

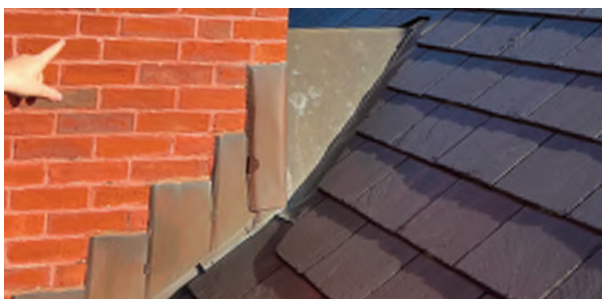
Image C-46: Base and stepped counter flashing, and a copper cricket, are all in good shape.

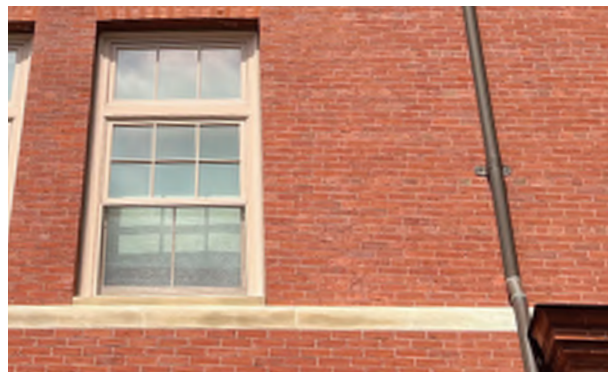
Image C-47: Overall, the building benefits from well-maintained masonry, all in excellent condition.

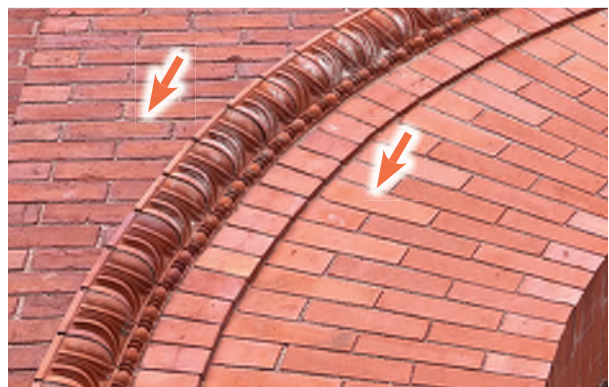
Image C-48: Standard brick units (left) stand in contrast with gauged and rubbed bricks at arches (right).

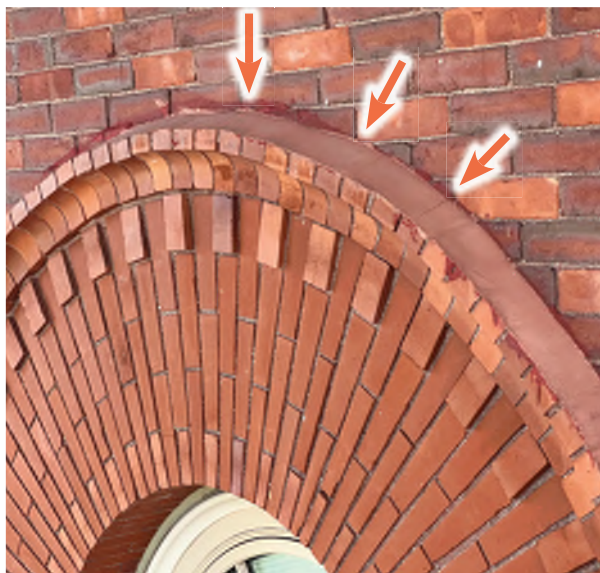
Image C-52: Red-tinted, smooth mortar at the upper archway surfaces appear to perform well..

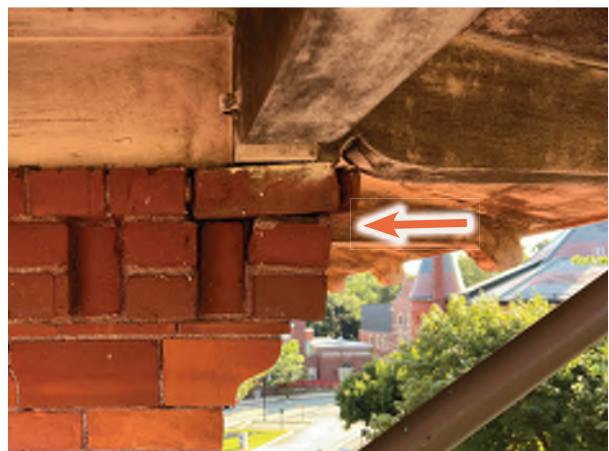
Image C-51: Loose bricks, notably at outside corners, require re-setting.

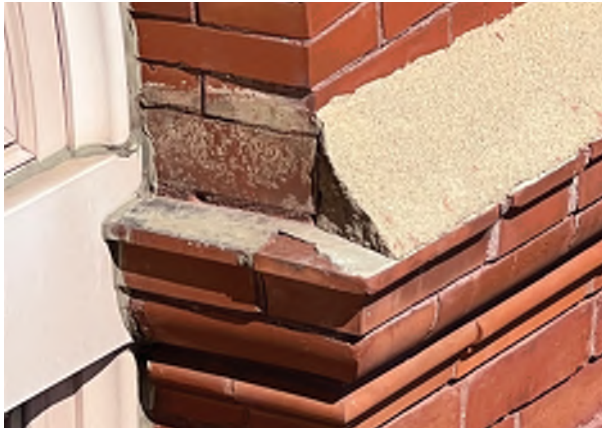
Image C-53: Although some in intact, chunks of the steep wash are randomly missing, mostly at the inner arch returns.

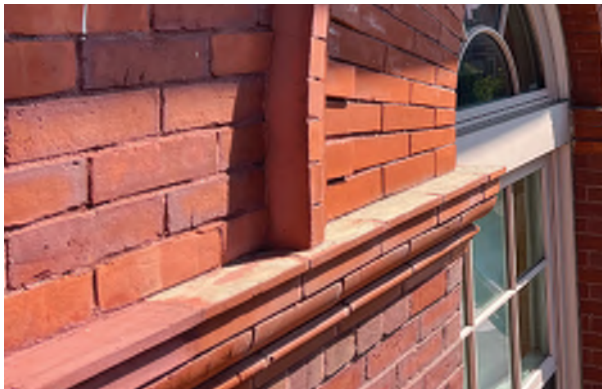
Image C-54: Elsewhere on the same projecting stringcourse, a missing mortar wash should be reestablished.

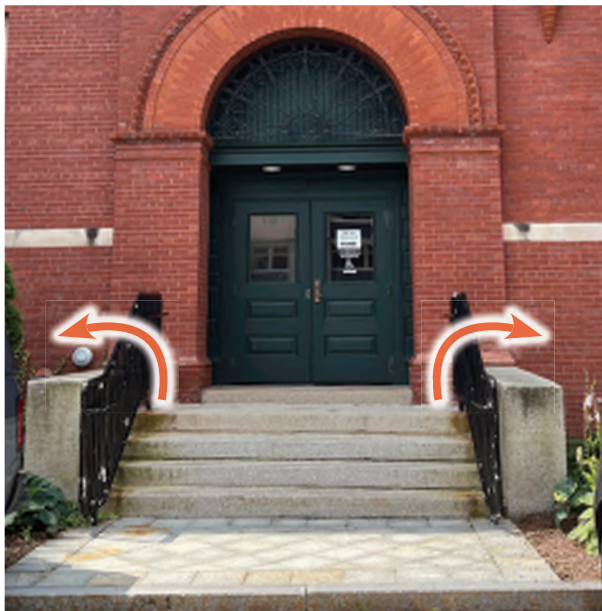
Image C-55: Rotating granite cheek walls at the north entry have slowly wreaked havoc on their adjacent bricks at the building.

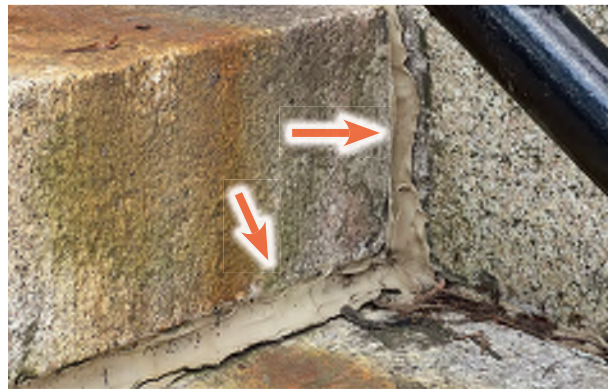
Image C-56: The slow shifting of granite treads are filled with sealants, wider and wider with each application.

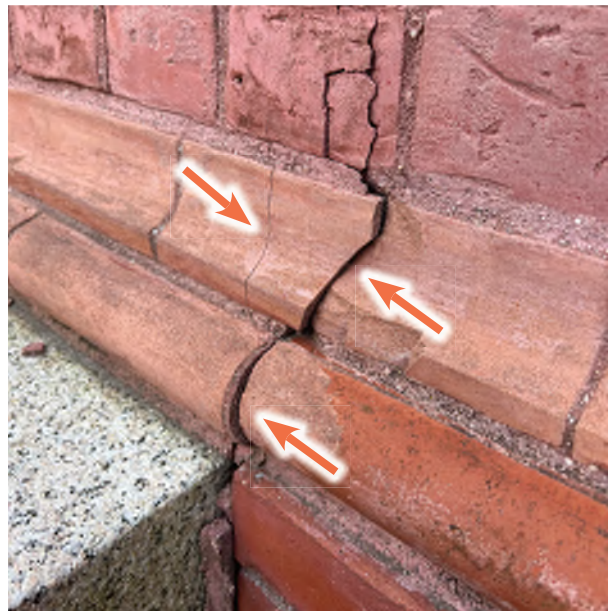
Image C-57: Upward thrust of the rotating granite cheek walls have cracked the brickwork at the intersection, consistently.

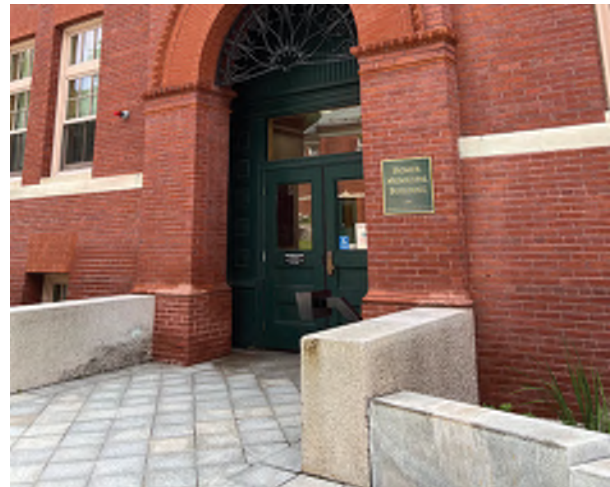
Image C-58: Similar rotating granite cheek walls have damaged the west entry brickwork as well..

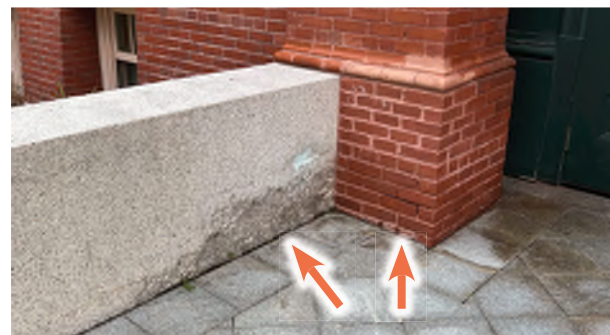
Image C-59: Excessive salts and de-icers at the high-traffic pavers have likely damaged both brick and granite.

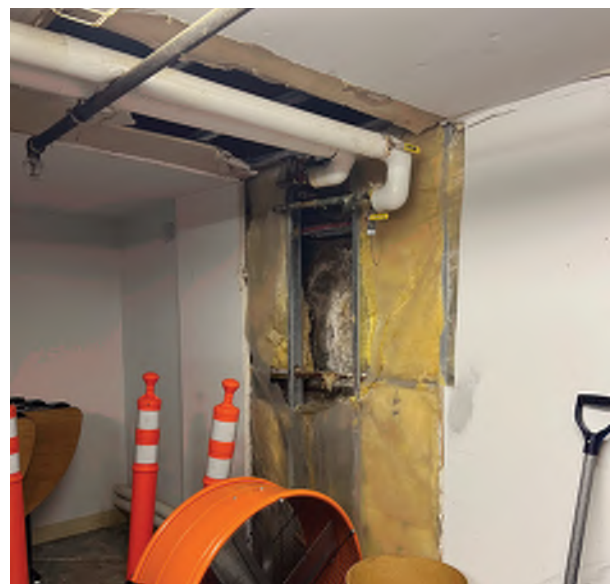
Image C-60: Internal leaks below the west entry suggest that water both ponds and enters the foundation..

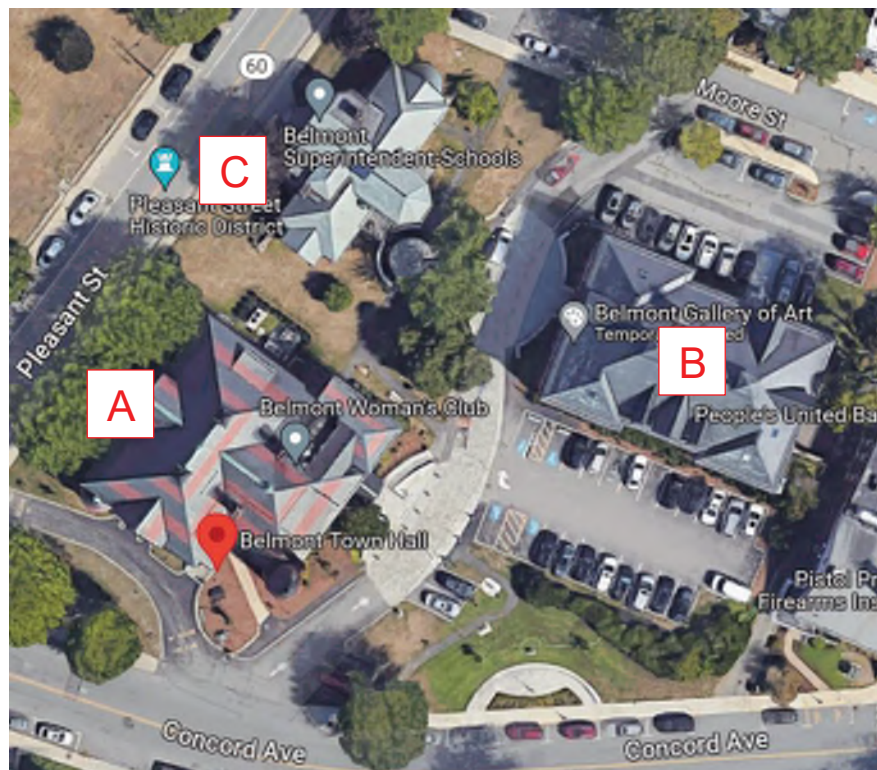
Figure 1: Overall View of Town Buildings

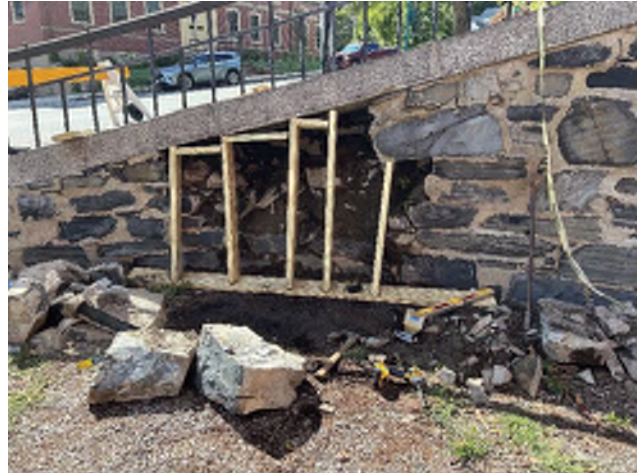
are directing water towards the walls, causing it to become trapped, freeze/thaw, and ultimately push the stones outward. A temporary support has been put in place to support the facing where the stones have fallen out.

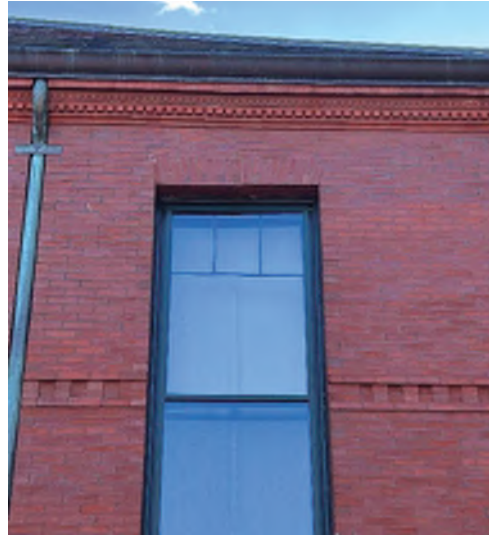
- There are several areas of spalling brick and efflorescence at splash-back zones where water, often laden with deicing salts, splashes against an adjacent wall surface and soaks into the brickwork. Under dry conditions, the water then evaporates back out of the brickwork and the salts crystalize just under the outer brick surfaces (a process called cryptoflorescence) and cause the units to spall. Where the brick is not deeply spalled, the mortar joints can be cut and repointed and a breathable water repellent coating can be applied to slow down this process. *Where bricks are significantly eroded, the bricks must be replaced with visually matching, but harder fired bricks that can better survive these effects.*

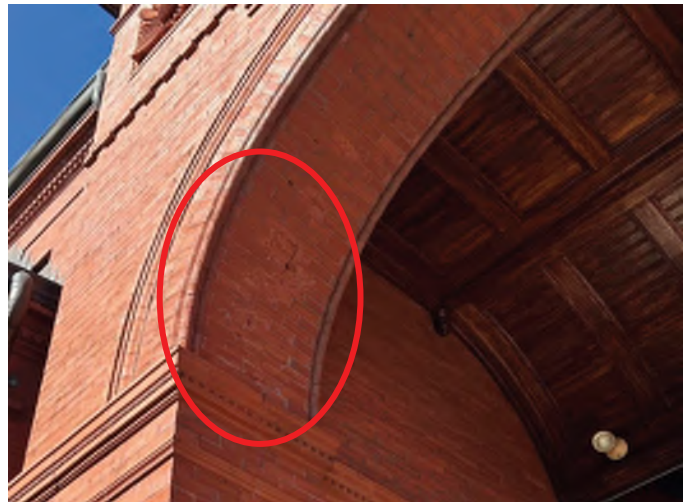
their bottom, outer surfaces to spall off during repeated freeze-thaw cycling. As it is both difficult and expensive to replace the bricks in these large arches, the best course of action is to try to slow down the water, most practically through cutting and pointing, flashing and sealing and/or

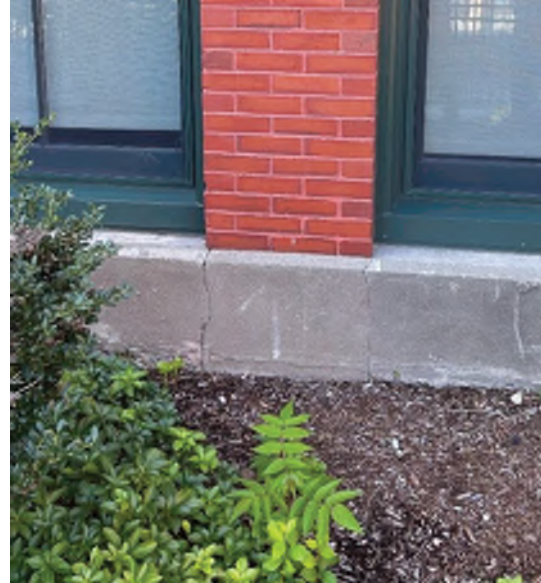
- We found three areas where the masonry appears to be bulging slightly. Two locations are at the second floor level windows on the east elevation and the other is at the same level on the north elevation. These areas should be probed further to determine the cause, which is most likely rust jacking of the outer steel lintel that runs over the openings and is causing the wall to bend outward. *If found to be significantly rusting, the lintel should be removed and replaced with galvanized steel, along with proper flashing.*

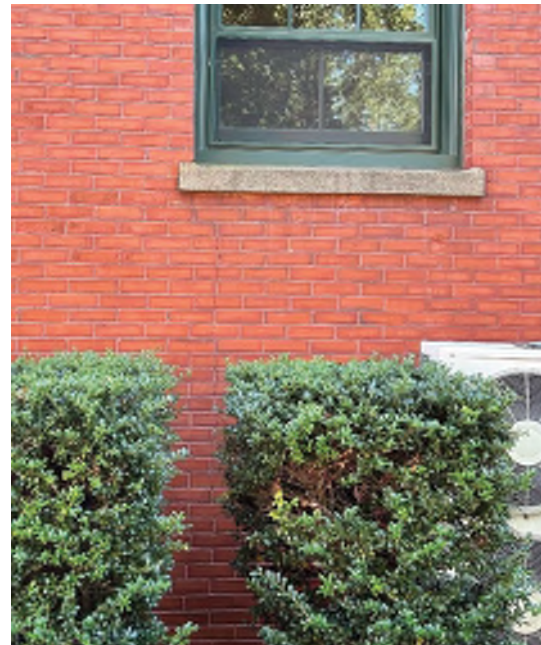
- We found a vertical crack at the first floor level of the north elevation along with cracked stone sills. Though further investigation is also needed, it is likely that the visible deterioration and resulting expansion of unloaded brick masonry below the windowsill has caused it to crack and bend upward. This expansion has also caused the brickwork to crack. *The sill and deteriorated brickwork should be dismantled with the sill being repaired with stainless steel pins and epoxy or it should be replaced.*

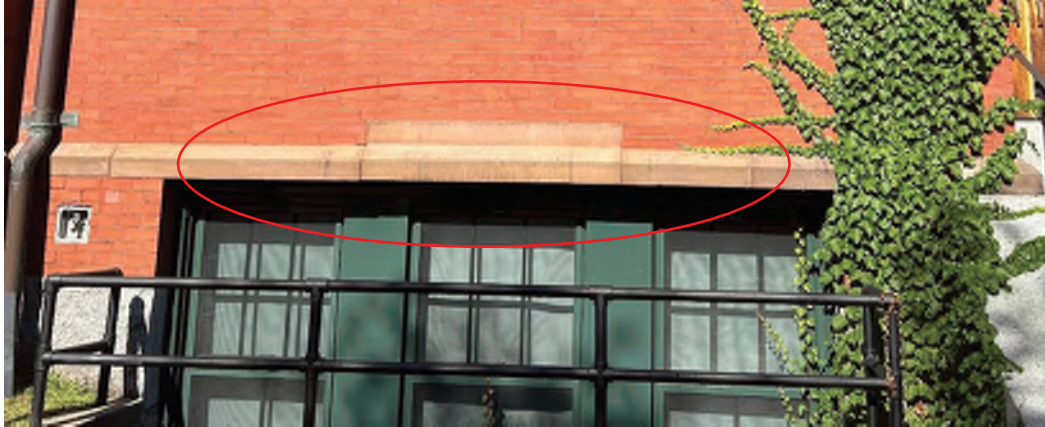
B. The Town Hall Annex:

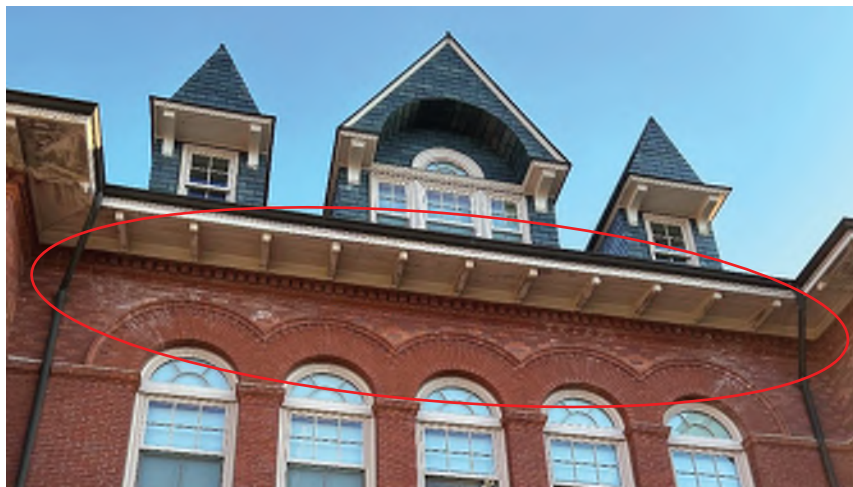
- One of the wooden soffit of the cornice appears uneven *and should be checked as to its attachment to the supporting framing from which it is suspended.* (See photo on following page)

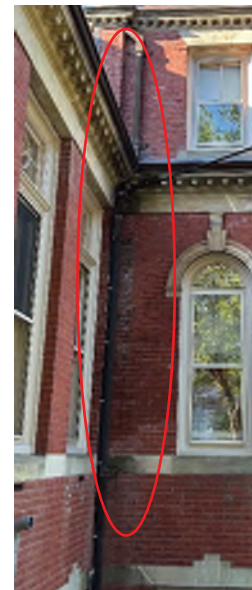
- We also found a few stones, both lintels and sills, that had chips or spalls in them *that should be patched with a matching stone repair mortar.*
- There are two brick masonry walls on the north and south sides of the Administration building that are starting to fail, more so on the south elevation than the north. The brick walls have precast coping stones on top, with deteriorating mortar joints. Water is penetrating into the wall, through the sky facing mortar joints and starting to bulge the masonry and erode the mortar. *Both walls will need to be rebuilt, with either a through wall flashing system or lead weather caps incorporated into the design to prevent water infiltration.*

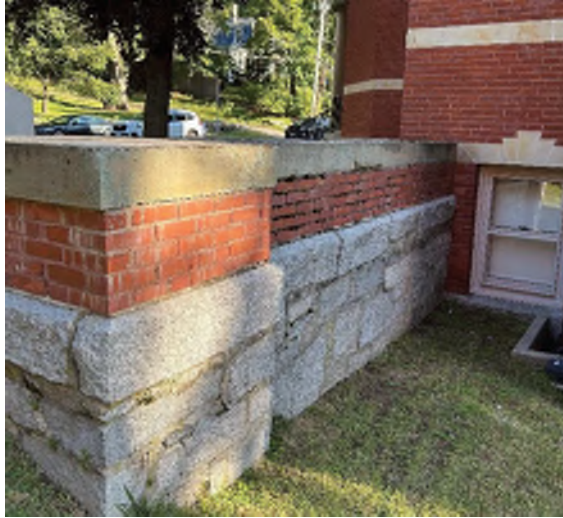
Thank you for the opportunity to evaluate this beautiful collection of Belmont's town buildings. Please reach out to our office should there be any questions or concerns.

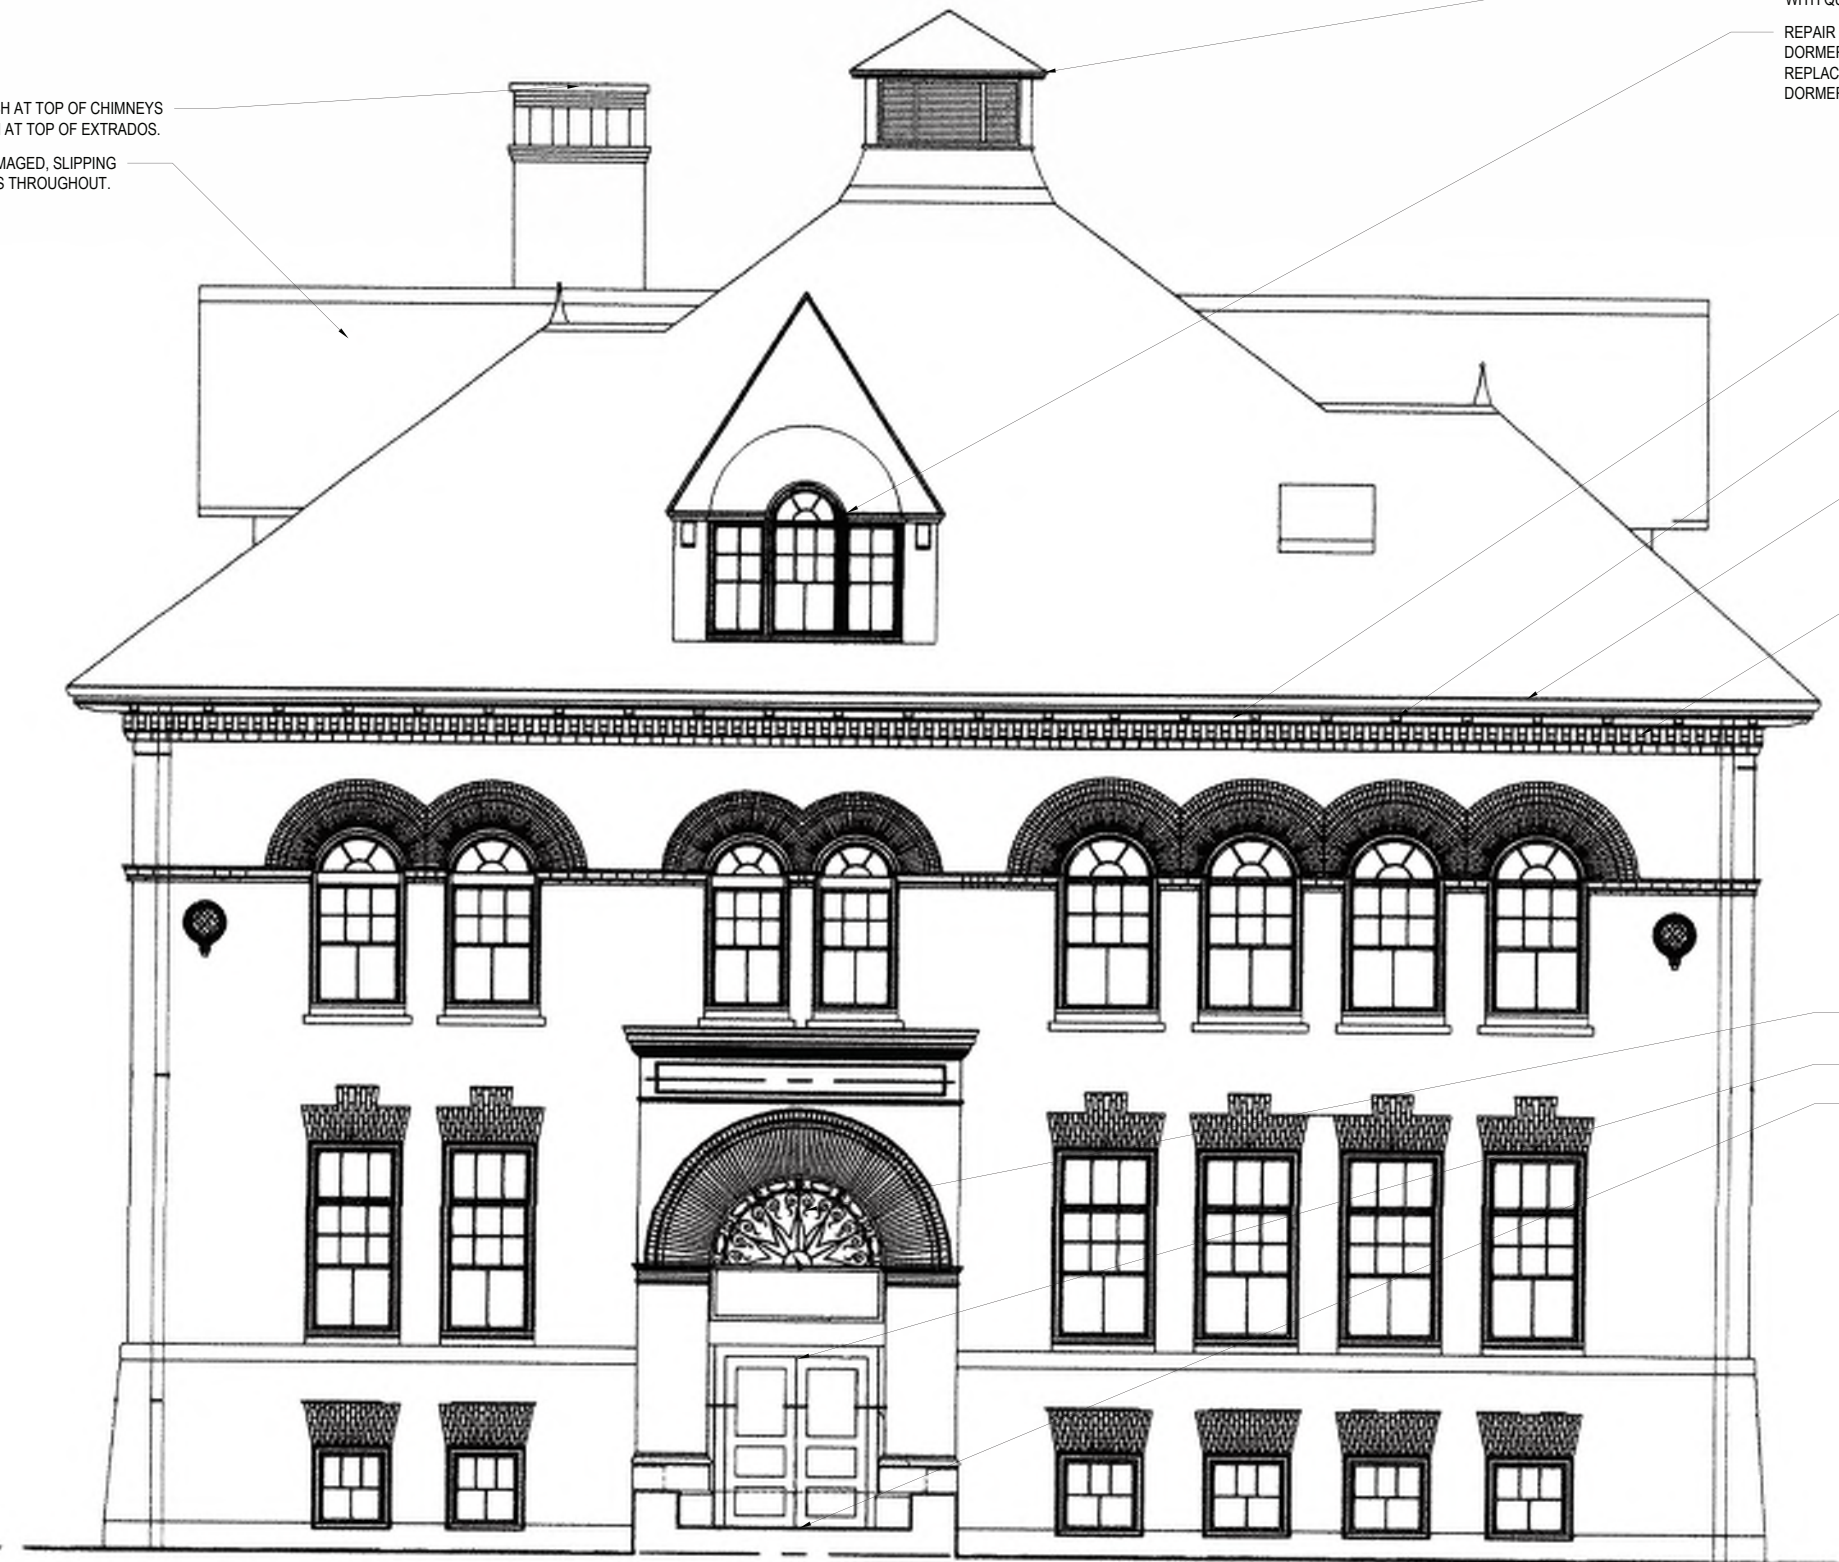
REMOVE PATIO PAVERS AT WEST FACADE ENTRY TO EXPOSE FOUNDATION AND SOURCE OF BASEMENT LEAKS. REBUILD DAMAGED MASONRY AND WATERPROOF BEFORE REINSTALLING PAVES WITH PROPER PITCH AND DRAINAGE CONSIDERATIONS. RESET SHIFTING MONOLITHIC GRANITE CHEEK WALLS AT WEST FACADE ENTRY AND CONSIDER REVERSING SLABS TO HIDE DAMAGE AT BASE. REPLACE SPALLED/CRACKED BRICKS USING SALVAGED UNITS. REPOINT MASONRY IN AFFECTED AREAS.
