EXISTING CONDITIONS ASSESSMENT

BELMONT, MA CIVIC COMPLEX

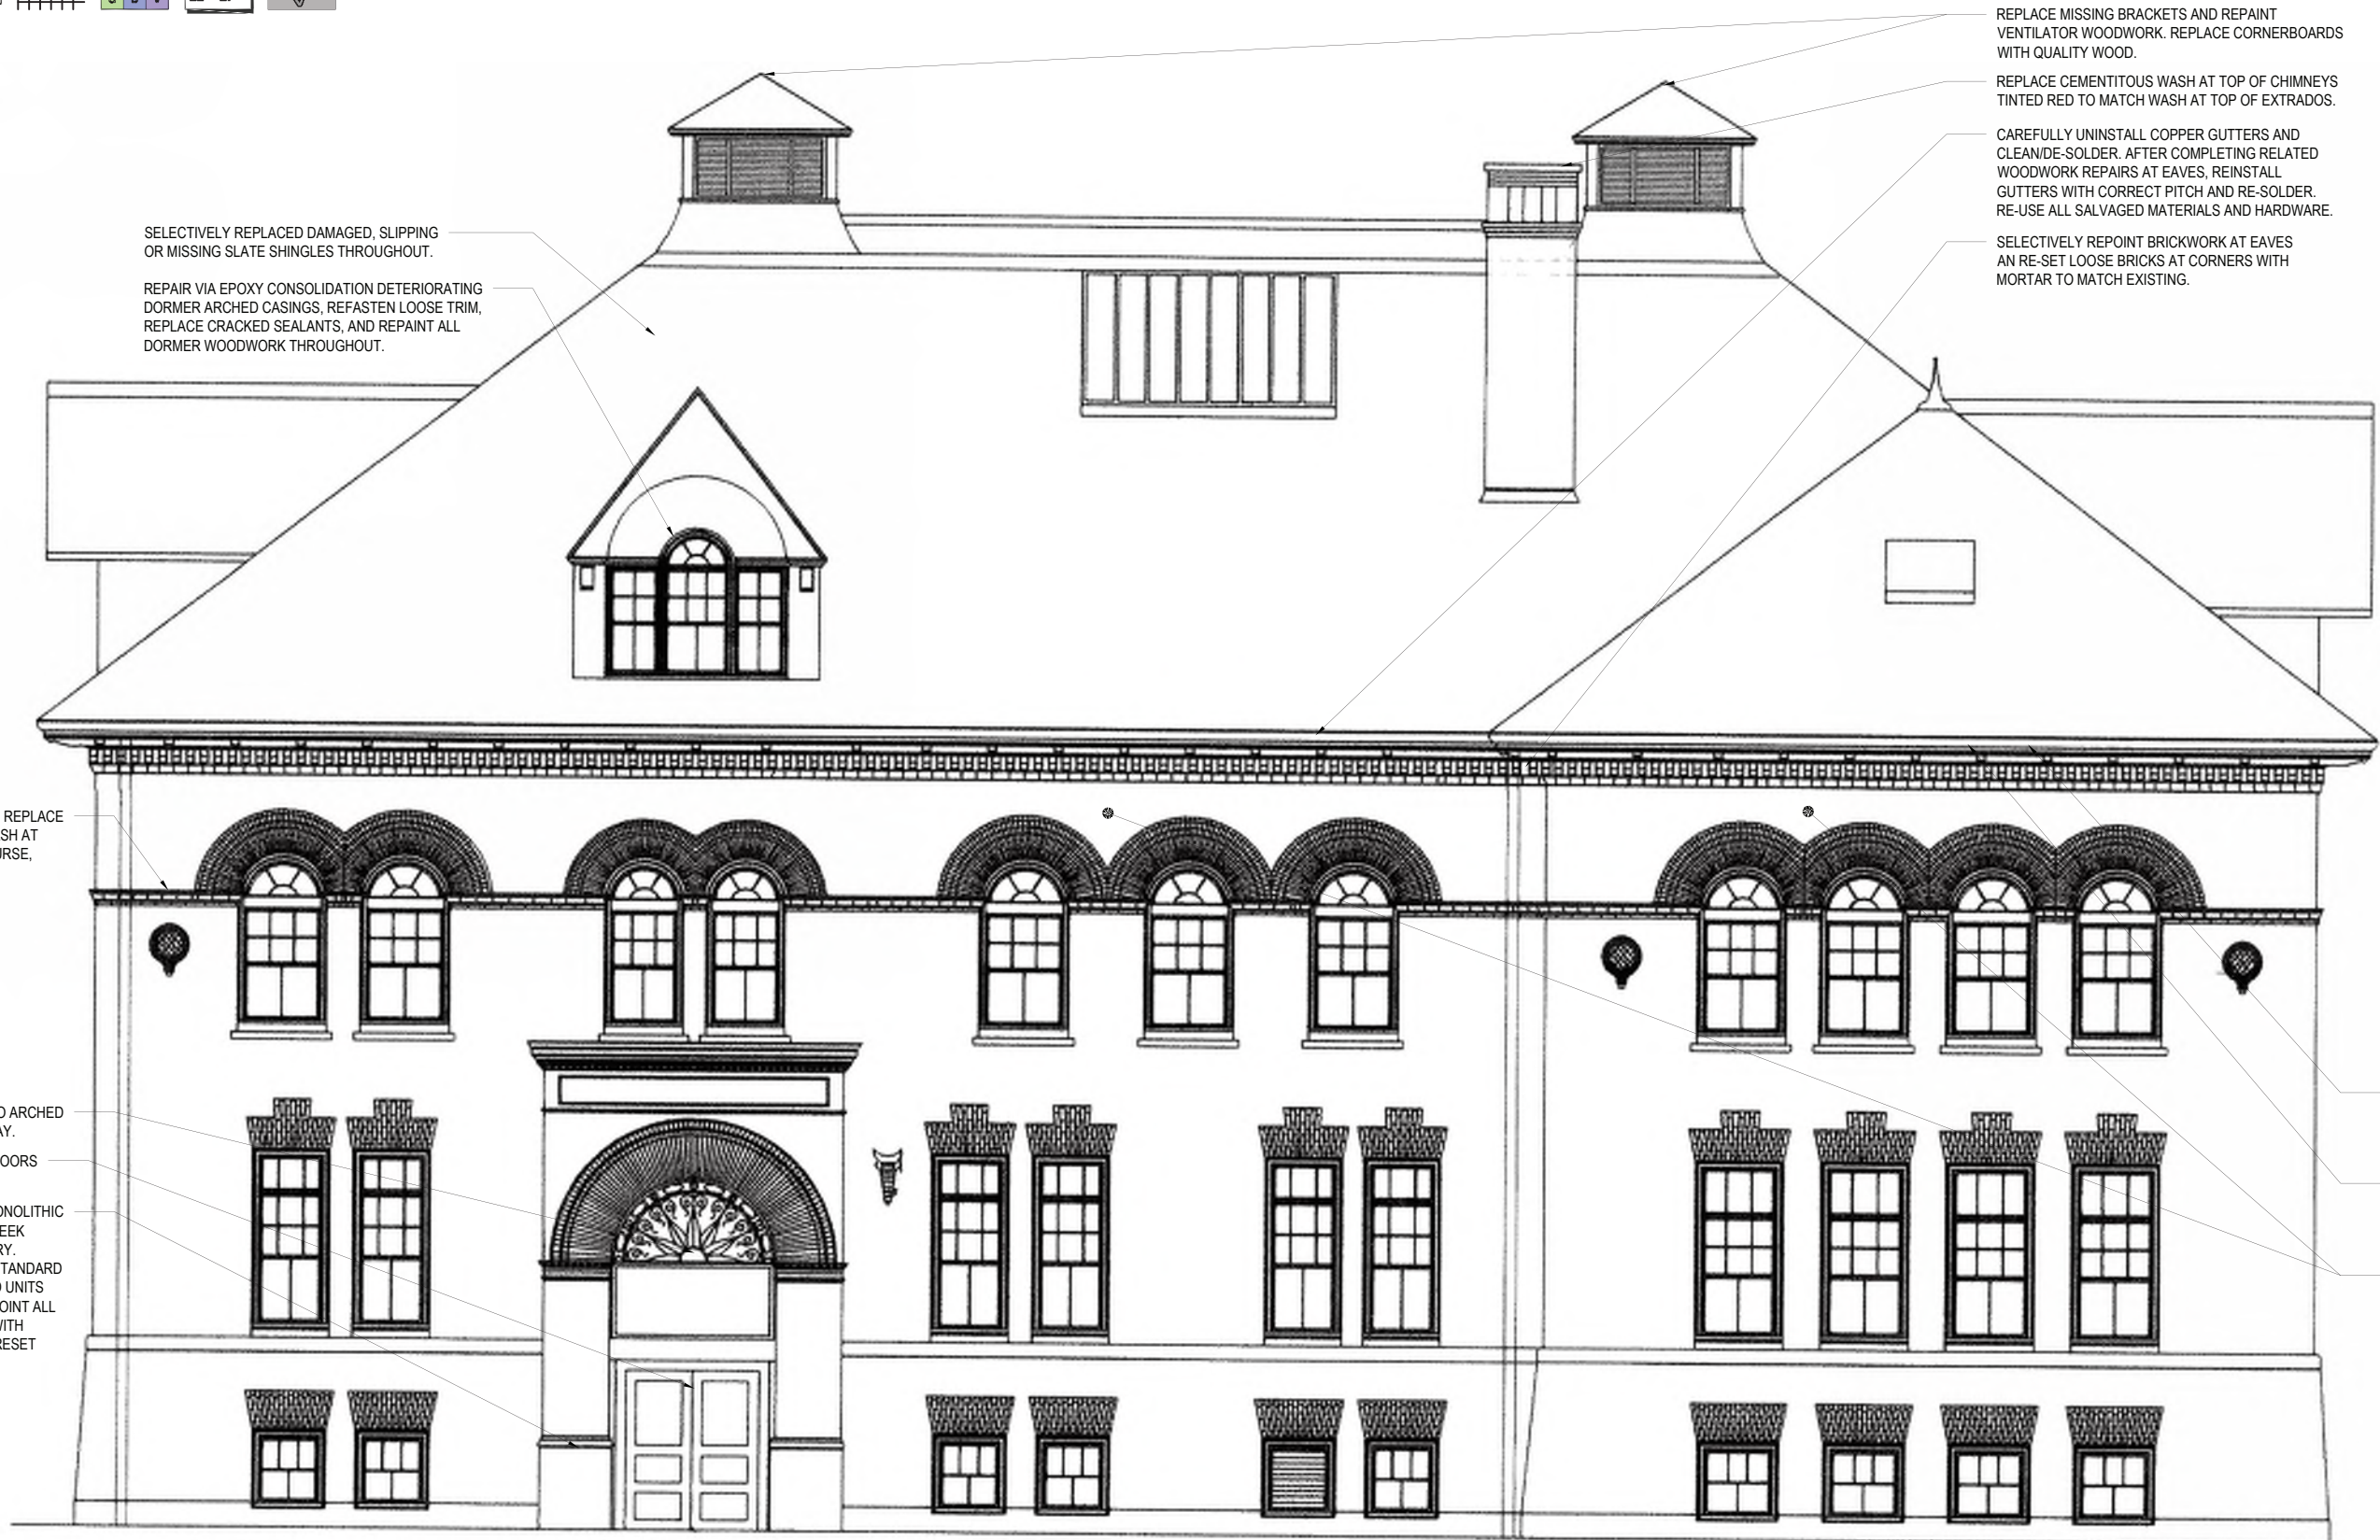
SELECTIVELY REPLACED DAMAGED, SLIPPING OR MISSING SLATE SHINGLES THROUGHOUT.
