STRUCTURES INSPECTION FIELD REPORT

ROUTINE & SPECIAL MEMBER INSPECTION

CITY/TOWN BELMONT=WALTHAM		8.-STRUCTURE NO. B07015-7VB-MUN-CUL		11-Kilo. POINT 000.000	41-STATUS D:OPEN	90-ROUTINE INSP. DATE MAY 2, 2022	
07-FACILITY CARRIED ST 60 TRAPELO RD			MEMORIAL NAME/LOCAL NAME		27-YR BUILT 1850	106-YR REBUILT 1900	YR REHAB'D (NON 106) 0000
06-FEATURES INTERSECTED WATER BEAVER BROOK			26-FUNCTIONAL CLASS Urban Arterial		DIST. BRIDGE INSPECTION ENGINEER J. Dideo		
43-STRUCTURE TYPE 801 : Masonry Slab			22-OWNER Town Agency	21-MAINTAINER Town Agency	TEAM LEADER <i>Joseph J. Dideo</i> T. Leiper		
107-DECK TYPE 1 : Concrete Cast-in-Place			WEATHER Clear	TEMP. (air) 12°C	TEAM MEMBERS P. BURKE <i>P. Burke</i>

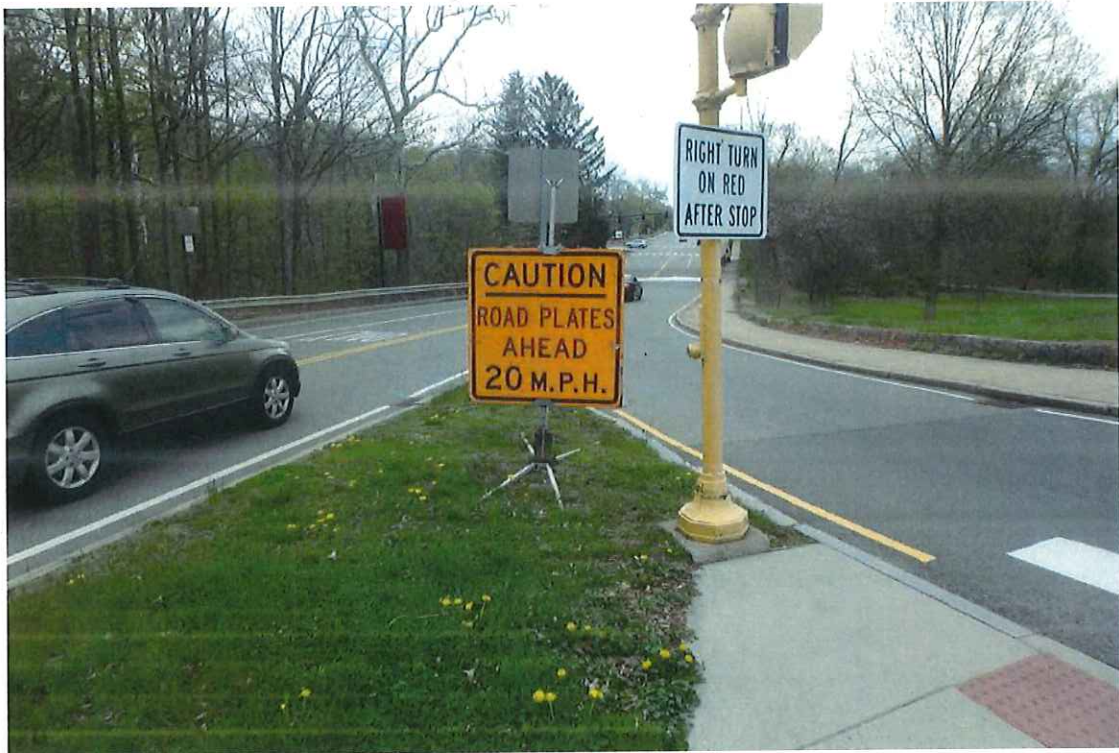
- Sketch 1 : Roadway Plate Conditions
- Sketch 2 : Superstructure Conditions
- Sketch 3 : Steel Beam Conditions
- Photo 1 : "Caution" sign in-place at the west approach.

Photo 1: "Caution" sign in-place at the west approach.

"Caution" signs were placed at both approaches. **See Photos 1 & 2.**

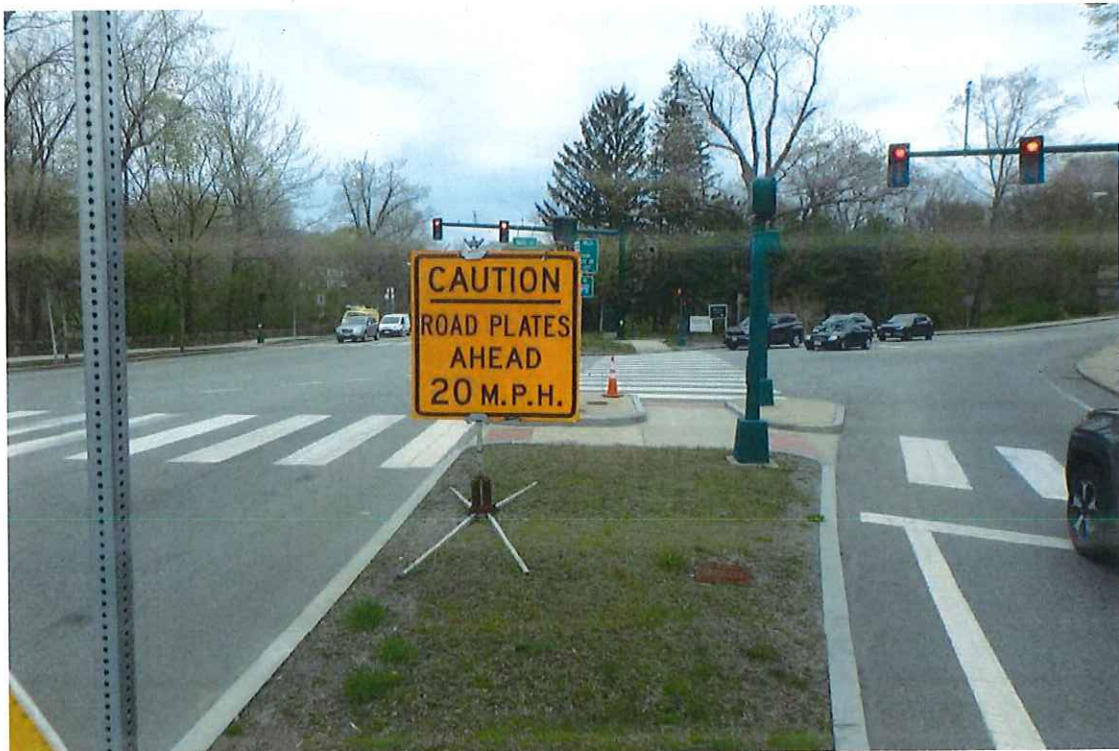
- Photo 2 : "Caution" sign in-place at the east approach.
- Photo 3 : Steel Plate 4 and 5 at the northeast corner repaired potholes and a 2'-0" W x 7" L patch with radial cracking.

Photo 2: "Caution" sign in-place at the east approach.
