Project Description

Belmont Town Hall

Metal Railing and Stone Retaining Wall Study
455 Concord Avenue, Belmont, MA 02478

February 12, 2018

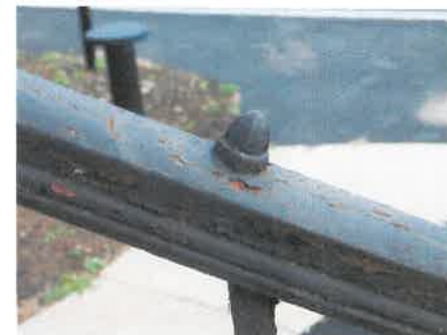
5 Existing Top Rail Photo
12" = 1'-0"

2. The curved section of railing is in very poor condition with many broken sections of the cast iron top rail or cap as well as a lack of dimensional conformance to guard rail requirements.
